AIRCRAFT ACCIDENT REPORT AND EXECUTIVE SUMMARY

Reference:		CA18/2/3/10337	
Aircraft Registration	ZS-TFH	Date of Accident	21 June 2023		Time of Accident	1436Z	
Type of Aircraft	Air Tractor AT- 802A			Type of Operation		Aerial Works - Firefighting (Part 137)	
Pilot-in-command Licence Type	Commercial Pilot Licence (CPL)		Age	49	Licence Valid	Yes	
Pilot-in-command Flying Experience	Total Flying Hours		3 146.80		Hours on Type	273.2	
Last Point of Departure	Nelspruit Airport (FANS), Mpumalanga Province						
Next Point of Intended Landing	Elandshoogte Airfield near Ngodwana, Mpumalanga Province						
Damage to Aircraft	Destroyed						
Location of the accident site with reference to easily defined geographical points (GPS readings if possible)							
Nooitgedacht Plantation (SAPPI) in Ngodwana at GPS co-ordinates 25°39'33.03" S 030°32'10.01" E at an elevation of 6322 feet (ft)							
Meteorological Information	Wind direction: 080°; wind speed: 2 kts; visibility: 5km; cloud cover: scattered; cloud base: 1 300ft; temperature: 19°C; dew point: 11°C; QNH: 1019

Probable Cause/s and/or Contributory Factors							
The pilot misjudged the climb height required to clear the terrain. This resulte

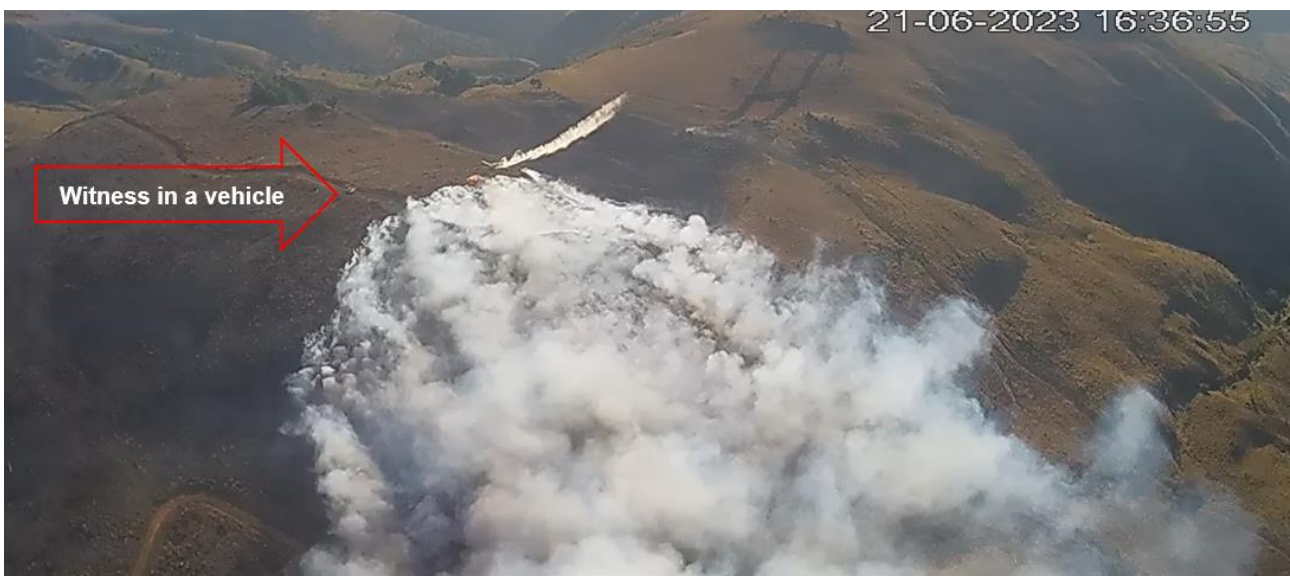
Figure 1: ZS-TFH as it released its second load of water. (Source: Operator)

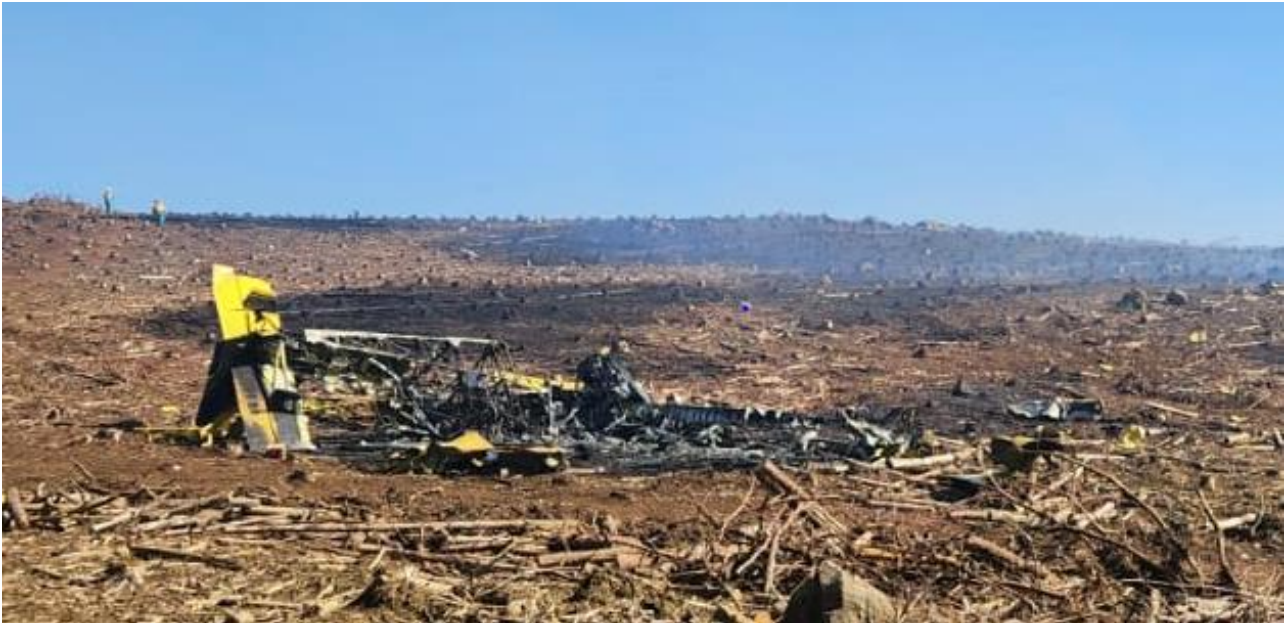
1.3.1. The aircraft was destroyed by post-impact fire.

Figure 3: The wreckage post-accident.

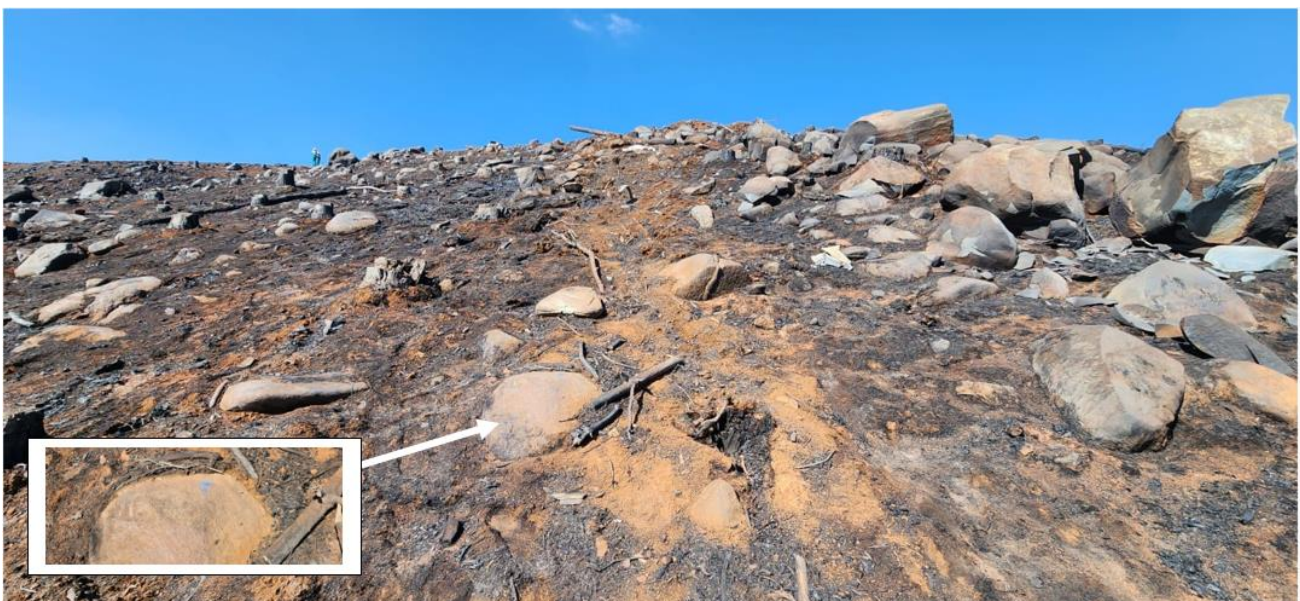
1.12.1. The aircraft impacted the rising terrain and dispersed in a radius of 350m. The aircraft impacted the terrain with the left-side main landing gear and the hopper and then burst into flames. It catapulted forward for approximately 250m before it came to rest in an inverted position facing north.

Figure 5: A blue paint mark on the rock that the aircraft's hopper impacted.

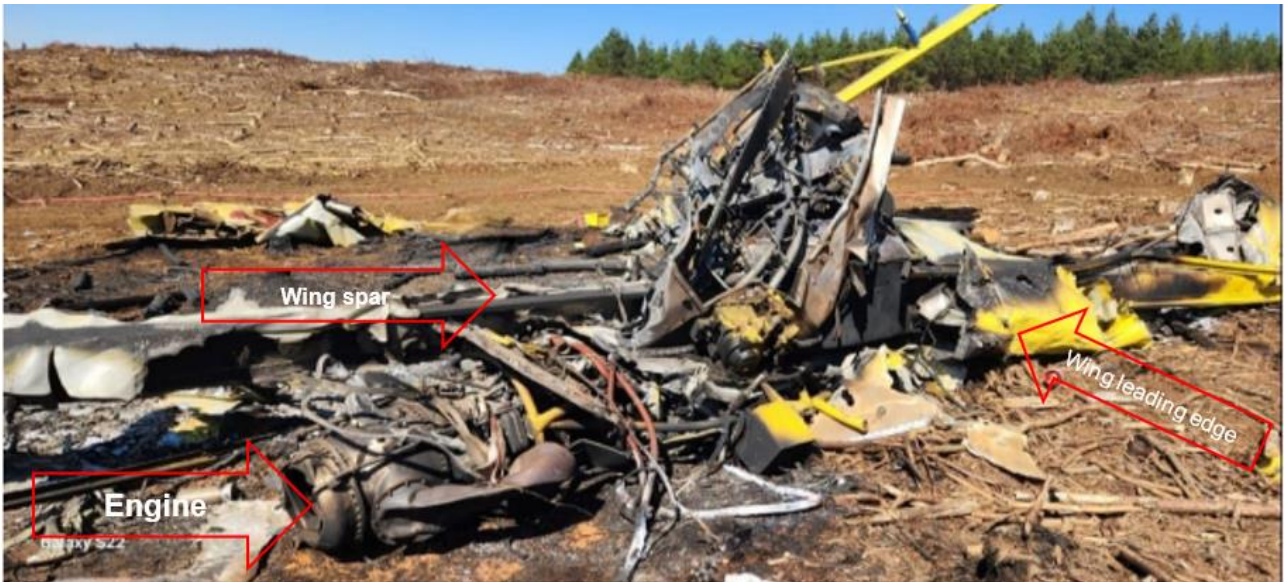
Figure 8: The front view of the main wreckage with damaged wings.

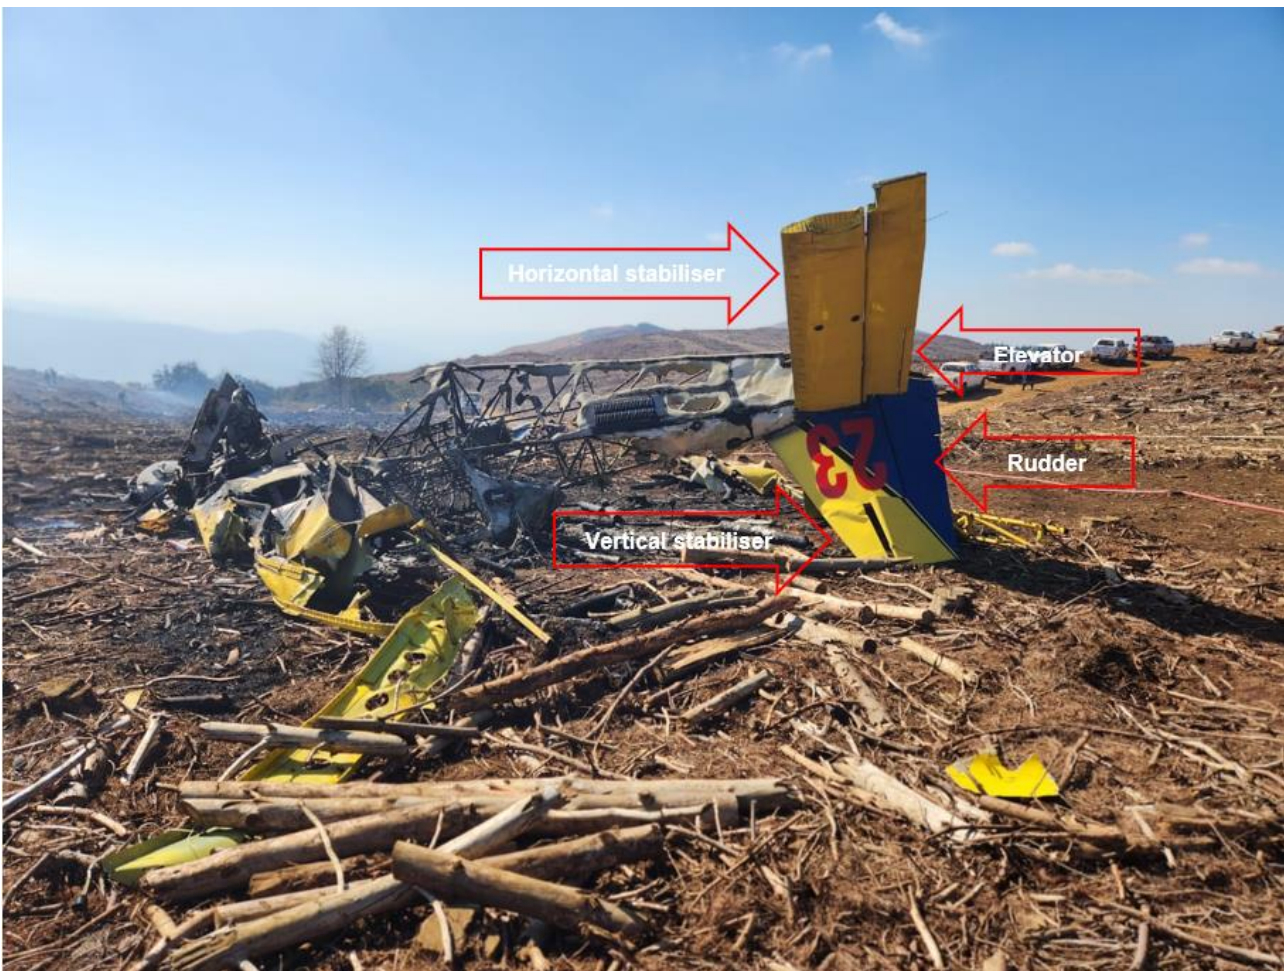
Figure 9: Left view of the main wreckage.

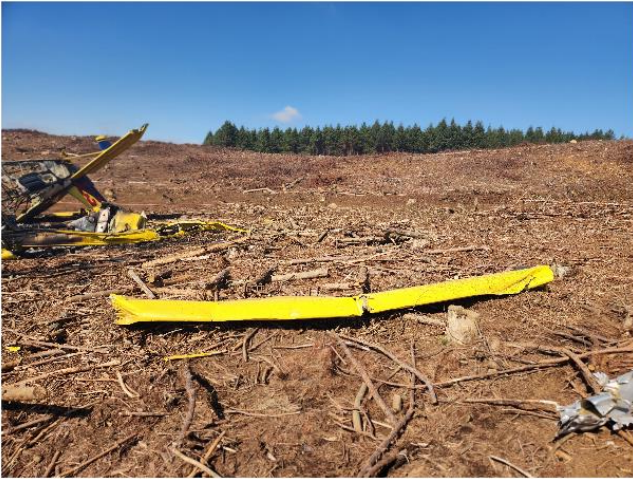
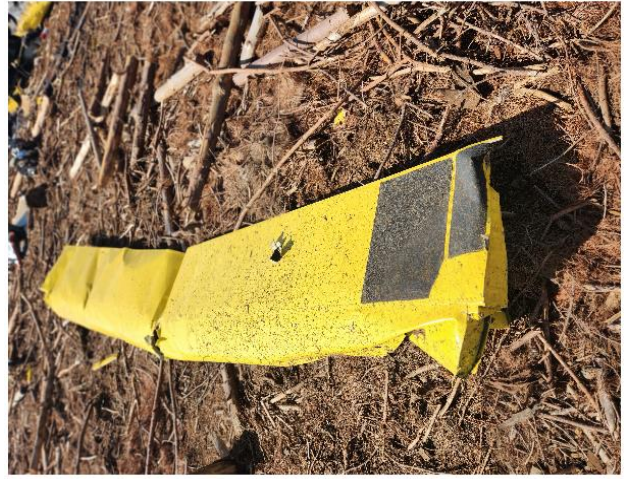
1.12.4 The right-side flap was found approximately 10m from the main wreckage; it was severed before the aircraft came to rest.

Figure 10 and 11: Shows bottom and top view of the right-side flap.

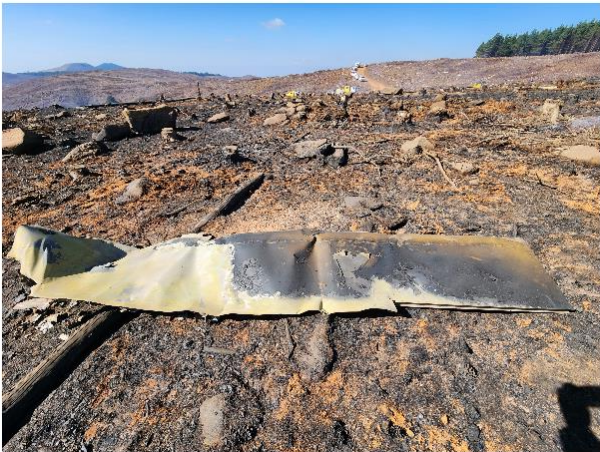
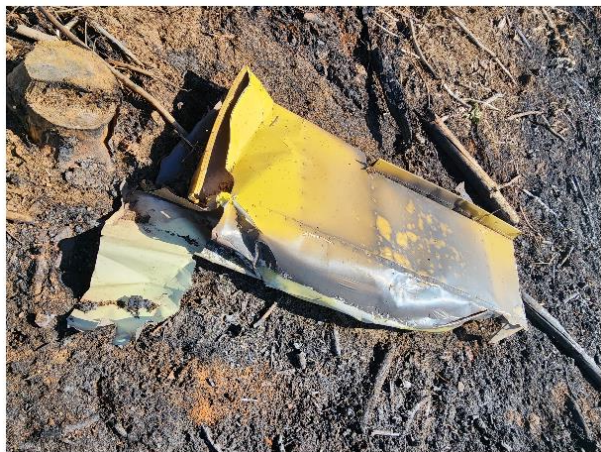
1.12.5 The left and right ailerons broke off from the wing trailing edge during the accident sequence.

Figure 12: The right-side aileron with the trim tab missing. **Figure 13:** Shows the left-side aileron with the trim tab still attached.

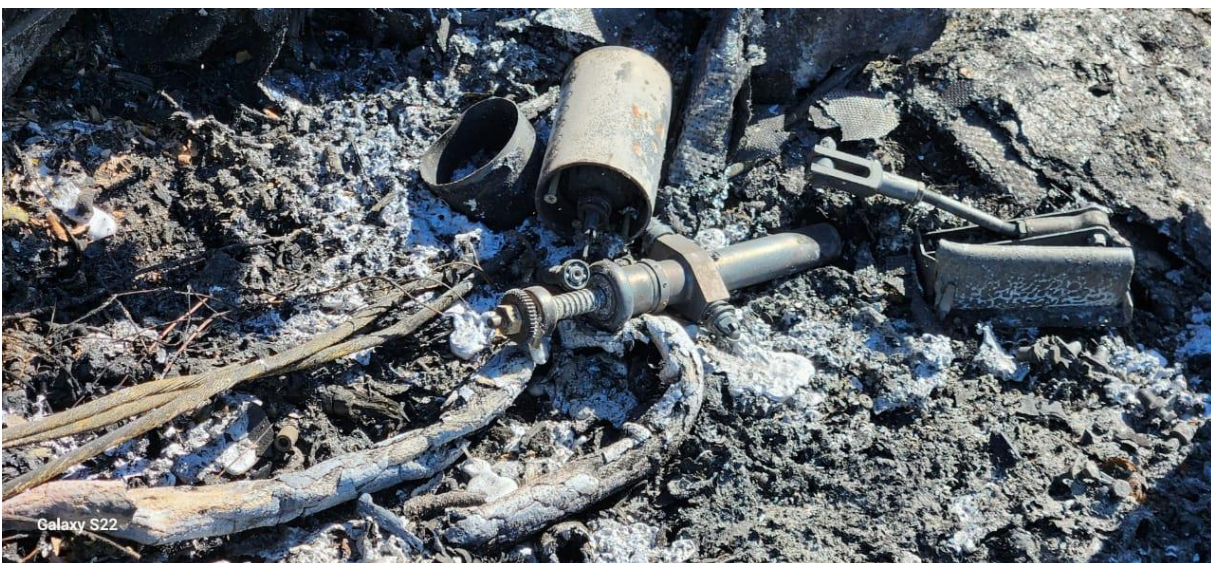
1.12.6 The jackscrew was found in an open position, an indication that the flaps were extended (down).

Figure 14: The open flap jackscrew.

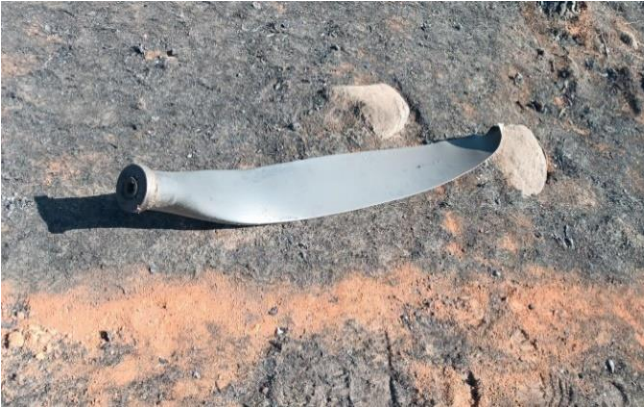
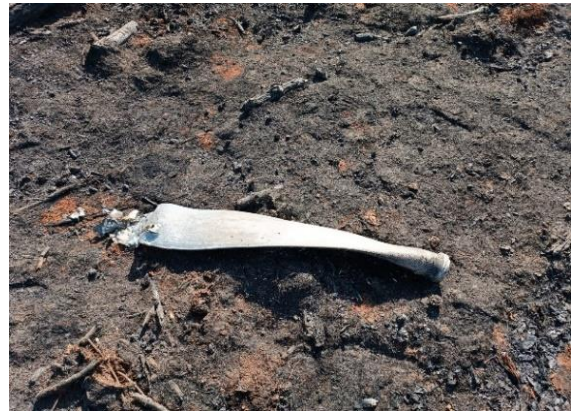
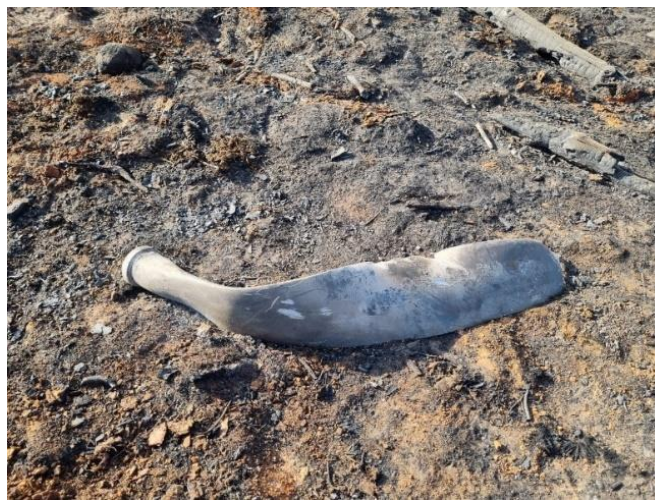
1.12.7 Parts of the aircraft separated and scattered in different directions, including the propeller blades. Only three of the five blades were recovered.

Figures 15, 16 and 17: Three of the five propeller blades were recovered at the accident site.

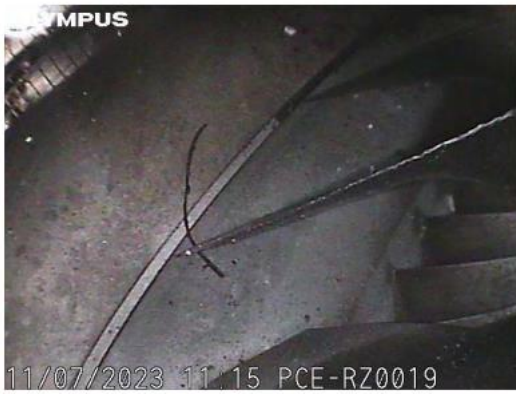
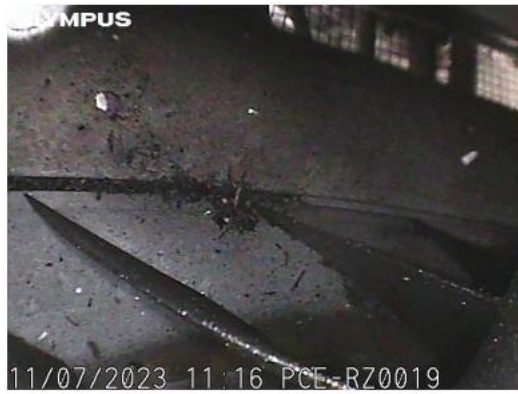
Compressor inlet housing condition with areas moderate coating deterioration and associated coating loss. Evidence of foreign debris observed (Grass, sand/dirt etc.).

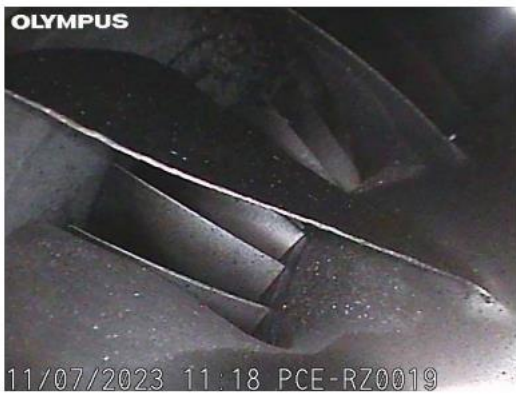
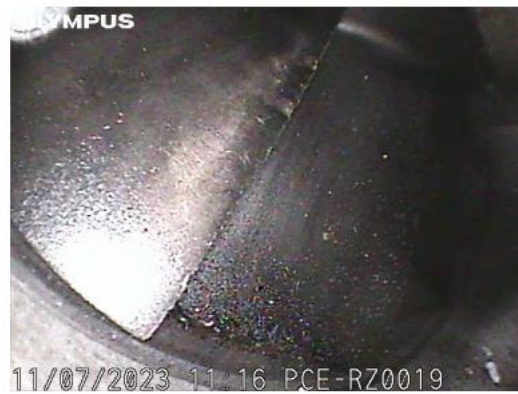
1st stage compressor blade condition with light levels of erosion and oil wetness observed. Foreign debris observed.

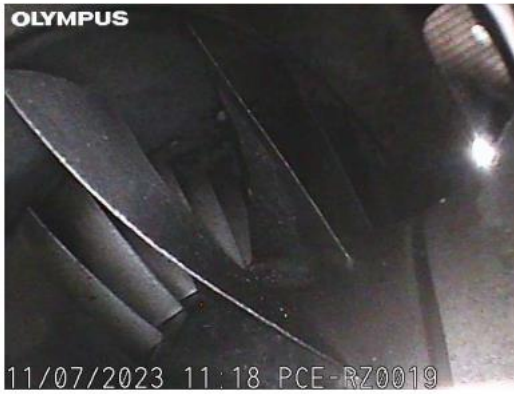
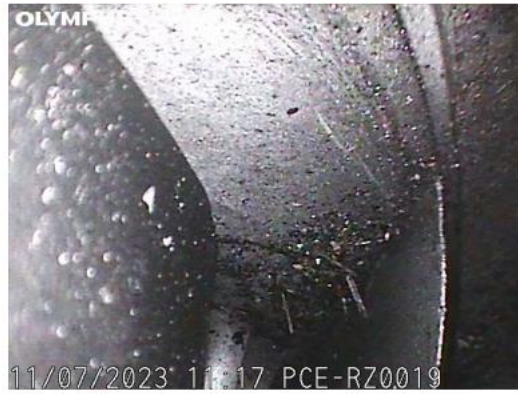
1st stage compressor blade condition with light levels of erosion and oil wetness observed. Foreign debris observed.

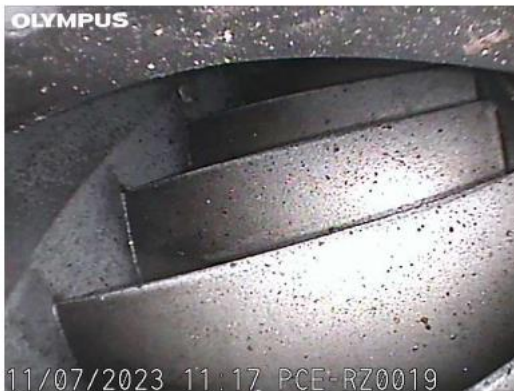
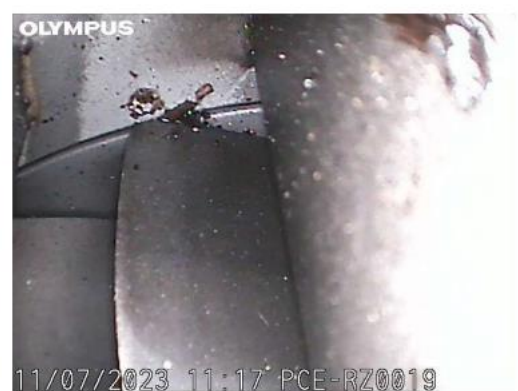
1st stage stator with light L.E. erosion and dirt build-up observed. 2nd stage comp. blade condition with light L.E. erosion observed. Foreign debris observed in 2nd stg. compressor area.

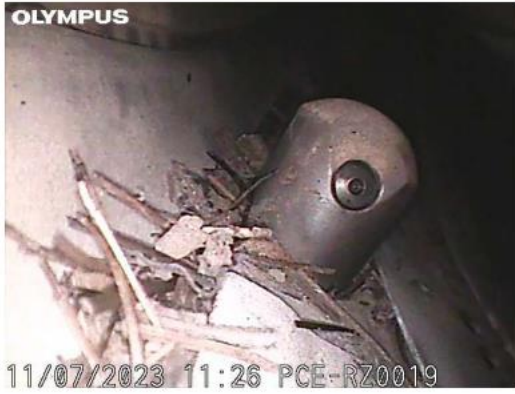
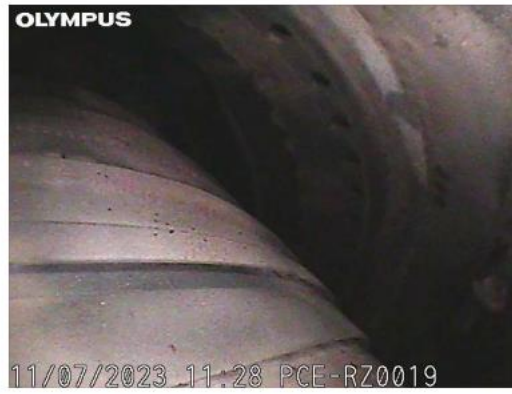
Combustion chamber with light thermal erosion and foreign debris observed.

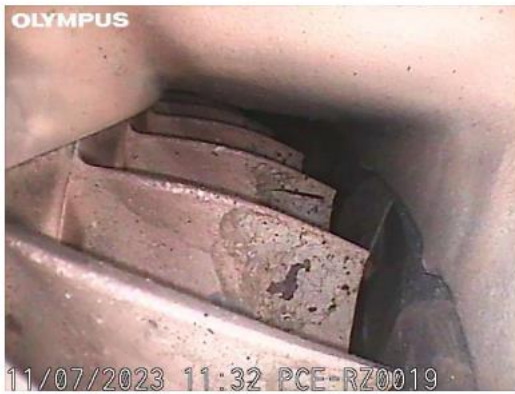
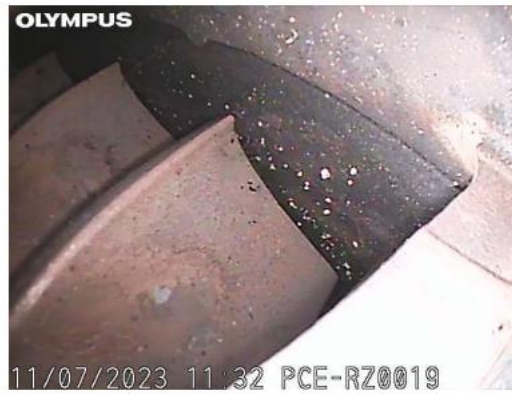
C.T. blade and segment condition with light erosion and dust build-up observed. Foreign debris observed in CT. area.

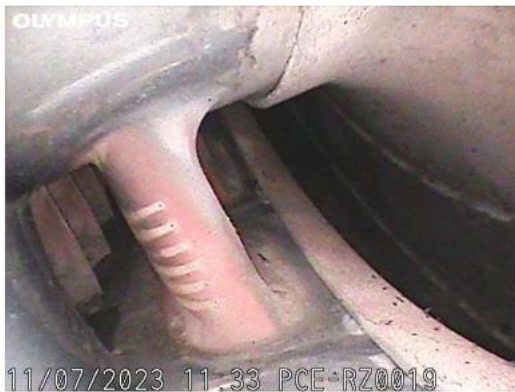
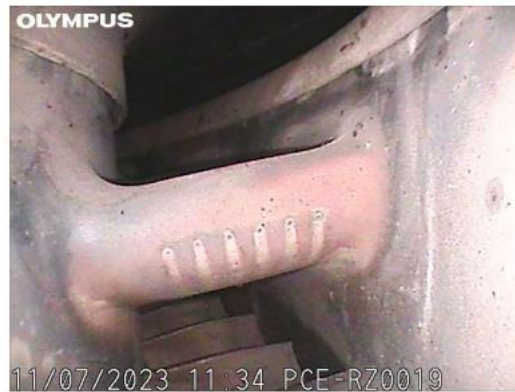
C.T. vane condition with light thermal coating deterioration, dirt build-up and light cracking

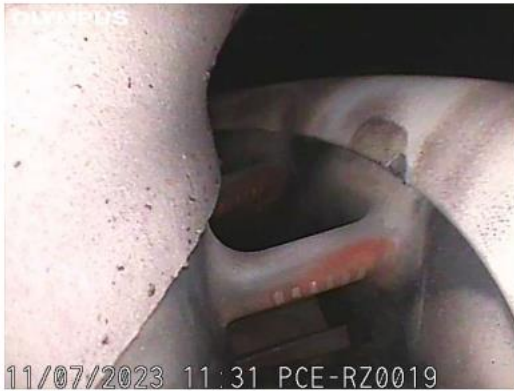
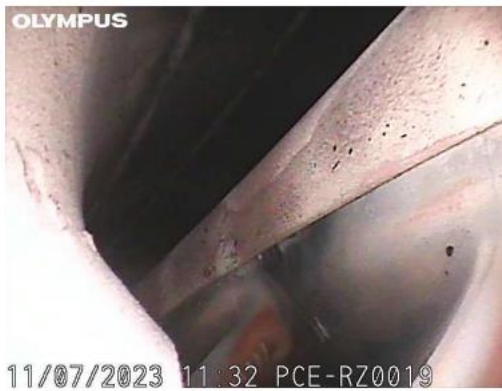
SED. condition with light thermal deterioration, coating loss and dirt build-up. Foreign matter observed.

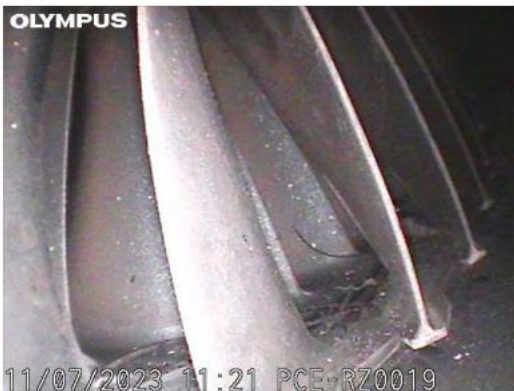
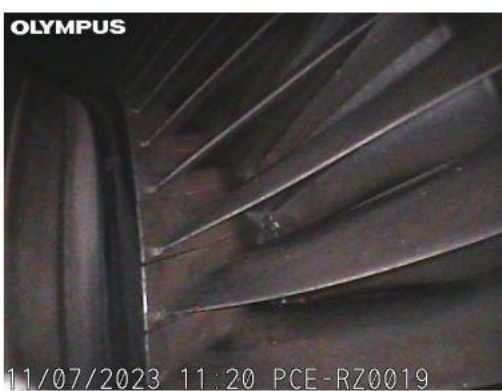
2nd stg. P.T. blade condition with light thermal coating deterioration and light surface corrosion. Foreign debris observed forward of 2nd stg. PT. blades.
