UAS LIMITED OCCURRENCE INVESTIGATION REPORT – FINAL

Reference Number	CA18/2/3/10338						
Classification	Accident	Date	21 June 2023		Time	2325Z	
Type of Operation	Unmanned Aircraft Systems (Surveillance) – Part 101						
Location							
Place of Departure	Piet Retief, Mpumalanga Province		Place of Intended Landing	Piet Retief, Mpumalanga Province			
Place of Occurrence	Piet Retief, Mpumalanga Province						
GPS Co-ordinates	Latitude	27°05'47" S	Longitude	030°49'10" E	Elevation	3900 ft	
Aircraft Information							
Registration	ZT-XNK		Class	3A			
Make; Model; S/N	Arace Sirin (Serial Number: SIR0014)						
Damage to Aircraft	Destroyed		Total UAS Hours	1 393.50			
Pilot-in-command							
Licence Type	Remote Pilot Licence (RPL)		Gender	Male	Age	32	
Licence Valid	Yes	Total Hours	670.6	Total Hours on Type	445.42		
Total Hours 30 Days	46.1		Total Flying on Type Past 90 Days	134.3			
People operating	1	Injuries (On ground)	0	Fatalities	0	Fatalities (on ground)	0

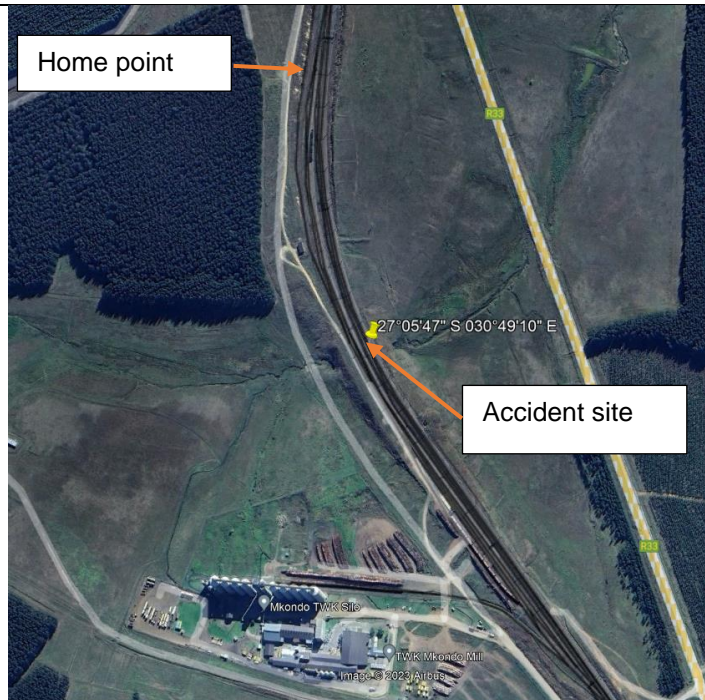
Figure 1: Overlay of the accident site. (Source: Google Earth)

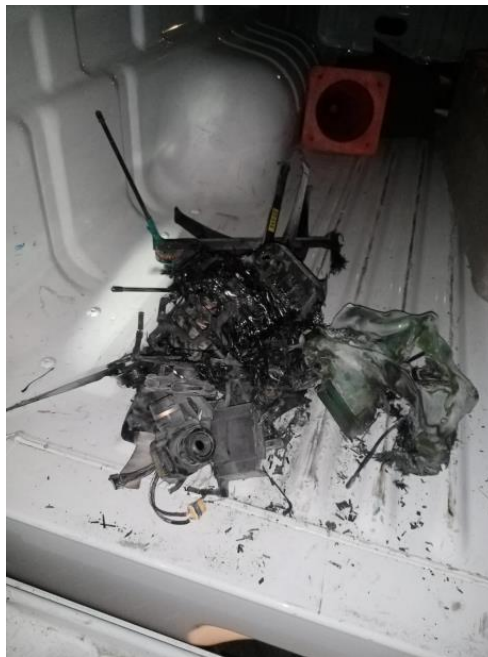
Figure 2: The UAS after it was recovered. (Source: Pilot)

8. The operator had an approved landowner's form dated 12 December 2022 with an expiry date of 31 December 2023. The form authorised the operator to conduct surveys on the land stipulated under the agreement.
9. According to the operator, the UAS was substantially damaged, and no data could be retrieved.
10. The UAS impacted the railway overhead lines and lost signal due to an electric shock. The operator's manual states that "*during loss of connection with the ground station, the UAS will return to the launch point at the same height it was when the connection was lost*". The UAS was suspended on the electrical overhead lines, thus, could not automatically return to the take-off launch pad. During an attempt to retrieve the UAS, a spark ignited the UAS before it fell on the railway tracks.

Impact with railway overhead lines resulted in temporary loss of connection with the remote pilot station during a stealth operation. It is likely that the temporary loss of connection was due to an electric shock. Whilst attempting to retrieve the UAS, a spark ignited it before it fell on the train tracks.

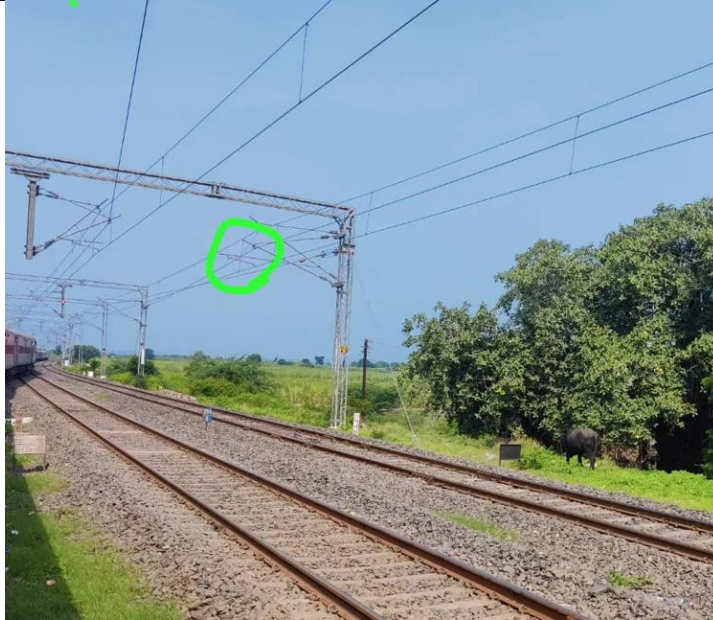
Figure 3: A similar rail track showing an approximate position where the UAS was suspended.
(Source: MeghaSyam)
