LIMITED OCCURRENCE INVESTIGATION REPORT – FINAL

Reference Number	CA18/2/3/10339						
Classification	Serious Incident	Date	18 June 2023	Time	1202Z		
Type of Operation	Remotely Piloted Aircraft Systems (Part 141)						
Location							
Place of Departure	Mooivallei Potchefstroom, North West Province	Place of Intended Landing	Mooivallei Potchefstroom, North West Province				
Place of Occurrence	Mooivallei Potchefstroom, North West Province						
GPS Co-ordinates	Latitude	26°49'19" S	Longitude	27°04'30" E	Elevation	4373 ft	
Aircraft Information							
Registration	ZT-UXD						
Make; Model; S/N	DJI, Phantom 4 (Serial Number: 07D2FBD0050028)						
Damage to UAS	Substantial		Total UAS Hours	37.77			
Pilot-in-command							
Licence Type	Remote Pilot Licence (RPL)		Gender	Male	Age	52	
Licence Valid	Yes	Total Hours	6108	Total Hours on Type	67.6		
Total Hours Past 30 Days	21.8		Total Flying Hours on Type Past 90 Days	4.12			
People Controlling	2	Injuries	0	Fatalities	0	Other (on ground)	0

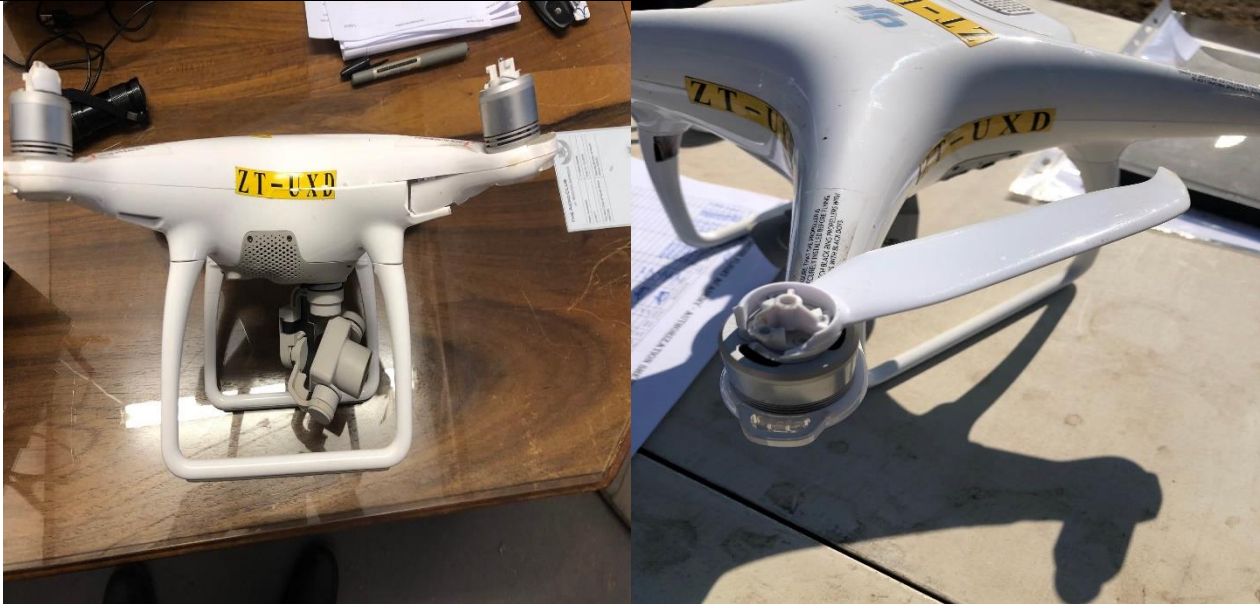
Figure 1: The broken propellers on the UAS. (Source: Pilot)

The investigation revealed that there were cracks on the UAS's propeller blades which led to multiple failures and, subsequently, caused the UAS to lose lift and propulsion and, thus, impacted the ground.

The rotor blades of the UAS disintegrated during the flight due to cracks. The UAS lost lift and propulsion and impacted the ground.
