<b>UAS LIMITED OCCURRENCE INVESTIGATION REPORT – FINAL</b>
--

<b>Reference Number</b>		CA18/2/3/10340							
<b>Classification</b>		Accident	<b>Date</b>		26 June 2023	<b>Time</b>		2002Z	
<b>Type of Operation</b>		Unmanned Aircraft System – Surveillance (Part 101)							
<b>Location</b>									
Place of Departure		Private Farm in Embalenhle, Mpumalanga Province		Place of Intended Landing		Private Farm in Embalenhle, Mpumalanga Province			
Place of Occurrence		Embalenhle, Mpumalanga Province							
GPS Co-ordinates		Latitude	26°35'18.78"S	Longitude	028°49'35.04" E	Elevation	5 105 ft		
<b>Aircraft Information</b>									
Registration		ZT-YWO		Class		3A			
Make; Model; S/N		Arace Sirin (Serial Number: SIR151)							
Damage to Aircraft		Substantial		Total UAS Hours		131.52			
<b>Pilot-in-command</b>									
Licence Type		Remote Pilot Licence (RPL)		Gender		Male	Age	25	
Licence Valid		Yes	Total Hours		382.14	Total Hours on Type		382.14	
Total Hours 30 Days		49.2		Total Flying on Type Past 90 Days		150

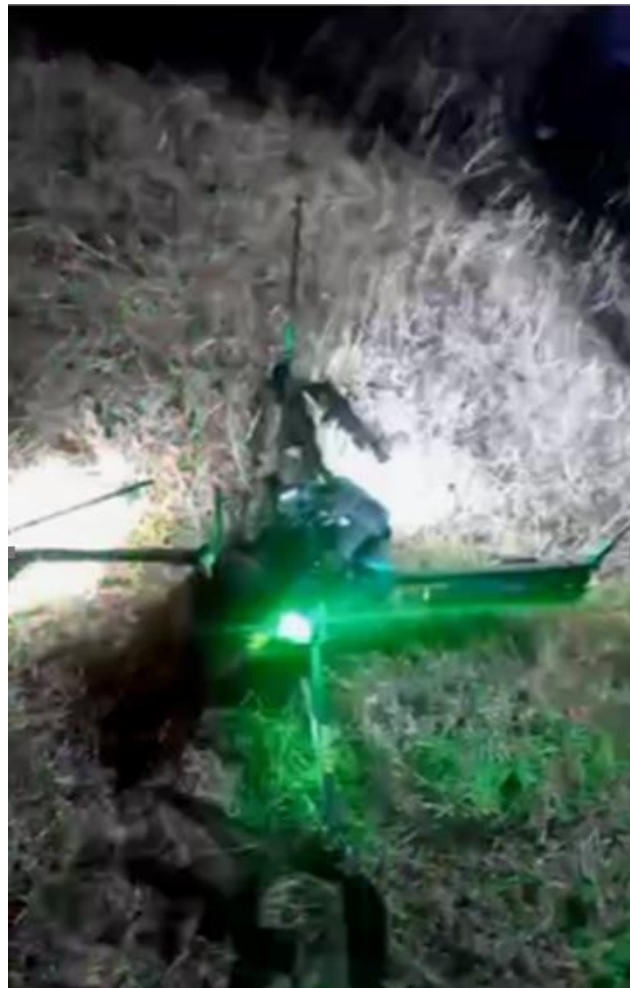
**Figure 2:** The UAS at the accident site before recovery. (Source: Operator)

The pilot kept changing the home point and, thus, the UAS kept flying further in return to launch (RTL) mode until it crashed.

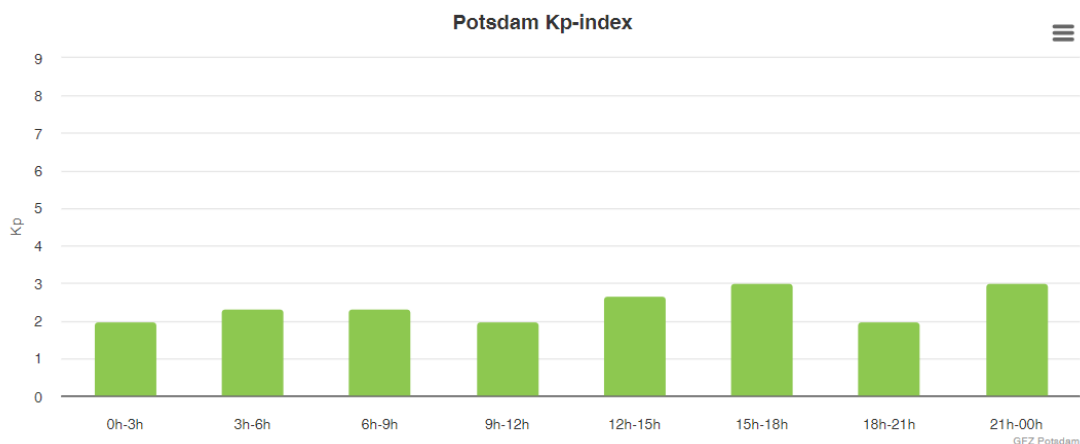
1. The KP's excellent index was low at the time of the flight.  
(Note: Kp is an indicator of disturbance in the Earth's magnetic field)

**Graph 1:** GFZ Postdam official Kp index for 26 June 2023.
