LIMITED OCCURRENCE INVESTIGATION REPORT – FINAL

| Reference Number | CA18/2/3/10341 | | | | | | |
| Registration | ZS-OKV | | | | | | |
| Make; Model; S/N | Piper PA22-108 (Serial Number: 22-9419) | | | | | | |

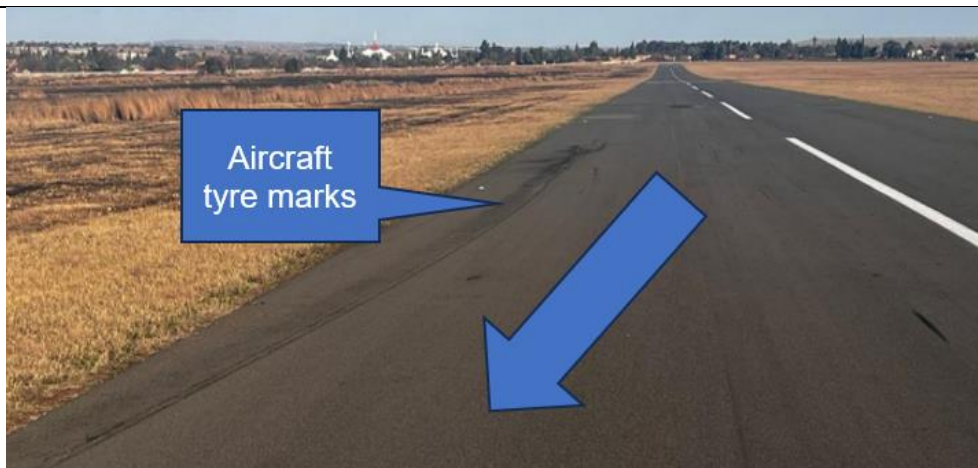
Figure 1: Arrow showing the direction of landing and tyre marks. (Source: Operator)

- The chief flying instructor (CFI) who was at the holding point of Runway 36 and engaged in run ups at the time heard the ZS-OKV join overhead the airfield. When the CFI was ready to depart, he observed ZS-OKV on final approach for Runway 36 and he waited to watch the aircraft land. The landing seemed to be progressing normally, but the aircraft was a bit high. This was not alarming because the height was recoverable. The CFI then heard the SP make a radio call “going around”. The aircraft did not immediately climb, but the performance looked normal. The CFI heard the SP make another radio call “landing” and then he saw the aircraft dive towards the runway and impacted it with the nose wheel, which subsequently collapsed.

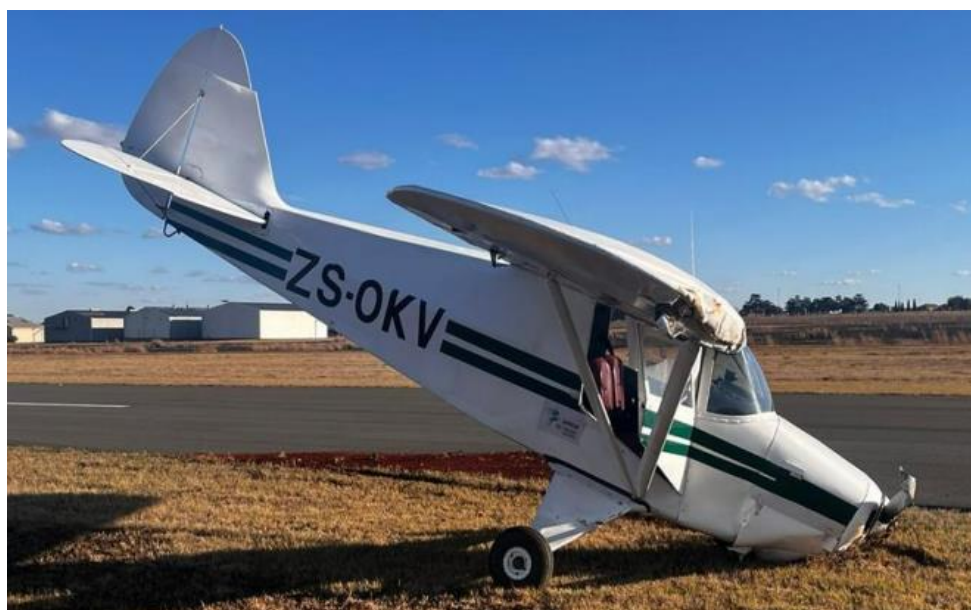
Figure 2: The final resting position of the aircraft. (Source: Operator)

The aircraft had an unstable approach and it bounced and landed with the nose wheel which subsequently collapsed. The aircraft came to a stop on the grass on the right of Runway 36.

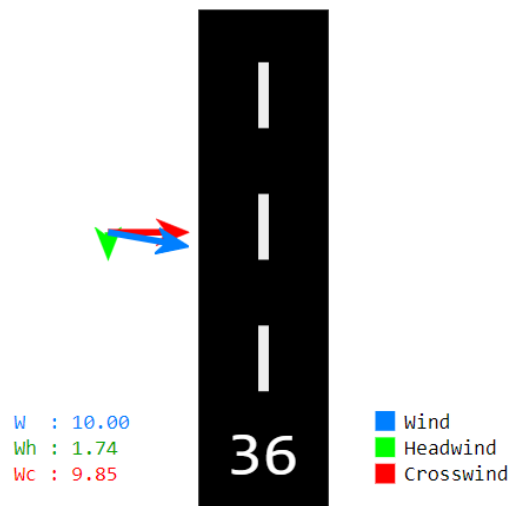
| Wind Direction | 280° | Wind Speed | 10 knots | Visibility | 9999 |

Figure 3: Wind component. (Source: <https://e6bx.com/wind-components>)

The aircraft cross wind component is 15 miles per hour (13 knots).
