**UAS LIMITED OCCURRENCE INVESTIGATION REPORT – FINAL**

<b>Reference Number</b>	CA18/2/3/10342						
<b>Classification</b>	Accident	<b>Date</b>	30 June 2023		<b>Time</b>	2216Z	
<b>Type of Operation</b>	Unmanned Aircraft System – Surveillance (Part 101)						
<b>Location</b>							
Place of Departure	Main Road, Westonaria Ward 1, Gauteng Province		Place of Intended Landing	Main Road, Westonaria Ward 1, Gauteng Province			
Place of Occurrence	360 metres north of the Main Road, Westonaria						
GPS Co-ordinates	Latitude	26°34'46.06" S	Longitude	27°40'45.68" E	Elevation	4902 feet	
<b>Aircraft Information</b>							
Registration	ZT-UOZ		Class	4A			
Make; Model; S/N	Bathawk (Serial Number: B0017)						
Damage to Aircraft	Substantial		Total UAS Hours	1242.10			
<b>Pilot-in-command</b>							
Licence Type	Remote Pilot Licence (RPL)		Gender	Male		Age	59
Licence Valid	Yes	Total Hours	2627:20		Total Hours on Type	1290:43	
Total Hours 90 Days	203:25		Total Flying on Type Past 90 Days	21:39

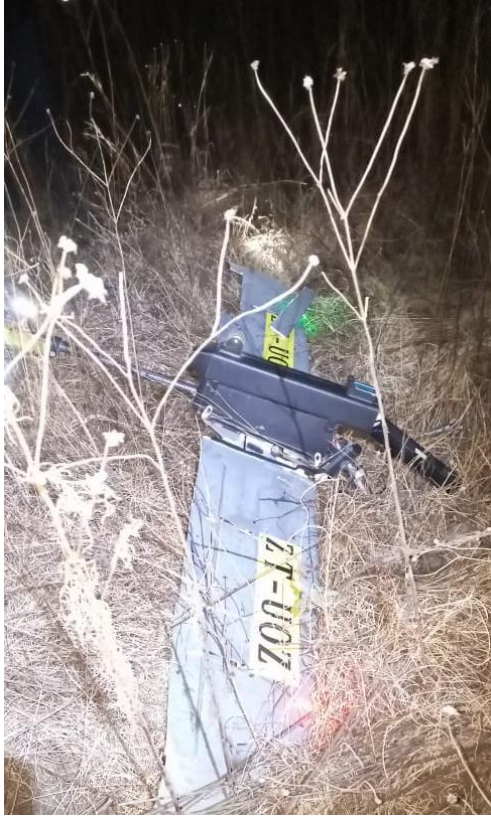
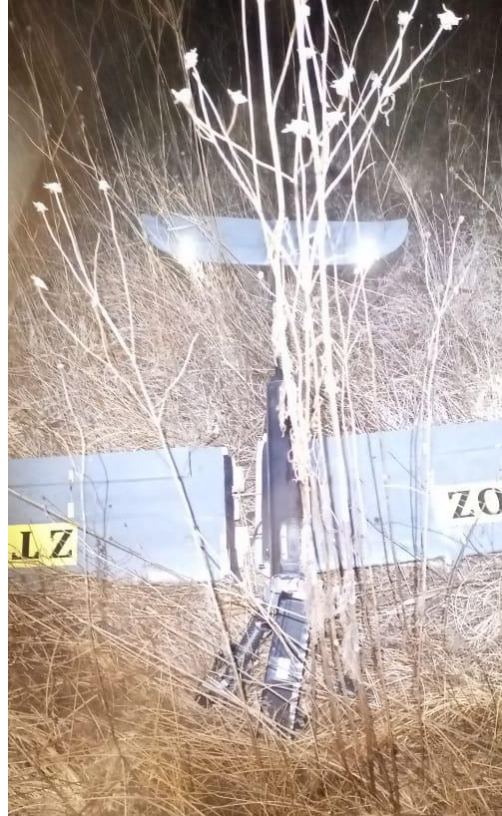
roll. The pilot engaged Loiter mode (*assisted flight mode with position and altitude hold*), however, the UAS could not maintain a level flight and it spun to the left then recovered, and thereafter, spun to the right before it impacted the terrain. The pilot and his colleagues dispatched to the last recorded location that was captured on the remote pilot station and found the UAS crashed approximately 360 metres north of the ground station. The UAS sustained substantial damage. No injuries were reported on the ground.

**Figures 1 and 2:** The UAS at the accident site in an inverted position with the right aileron separated (left); and damage on the UAS gimbal and front fuselage (right). (Source: Operator)

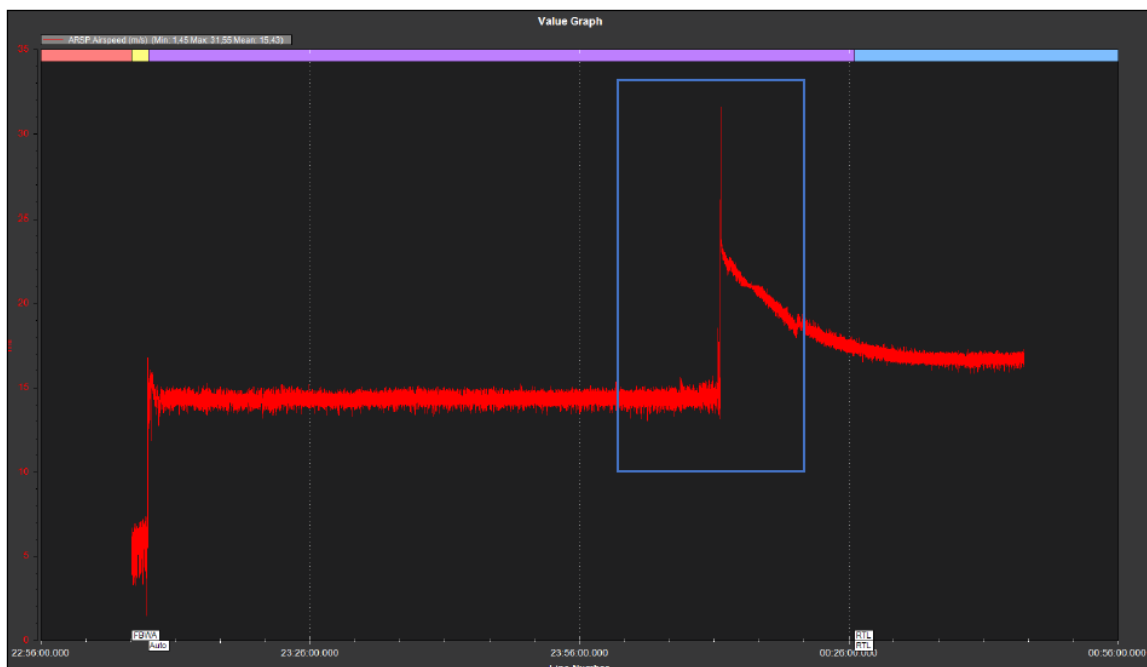
**Figure 3:** The airspeed stayed consistent during the flight until the nose pitched down, increasing the stall. (Source: Operator)

At 22:17 UTC: The aircraft started stalling and the nose pitched down and the UAS rapidly decreased altitude.

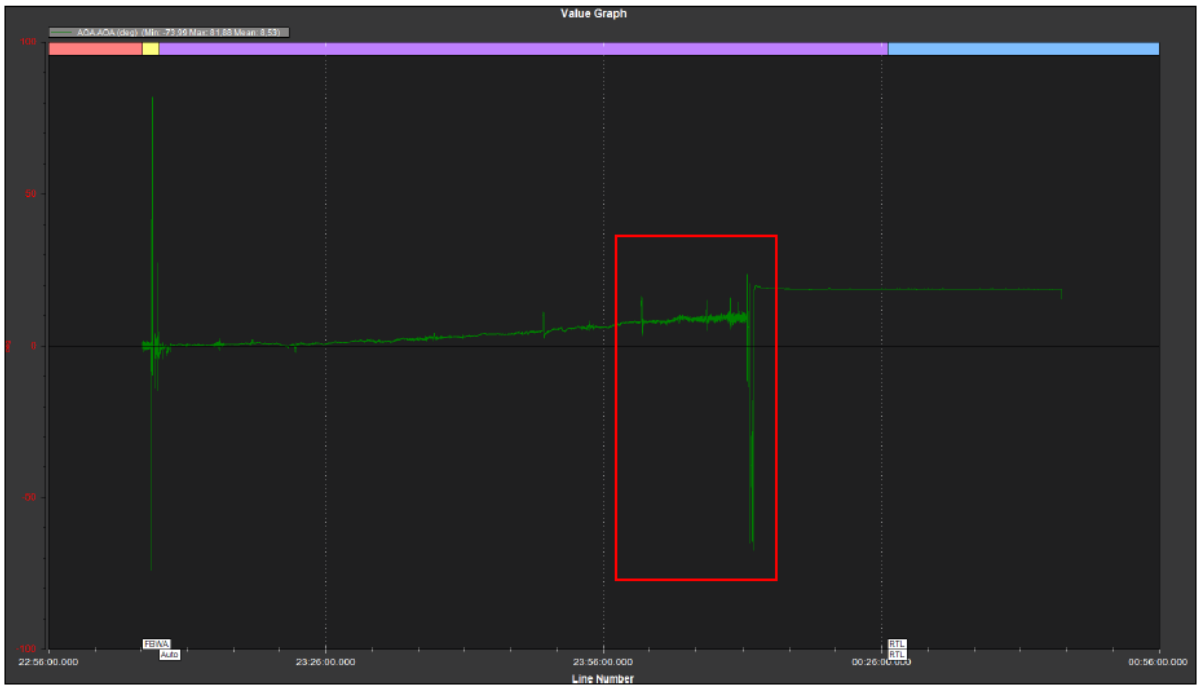
**Figure 4:** The aircraft (UAS) indicated consistent increase in the Angle of Attack before it stalled. (Source: Operator)

1. The aircraft (UAS) system shows a consistent speed throughout the flight. However, towards the return to home location stage, the aircraft (UAS) system did not indicate the correct speed.
2. While the aircraft was returning to home, the auto mode was consistently increasing the Angle of Attack to stay at altitude and decreasing the air speed (due to increase in wind, as well as battery issues).

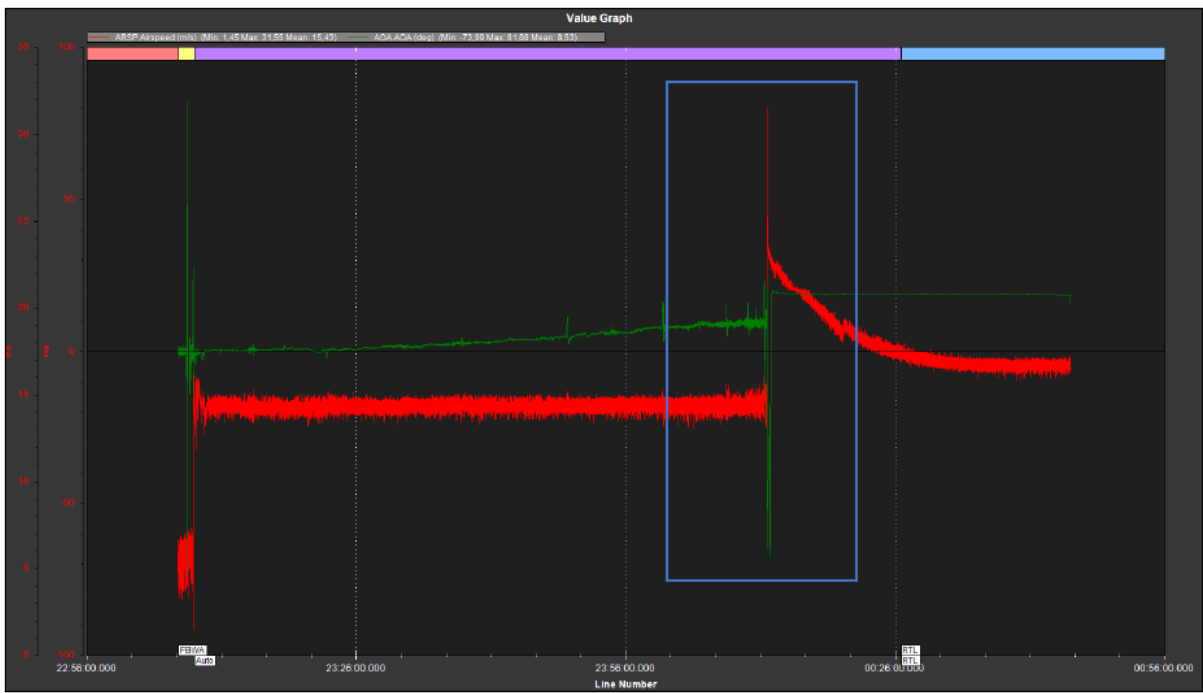
**Figure 5:** The air speed sensor was faulty during the return-to-launch stage. This led to the increase in the Angle of Attack. (Source: Operator)

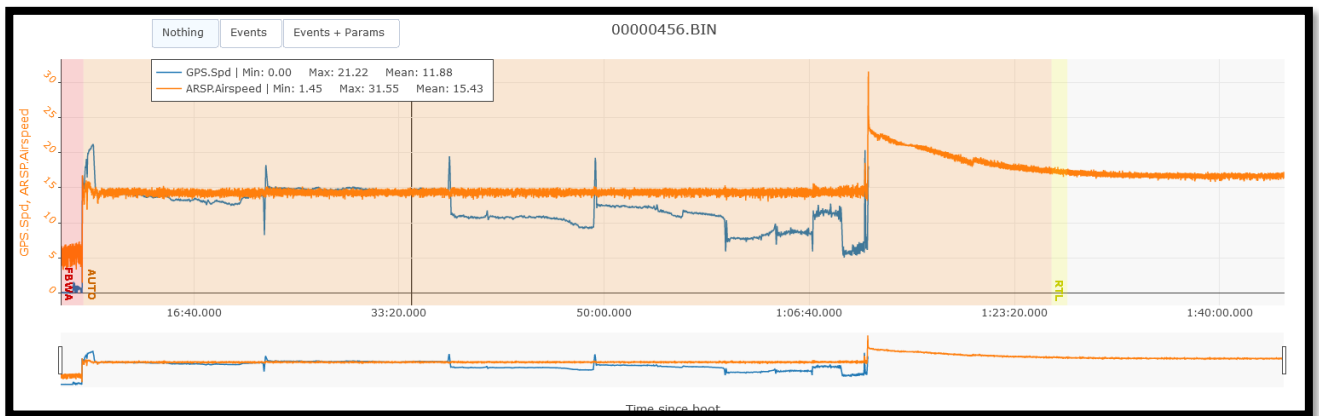
**Figure 6:** The airspeed shows a consistent speed before the stall. Ground speed, however, shows that there was a decrease in speed before the stall. (Source: Operator)

7. The downloaded logs showed that the UAS experienced low airspeed and an increase in the Angle of Attack which resulted in a stall, and thus, led to the crash. According to the UAS user manual, the change in wind direction will either increase or decrease the UAS's speed. The speed can decrease to below allowable operating speed which could result in a stall.

<b>Probable Cause</b>
The UAS experienced low airspeed due to the change in wind direction which increased the Angle of Attack, and thus, led to the stall.
<b>Contributing Factor(s)</b>
None.
<b>Safety Actions</b>
The operator issued the following safety actions and mitigations: <ol style="list-style-type: none"> <li>1. Pilots should maintain their flight and remain aware of changing weather conditions.</li> <li>2. Pilots should change modes to recover from stalls. However, they should also be trained to correctly address similar situations.</li> </ol>
<b>Safety Message and/or Safety Recommendation/s</b>
None.
<b>About this Report</b>
<i>The decision to conduct a limited investigation is based on factors including whether the cause is known and the evidence supporting the cause is clear, the level of safety benefit likely to be obtained from an</i>
