UAS LIMITED OCCURRENCE INVESTIGATION REPORT – FINAL

Reference Number	CA18/2/3/10344						
Classification	Accident	Date	4 July 2023		Time	2202Z	
Type of Operation	Remotely Piloted Aircraft System (Part 101)						
Location							
Place of Departure	Panbult near Piet Retief, Mpumalanga Province		Place of Intended Landing	Panbult near Piet Retief, Mpumalanga Province			
Place of Occurrence	Open field in Panbult near Piet Retief, Mpumalanga Province						
GPS Co-ordinates	Latitude	26°49'.38" S	Longitude	30°29'.05" E	Elevation	4 725 feet	
Aircraft Information							
Registration	ZT-XRX		Class	3A			
Make; Model; S/N	Arace Sirin (Serial Number: SIR0038)						
Damage to UAS	Substantial			Total UAS Hours	819.19		
Pilot-in-command							
Licence Type	Remote Pilot Licence (RPL)		Gender	Male	Age	33	
Licence Valid	Yes	Total Hours	282.35		Total Hours on Type	97.45	
Total Hours Past 90 Days	97.45		Total Flying Hours on Type Past 30 Days	35.2			
People Controlling	1	Injuries	0	Fatalities	0	Other (on ground)	0

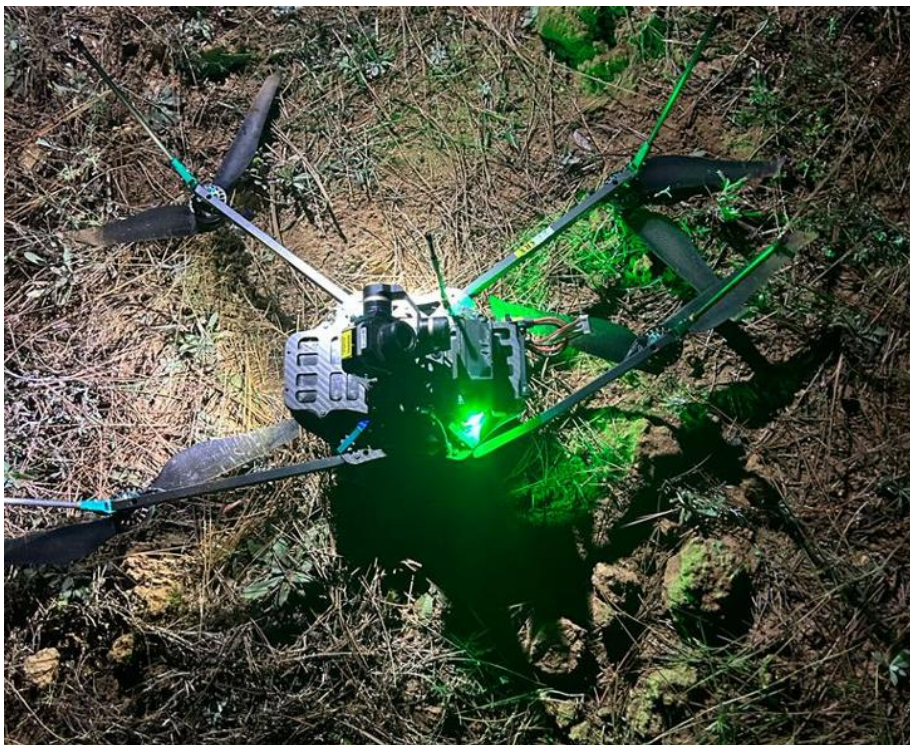
Figure 2: The UAS at the accident site. (Source: Operator)

The UAS disconnected from the remote pilot station unit during the flight, whereafter it entered an uncontrolled descent and crashed on the ground. The cause of the disconnection could not be determined.
