## AIRCRAFT ACCIDENT REPORT AND EXECUTIVE SUMMARY

<b>Reference:</b>		CA18/2/3/10346	
<b>Paraglider Registration</b>	N/A	<b>Date of Accident</b>	3 July 2023		<b>Time of Accident</b>	1424Z	
<b>Type of Paraglider</b>	Duet Pro		<b>Type of Operation</b>		Training (Part 141-Subpart 8)		
<b>Pilot-in-command Licence Type</b>	National Pilot Licence (NPL)		<b>Age</b>	22		<b>Licence Valid</b>	Yes
<b>Pilot-in-command Flying Experience</b>	<b>Total Flying Hours</b>		380		<b>Total Hours on Type</b>	380	
<b>Last Point of Departure</b>	Signal Hill in Cape Town, Western Cape Province						
<b>Next Point of Intended Landing</b>	Sea Point Promenade grass area in front of the Winchester Mansions Hotel, Western Cape Province						
<b>Damage to Paraglider</b>	Substantial						
<b>Location of the accident site with reference to easily defined geographical points (GPS readings if possible)</b>							
Atlantic Ocean, approximately 114m from the shoreline at GPS co-ordinates determined to be South 33°54'38.1" East 18°23'26.5" at an elevation of about 65ft

<b>Probable Cause</b>							
Paraglider 1 conducted a manoeuvre which resulted in a collision with Paraglider 2, and Paraglider 1 flight instructor lost

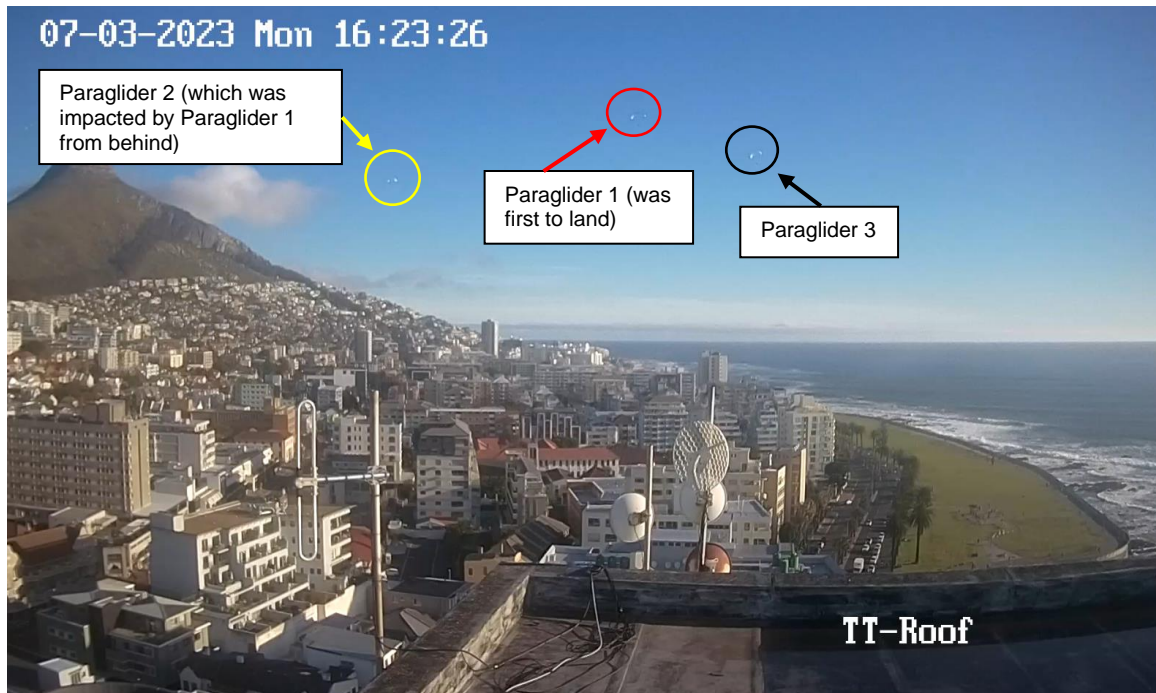
**Figure 2:** The video footage shows three paragliders: Paraglider 1 (accident paraglider) in the middle; Paraglider 2 on the left; and Paraglider 3 on the right was not involved in this accident.  
(Source: Close Circuit Television (CCTV) camera)

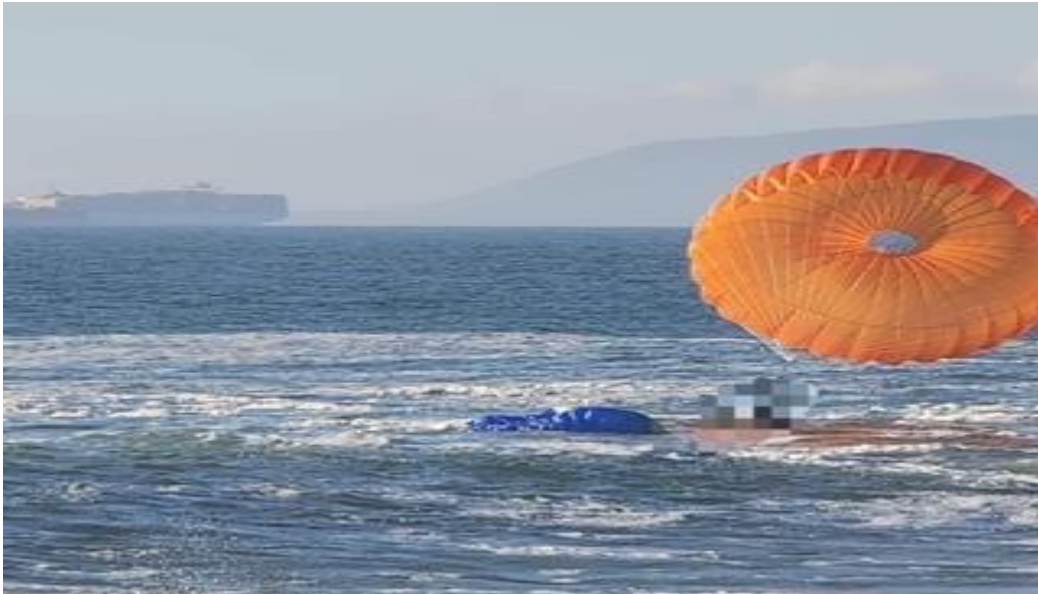
1.3.1. Paraglider 1 wing was substantially damaged, and some of the suspension lines snapped.

**Figure 3:** Paraglider 1's wing partially submerged (blue) in the ocean, and the deployed reserve parachute. (Source: Eyewitness mobile phone footage)

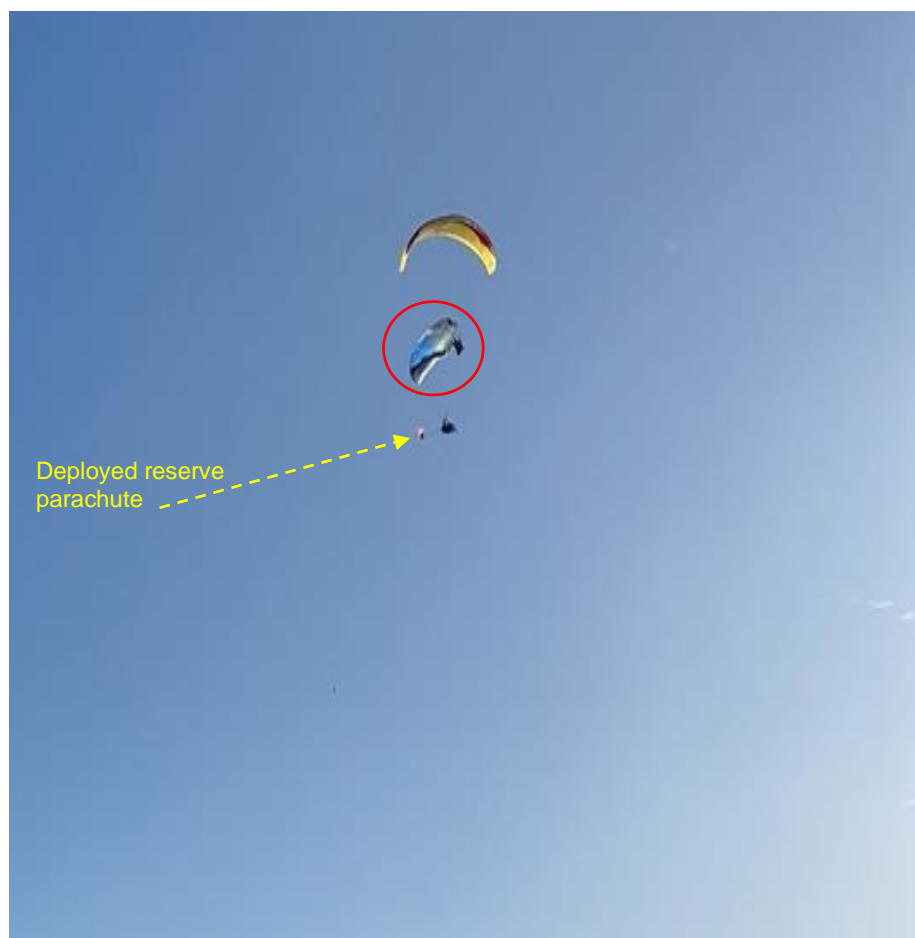
At 14:24:28Z, Paraglider 1's wing impacts the occupants of Paraglider 2 from behind. The occupants of Paraglider 2 are momentarily wrapped in the wing fabric of Paraglider 1 (Figure 9) with the suspension lines on their left legs.

**Figure 8:** Video footage shows the wing of Paraglider 1 impacting Paraglider 2 occupants from behind (red circle). (Source: Eyewitness mobile phone footage)

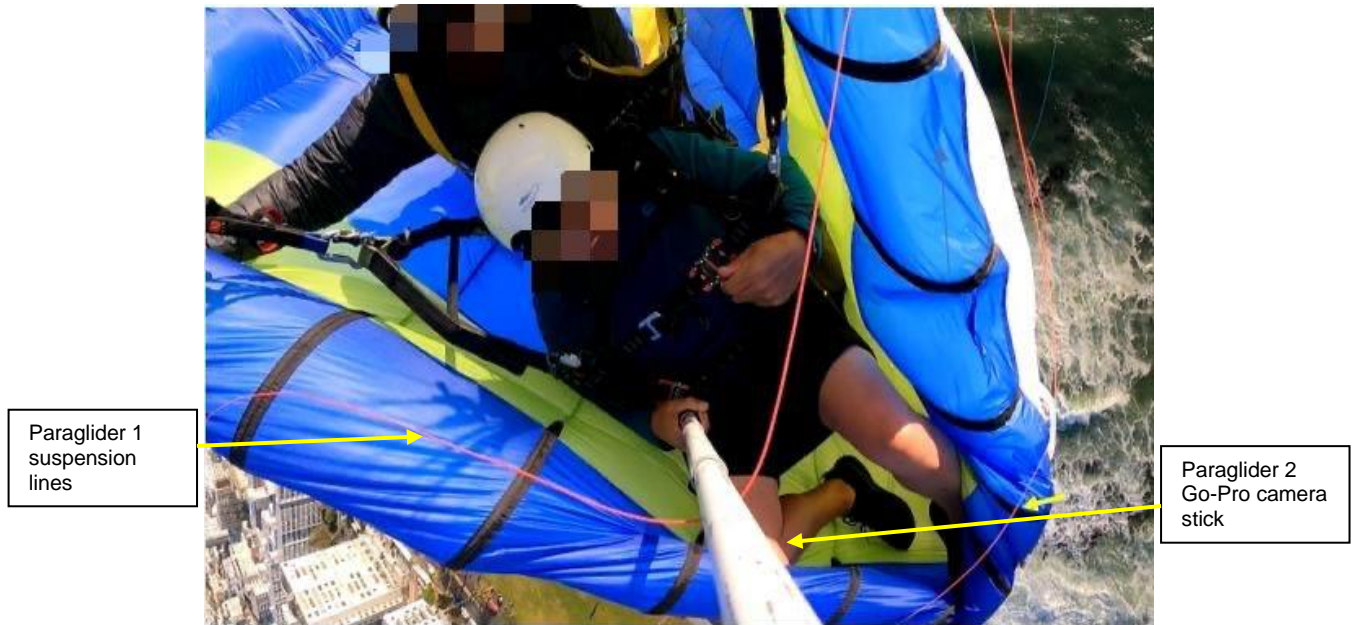
At 14:24:33Z, Paraglider 1's wing fabric tears and separates from the occupants of Paraglider 2. Consequently, Paraglider 1's wing deflates and could not fly or sustain lift.

**Figure 9:** Paraglider 2 Go-Pro camera video footage shows Paraglider 2 occupants wrapped in Paraglider 1's wing fabric and suspension lines.

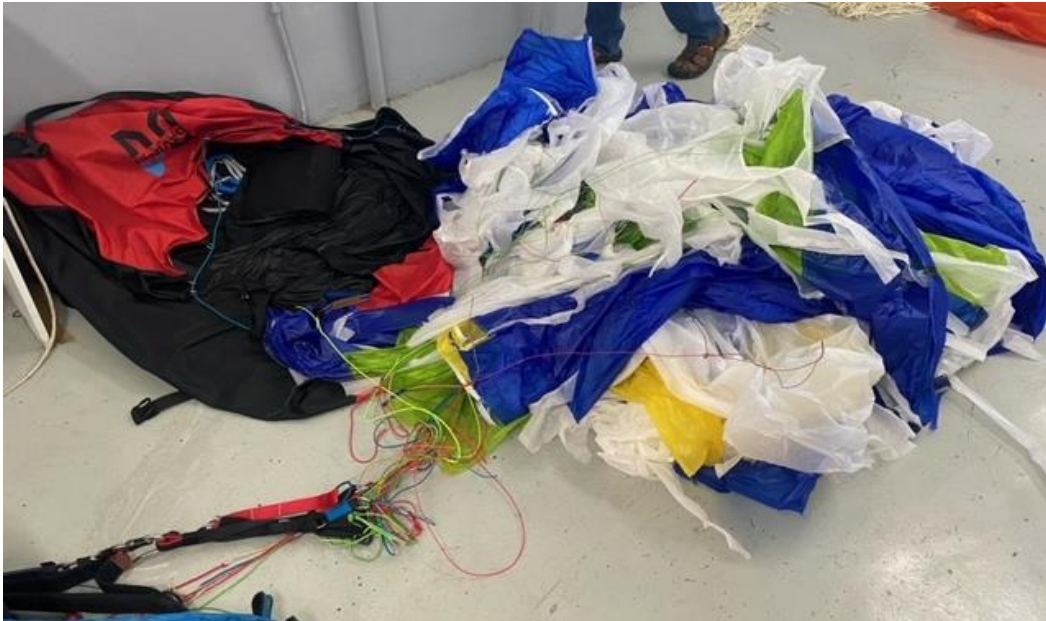
1.16.2 Paraglider 1's components were inspected, and no faults were found with any of its cells, cross-ports or V-ribs. All stitching was intact; the wing fabric was torn at multiple places.

1.16.3 The suspension lines were examined, some were found to have broken or snapped; they exhibited fracture features which were consistent with excessive stretching. The risers had no trace of damage. The harnesses were intact; all the webbing and material were in a satisfactory condition.

**Figure 11:** The torn wing fabric of Paraglider 1.

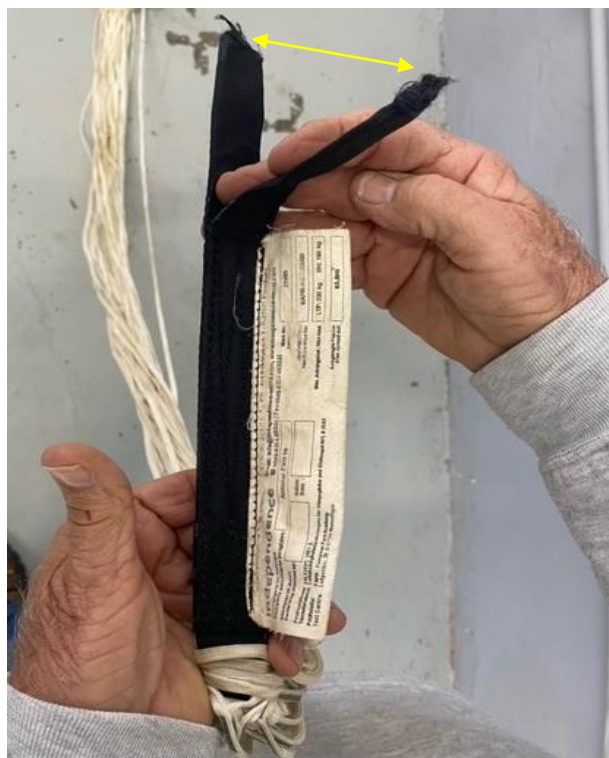
1.16.4 Paraglider 1 flight instructor and student pilot's seats were examined and were found to be intact with the safety harness clips operational. The reserve parachute was also inspected; the reserve strop, which is a connection point between the reserve parachute and the paraglider, had snapped during the accident sequence.

**Figure 12:** Paraglider 1 reserve strop that snapped.

- 4.2.1 It is recommended to the DTO that quick release type of harness carabiners be used to allow pilots to timeously separate from their paragliding gear during emergencies.
- 4.2.2 It is recommended to the DTO to introduce the use of hook knives during paragliding flights to enable pilots to cut through the webbing and suspension lines during emergencies.
- 4.2.3 There seem to be a grey area between people visiting SAHPA launching sites who voluntarily undertake joy rides for pleasure and the DTO registered student pilots. It is, therefore, recommended to the Director of Civil Aviation (DCA) that the responsible division within the Regulator provides clear regulations and guideline/s detailing who fits the title/description of a passenger and a student pilot so that the applicable regulations can be enforced; this will ensure that the paragliding activities are conducted safely.

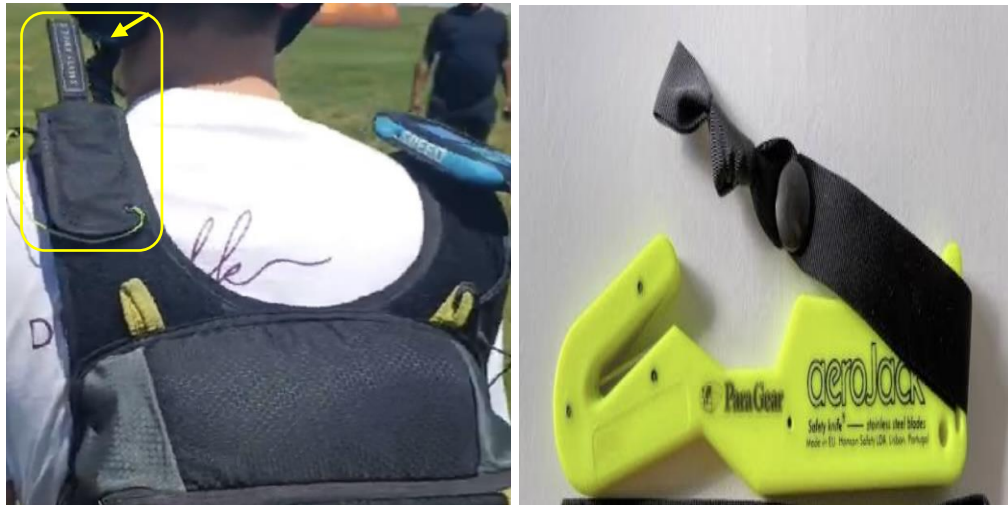
Paraglider 1's wing (accident paraglider) had a white underside colour, and the top was blue with a yellow flash. There was no evidence of a hook knife (tool used to cut the webbing and the suspension lines in an emergency) on the flight instructor's shoulder strap.

**Figures 16 and 17:** An illustration of the area where a hook knife is usually placed (left); hook knife (right). (Source: SAHPA)
