## AIRCRAFT ACCIDENT REPORT AND EXECUTIVE SUMMARY

<b>Reference:</b>		CA18/2/3/10346		
<b>Paraglider Registration</b>	N/A	<b>Date of Accident</b>	3 July 2023		<b>Time of Accident</b>	1424Z		
<b>Type of Paraglider</b>	Duet Pro		<b>Type of Operation</b>		Training (Part 141-Subpart 8)			
<b>Pilot-in-command Licence Type</b>	National Pilot Licence (NPL)		<b>Age</b>	22		<b>Licence Valid</b>	Yes	
<b>Pilot-in-command Flying Experience</b>	<b>Total Flying Hours</b>		380		<b>Total Hours on Type</b>	380		
<b>Last Point of Departure</b>	Signal Hill in Cape Town, Western Cape Province							
<b>Next Point of Intended Landing</b>	Sea Point Promenade grass area in front of the Winchester Mansions Hotel, Western Cape Province							
<b>Damage to Paraglider</b>	Substantial							
<b>Location of the accident site with reference to easily defined geographical points (GPS readings if possible)</b>								
Atlantic Ocean, approximately 114m from the shoreline at GPS co-ordinates determined to be South 33°54'38.1" East 18°23'26.5" at an elevation of about 65ft

**Reference Number** : CA18/2/3/10346  
**Occurrence Category** : Accident (Category 1)  
**Type of Operation** : Training (Part 141)  
**Parag

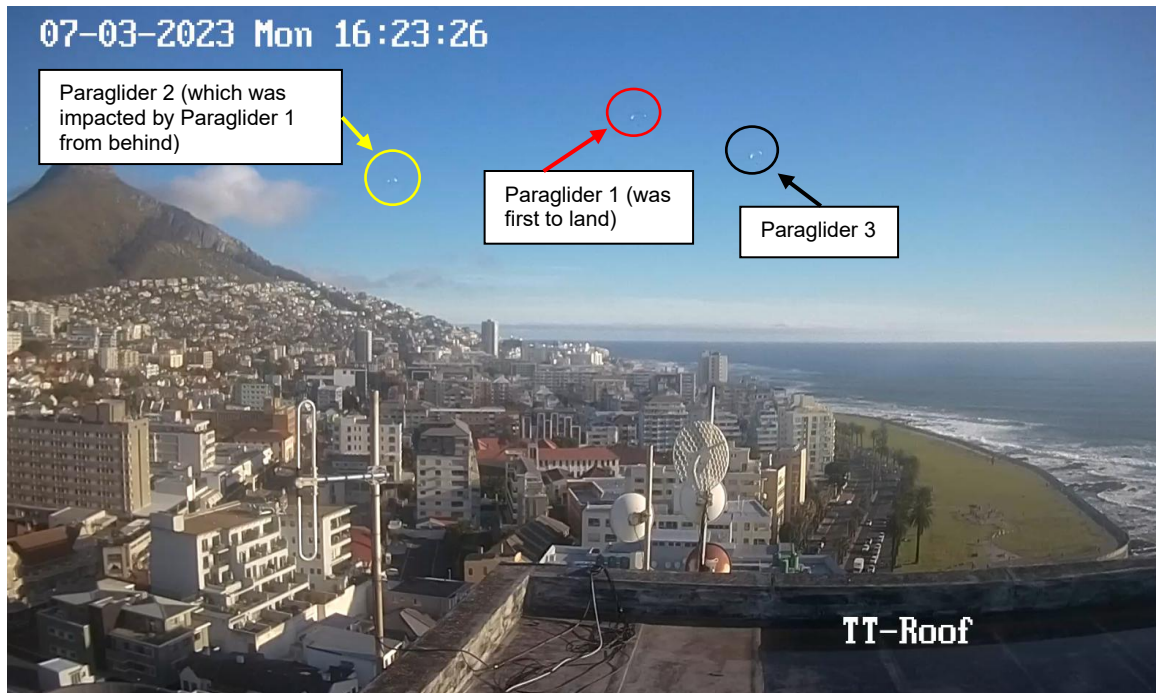
**Figure 2:** The video footage shows three paragliders: Paraglider 1 (accident paraglider) in the middle; Paraglider 2 on the left; and Paraglider 3 on the right was not involved in this accident.  
(Source: Close Circuit Television (CCTV) camera)

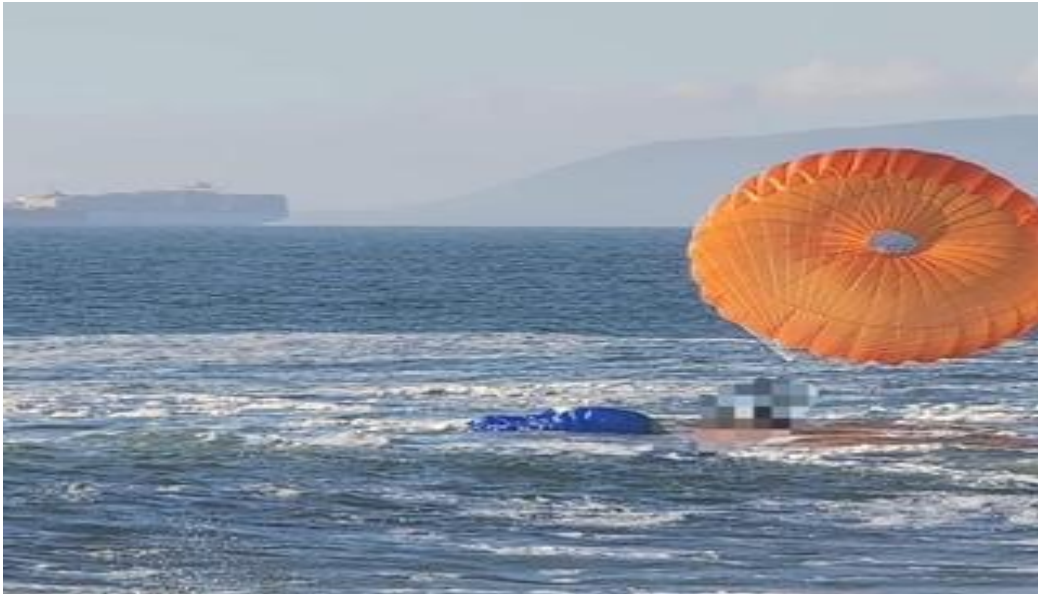
1.3.1. Paraglider 1 wing was substantially damaged, and some of the suspension lines snapped.

**Figure 3:** Paraglider 1's wing partially submerged (blue) in the ocean, and the deployed reserve parachute. (Source: Eyewitness mobile phone footage)

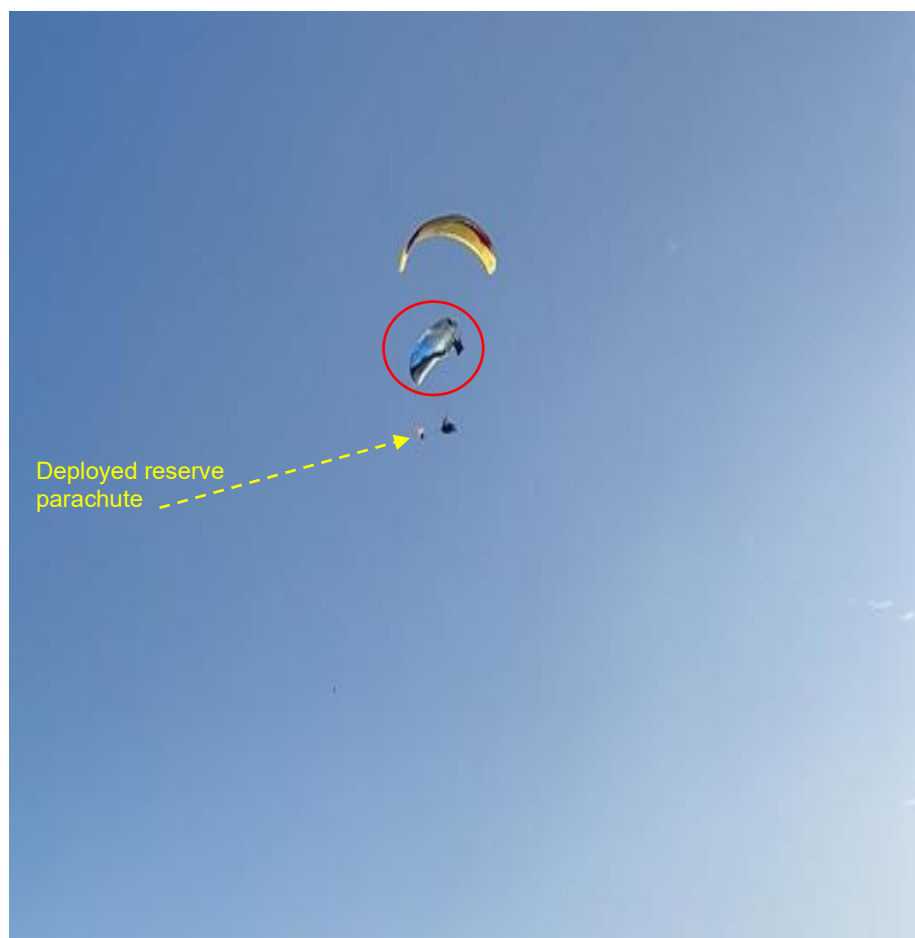
At 14:24:28Z, Paraglider 1's wing impacts the occupants of Paraglider 2 from the bottom left side. The occupants of Paraglider 2 are momentarily wrapped in the wing fabric of Paraglider 1 (Figure 9) with the suspension lines on their left legs.

**Figure 8:** Video footage shows the wing of Paraglider 1 impacting Paraglider 2 occupants from bottom left-side (red circle). (Source: Eyewitness mobile phone footage)

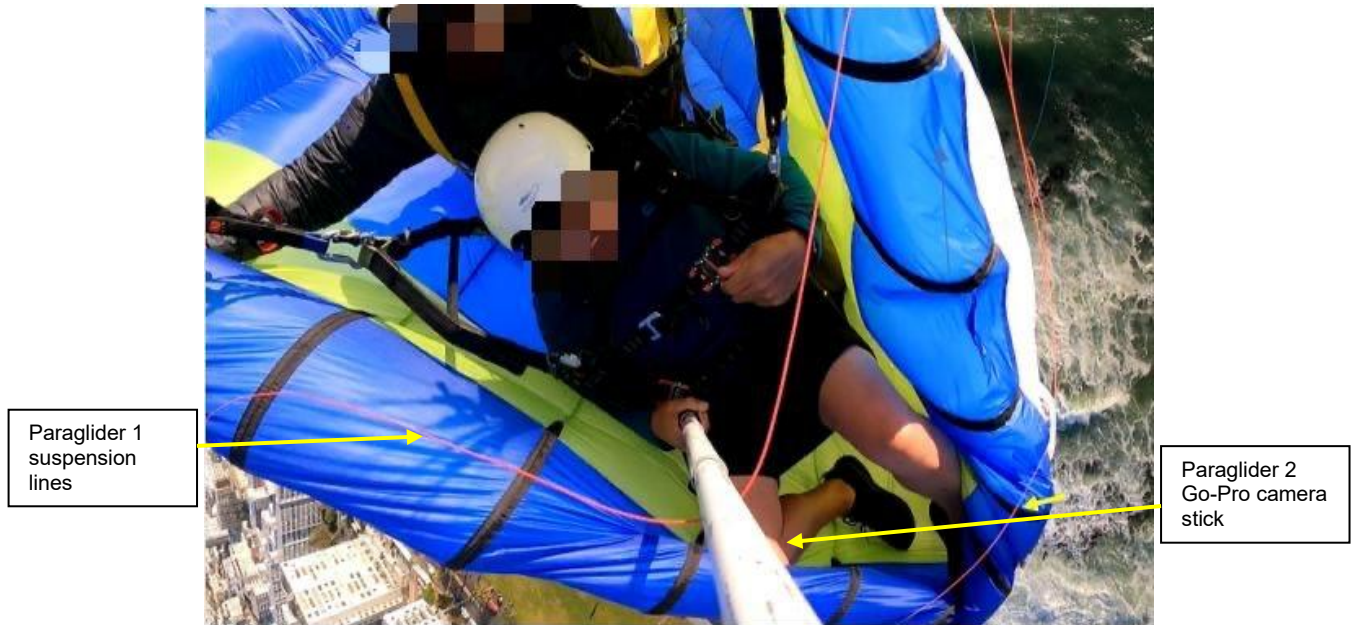
**Figure 9:** Paraglider 2 Go-Pro camera video footage shows Paraglider 2 occupants wrapped in Paraglider 1’s wing fabric and suspension lines.

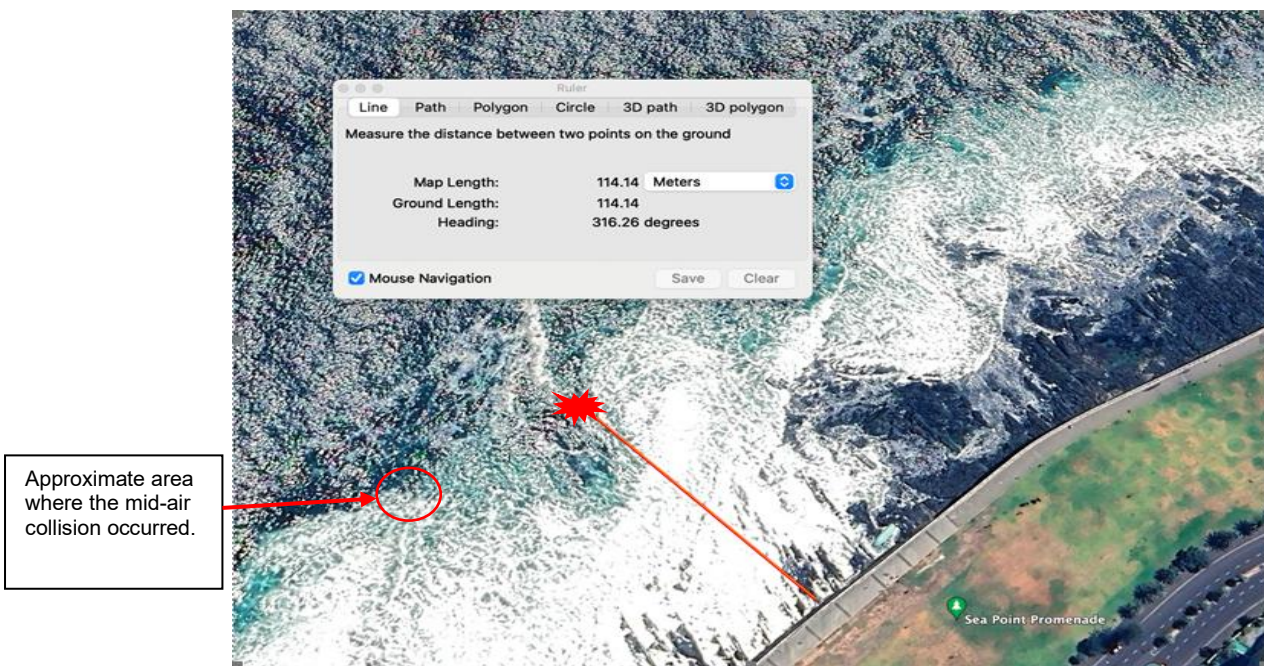
**Figure 10:** The approximate area where the mid-air collision occurred and the crash area which was approximately 114m from the shoreline. (Source: Google Earth)

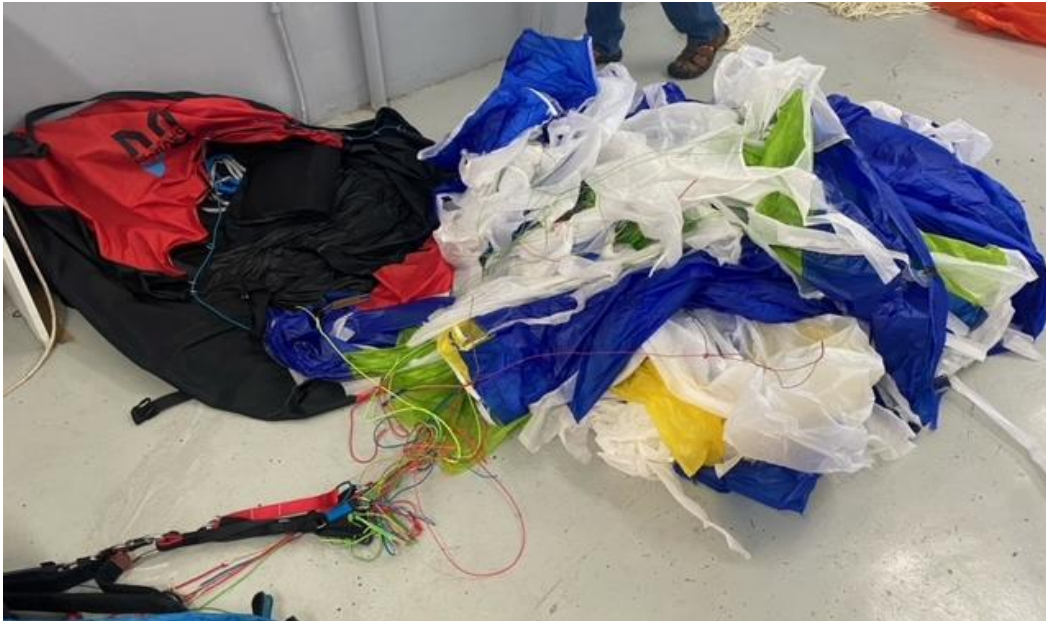
1.16.2 Paraglider 1's components were inspected, and no faults were found with any of its cells, cross-ports or V-ribs. All stitching was intact; the wing fabric was torn at multiple places.

1.16.3 The suspension lines were examined, some were found to have broken or snapped; they exhibited fracture features which were consistent with excessive stretching. The risers had no trace of damage. The harnesses were intact; all the webbing and material were in a satisfactory condition.

**Figure 11:** The torn wing fabric of Paraglider 1.

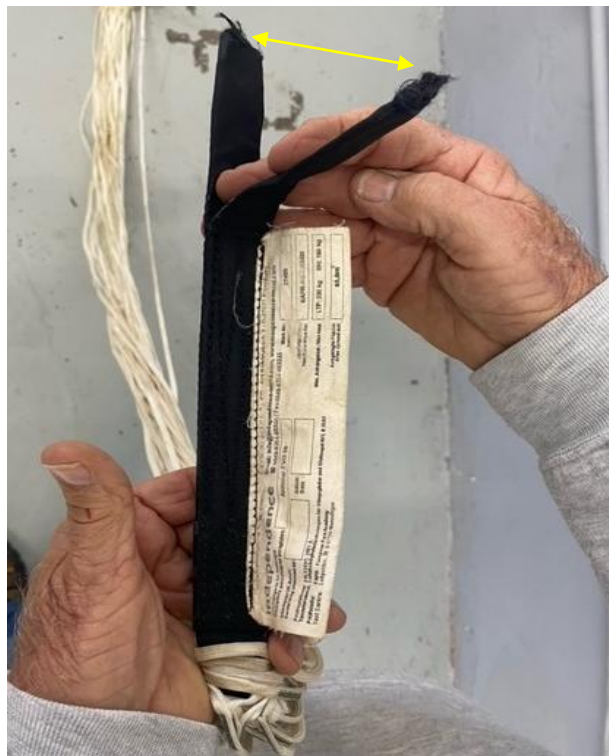
1.16.4 Paraglider 1 flight instructor and student pilot's seats were examined and were found to be intact with the safety harness clips operational. The reserve parachute was also inspected; the reserve stop, which is a connection point between the reserve parachute and the paraglider, had snapped during the accident sequence.

**Figure 12:** Paraglider 1 reserve stop that snapped.

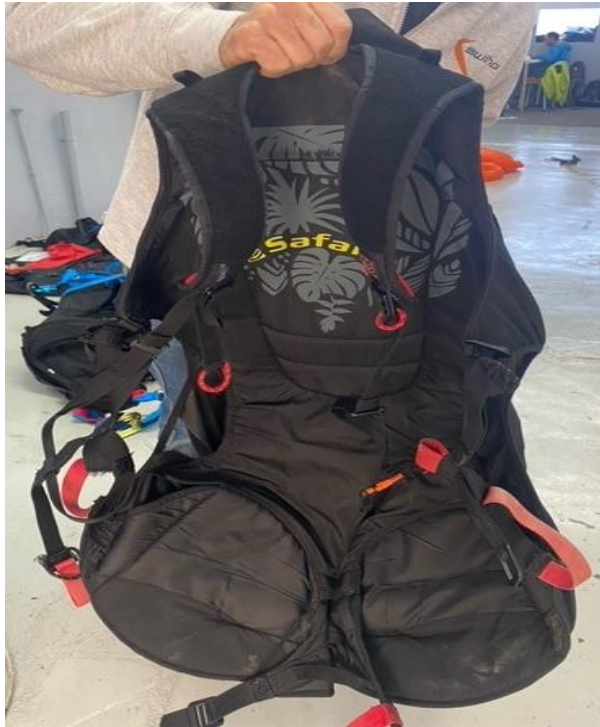
**Figure 13:** The student pilot's seat.

**4.2.1** It is recommended to the DTO that quick release type of harness carabiners be used to allow pilots to timeously separate from their paragliding gear during emergencies.

**4.2.2** It is recommended to the DTO to introduce the use of hook knives during paragliding flights to enable pilots to cut through the webbing and suspension lines during emergencies.

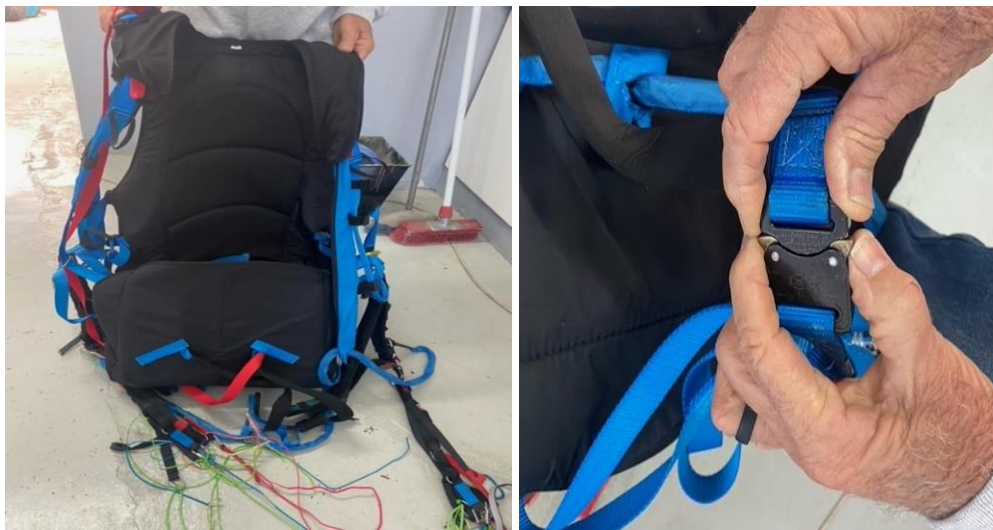
**Figures 14/15:** The flight instructor's seat (left) and its safety buckle/clip in a locked position (right).
