UAS LIMITED OCCURRENCE INVESTIGATION REPORT – FINAL
--

Reference Number	CA18/2/3/10347						
Classification	Accident	Date	6 July 2023	Time	2259Z		
Type of Operation	Unmanned Aircraft System – Surveillance (Part 101)						
Location							
Place of Departure	Arcelor Mittal near Vanderbijlpark, Gauteng Province		Place of Intended Landing	Arcelor Mittal near Vanderbijlpark, Gauteng Province			
Place of Occurrence	Arcelor Mittal near Vanderbijlpark, Gauteng Province						
GPS Co-ordinates	Latitude	26°38'39.4" S	Longitude	27°49'07.8" E	Elevation	4923 ft	
Aircraft Information							
Registration	ZT-YPM		Class	3A			
Make; Model; S/N	Mavic 2; Enterprise Advanced (Serial Number: MAV117)						
Damage to Aircraft	Substantial		Total UAS Hours	61.01			
Pilot-in-command							
Licence Type	Remote Pilot Certificate		Gender	Male	Age	31	
Licence Valid	Yes	Total Hours	22.27	Total Hours on Type	22.27		
Total Hours 30 Days	10.2		Total Flying on Type Past 90 Days	19.21			
People Controlling	1	Injuries (On ground)	0	Fatalities	0	Fatalities (on ground)	0

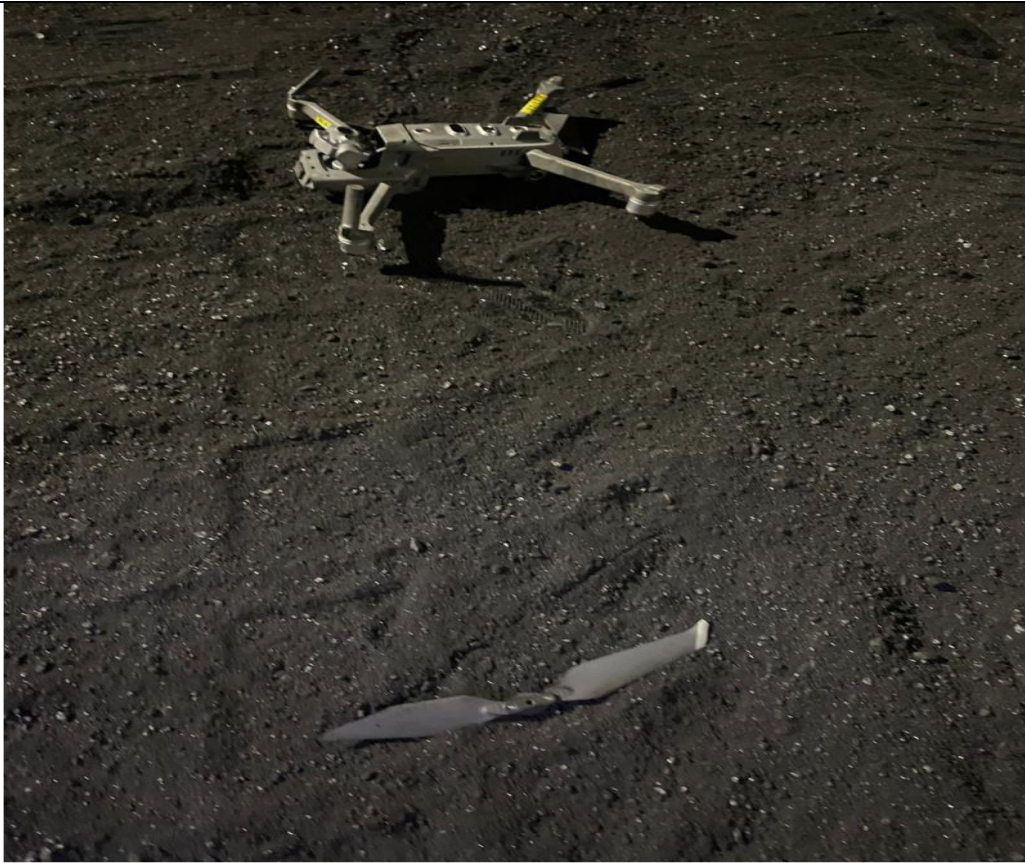
What Happened							
<p>On 6 July 2023, an unmanned aircraft system (UAS) with registration ZT-YPM was launched for surveillance of a steel mill factory plant at Arcelor Mittal near Vanderbijlpark, Gauteng province. The flight was conducted under beyond visual line of sight (BVLOS) rules by night and under the provisions of Part 101 of the Civil Aviation Regulations (CAR) 2011 as amended.</p> <p>The pilot reported that he completed two surveillance flights which were uneventful. In preparation for the third flight, he stated that he completed a pre-flight check with no anomalies found. Thereafter, the UAS was launched with the battery power at 100 percent, and the UAS climbed to 117 metres (m) (383 feet [ft]) above ground level (AGL) to survey the area and to take pictures. Approximately 4 minutes into the flight whilst at 378 ft, there was loss of connection between the remote pilot station and the UAS. The pilot engaged the return-to-home function, but there was no response. He then made his way to the last recorded position of the UAS and found it crashed. The UAS sustained substantial damage to one of the propellers and the battery. No person was injured on the ground.</p>

Figure 2: The UAS at the accident site. (Source: Pilot)

The investigation revealed that the battery terminals had red dust inside the terminals.

The UAS disconnected from the remote pilot station as a result of the red dust that had accumulated on the battery terminal.
