UAS LIMITED OCCURRENCE INVESTIGATION REPORT – FINAL

Reference Number	CA18/3/2/10348						
Classification	Accident	Date	10 July 2023	Time	2325Z		
Type of Operation	Unmanned Aircraft Systems – Surveillance (Part 101)						
Location							
Place of Departure	Dipaleseng near Balfour, Mpumalanga Province		Place of Intended Landing	Dipaleseng near Balfour, Mpumalanga Province			
Place of Occurrence	Dipaleseng, approximately 9.7km from the launch site						
GPS Co-ordinates	Latitude	26° 42' 42" S	Longitude	028° 35' 26" E	Elevation	5452 ft	
Aircraft Information							
Registration	ZT-YFW		Class	3A			
Make; Model; S/N	Arace; Sirin (Serial Number: SIR127)						
Damage to Aircraft	Minor		Total UAS Hours	826.58			
Pilot-in-command							
Licence Type	Remote Pilot Licence (RPL)		Gender	Male		Age	21
Licence Valid	Yes	Total Hours	680.18	Total Hours on Type	680.18		
Total Hours 30 Days	35.53		Total Flying on Type Past 90 Days	179.18			
Injuries	0	Injuries (On ground)	0	Fatalities	0	People Controlling	1

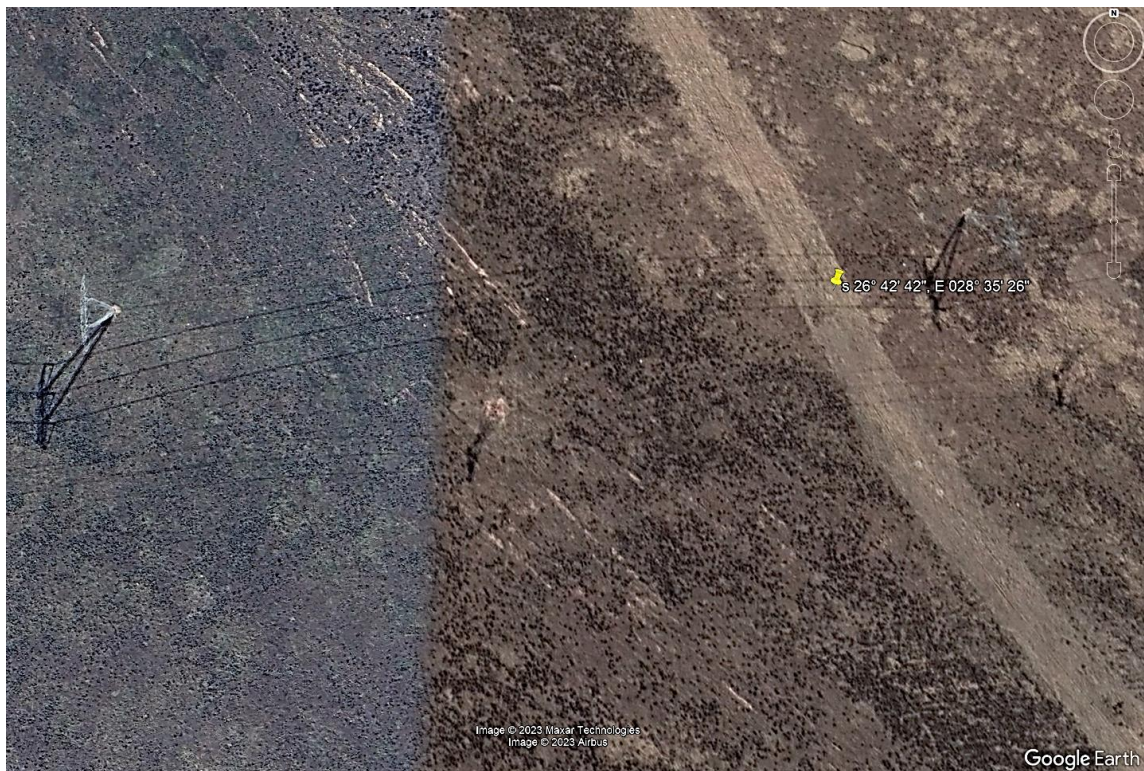
Figure 1 shows the view of the accident site. The pin location provided by the pilot indicated that the UAS was found under high-tension power lines. According to the Eskom report (Ch3Techdetails), the minimum clearance between the conductor and the ground must be 15.0 metres.

Figure 1: Overlay of the accident site. (Source: Google Earth)

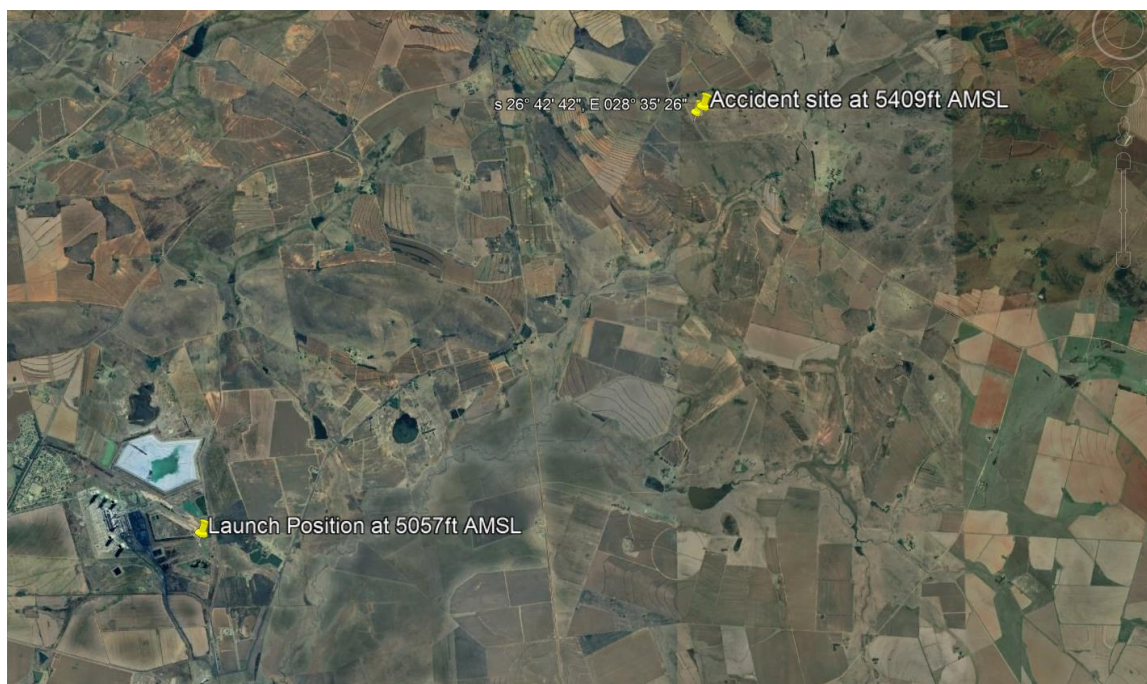
Figure 2: The elevation of the two points between the launch site and the accident site.

According to Google Maps location indicator, the UAS was launched at a field elevation of 5057 ft above mean sea level (AMSL). The accident occurred at a field elevation of 5409 ft AMSL. The height at which the UAS was operated (394 ft AGL) did not clear the obstacle due to the rising field which was higher than the launch site. The high-tension electrical power lines spanned across the UAS's flight path.

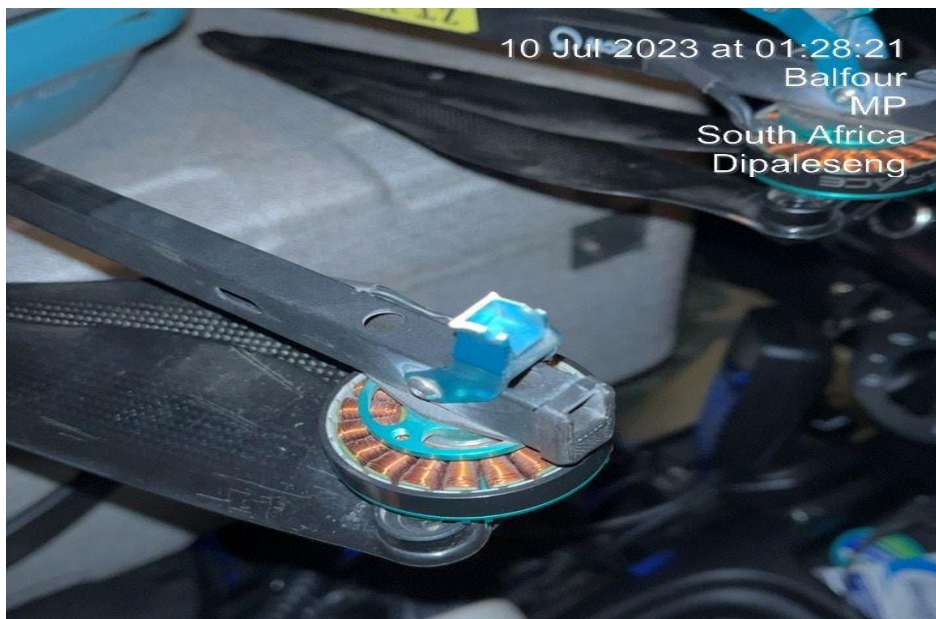
Figure 4: Damaged UAS landing gear. (Source: Operator)

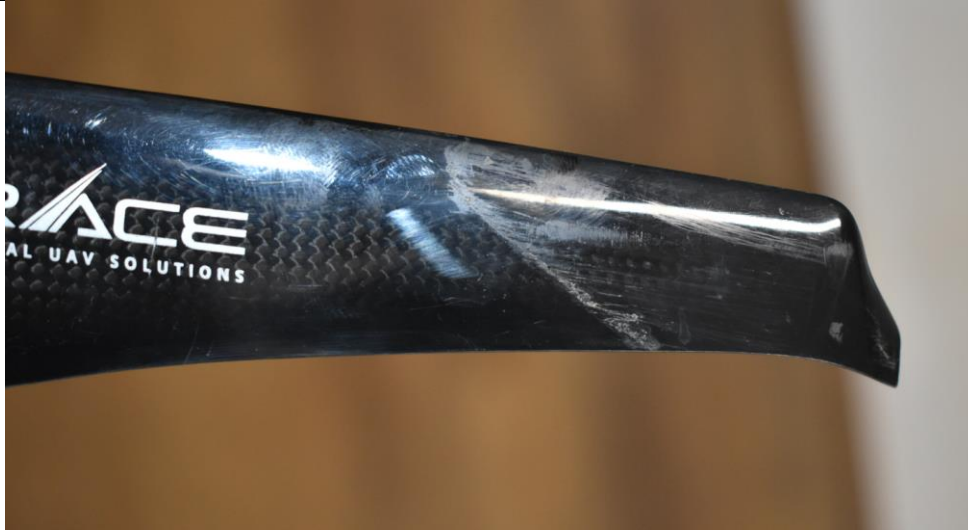
Figure 5: Scratch marks on the rotor blade. (Source: Operator)
