LIMITED OCCURRENCE INVESTIGATION REPORT – FINAL

Reference Number	CA18/2/3/10349						
Classification	Accident	Date	11 July 2023		Time	0615Z	
Type of Operation	Private (Part 91)						
Location							
Place of Departure	Worcester Private Farm, Thabazimbi, Limpopo Province		Place of Intended Landing	Boesmanskraal Safaris Private Farm, Thabazimbi, Limpopo Province			
Place of Occurrence	Boesmanskraal Safaris Private Farm						
GPS Co-ordinates	Latitude	24°09'50.69" S	Longitude	027°00'51.06" E	Elevation	3 018 ft	
Aircraft Information							
Registration	ZS-ORG						
Make; Model; S/N	Robinson R44 Raven II (Serial Number: 11285)						
Damage to Aircraft	Substantial		Total Aircraft Hours	1 184.6			
Pilot-in-command							
Licence Type	Private Pilot Licence (PPL)		Gender	Male		Age	62
Licence Valid	Yes	Total Hours	1 058.7		Total Hours on Type	149.8	
Total Hours 30 Days	17.5		Total Flying on Type Past 90 Days	32.9			
People On-board	1 + 1	Injuries	0	Fatalities	0	Other (on ground)	0

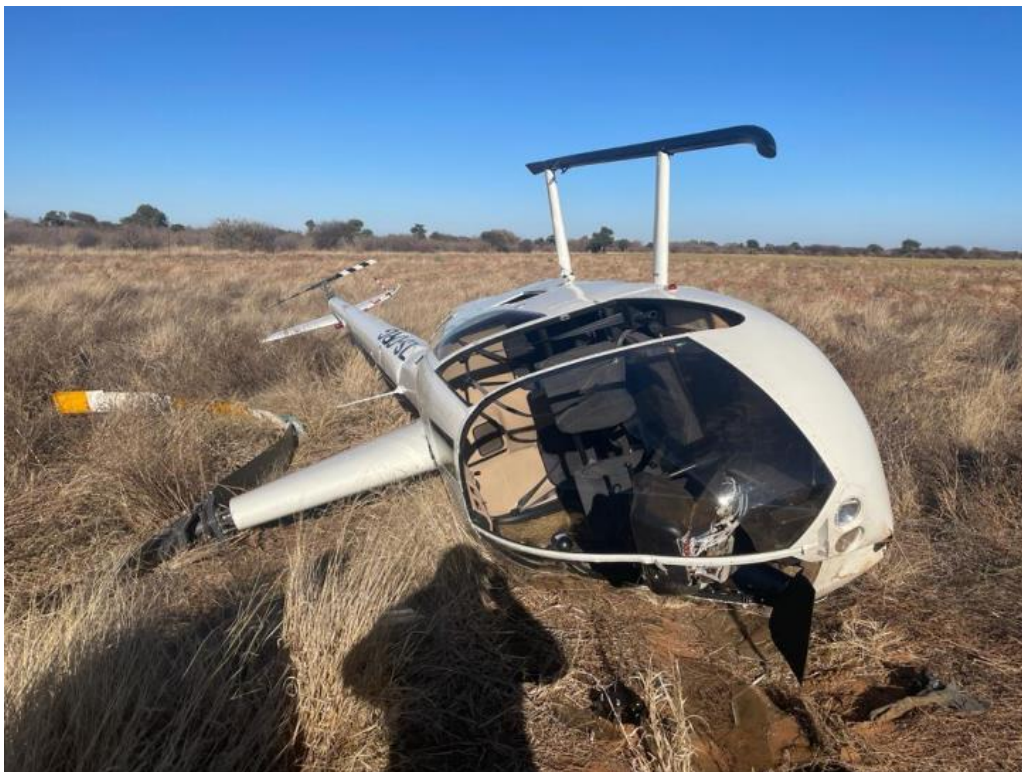
The helicopter sustained substantial damage during the accident sequence, however, neither of the occupants were injured.

Figure 1: The helicopter after the accident. (Source: Pilot)

The helicopter was established at hover in ground effect with the wind at 20 knots and gusting at 35 knots; this caused the yaw to the right before the pilot lost control. The helicopter is certified to hover IGE with the wind at 17 knots from any direction but, in this case, it was hovered at the wind speed above 17 knots. Strong crosswinds and tailwinds may require the use of more tail rotor thrust to maintain directional control. The increased tail rotor thrust absorbs power from the engine, which means that there would be less power available to the main rotor for the lift and, thus, a subsequent loss of rotor RPM would occur. The pilot lowered the collective whilst applying full left anti-torque pedal to stop the yaw, which was an incorrect technique (to correct the right yaw); this resulted in loss of control.
