AIRCRAFT ACCIDENT REPORT AND EXECUTIVE SUMMARY

Reference:		CA18/2/3/10350	
Aircraft Registration	ZS-ARC	Date of Accident	11 July 2023		Time of Accident	0617Z	
Type of Aircraft	Thrush S2R-H80		Type of Operation		Aerial Work - Crop Spraying (Part 137)		
Pilot-in-command Licence Type	Commercial Pilot Licence (CPL)		Age	43	Licence Valid	Yes	
Pilot-in-command Flying Experience	Total Flying Hours		11 044	Hours on Type	9 924.6		
Last Point of Departure	Rosenburg Farm, Malmesbury, near Western Cape Province						
Next Point of Intended Landing	Rosenburg Farm, Malmesbury, near Western Cape Province						
Damage to Aircraft	Substantial						
Location of the accident site with reference to easily defined geographical points (GPS readings if possible)							
Droeivlei Farm, approximately 10km south of Malmesbury at GPS 33°36'59.7" South 018°42'36.8" East, at an elevation of 357 feet (ft)							
Meteorological Information	Wind direction: 360°, wind speed: 2 knots, CAVOK, temperature: 3°C, Dew point 2°C, QNH 1023

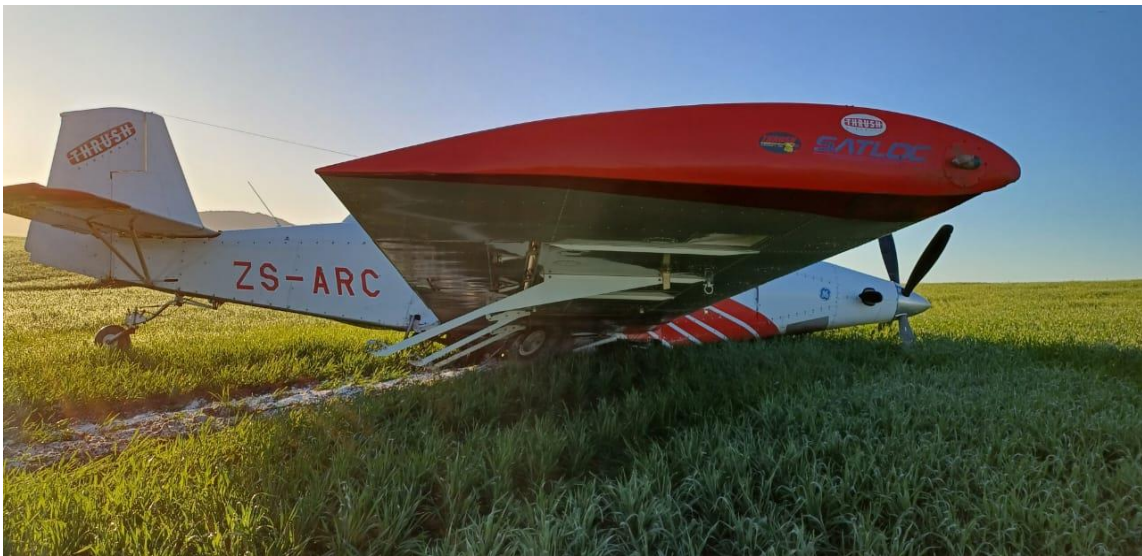
Figure 2: The ZS-ARC aircraft post-accident. (Source: Operator)

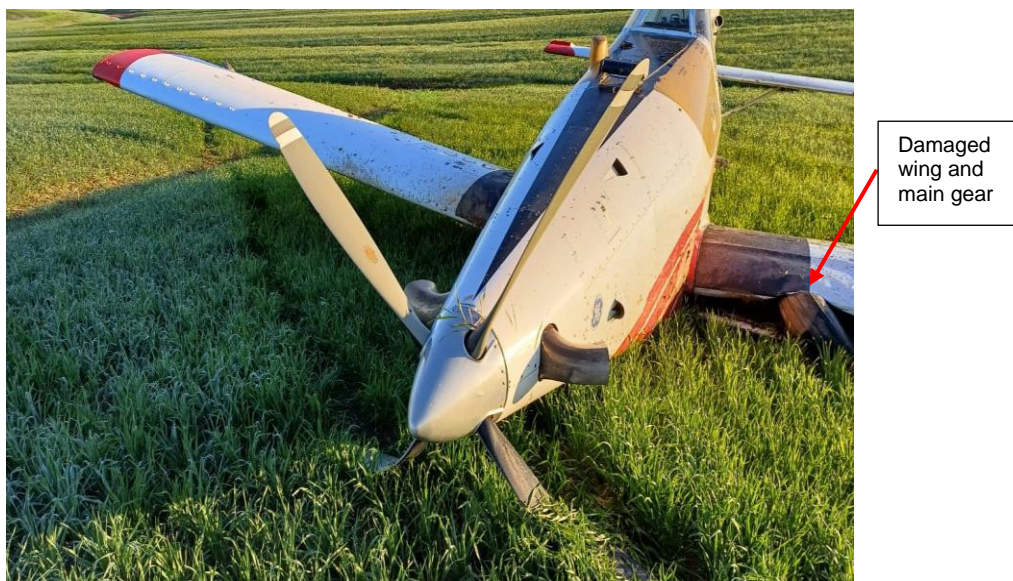
1.3.1. The aircraft sustained substantial damage.

Figure 3: The front view of the aircraft at the accident site. (Source: Operator)

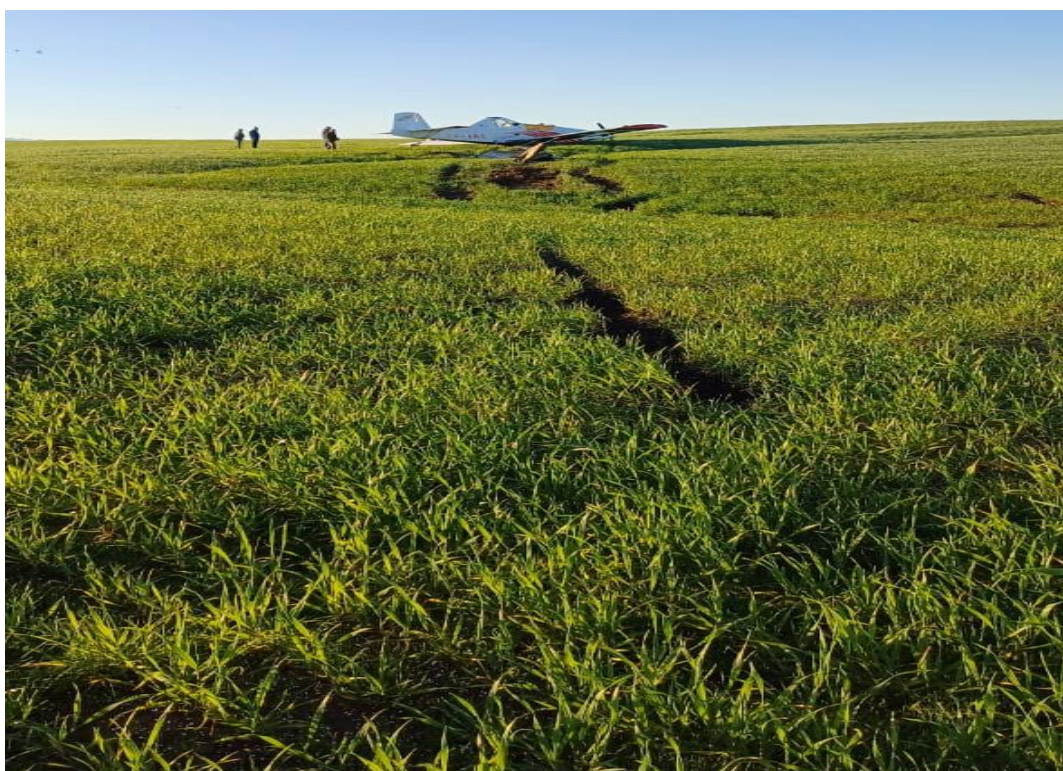
1.12.1. The aircraft impacted the ground with its tail wheel and skidded approximately 20 metres (m) during which the main landing gears broke and collapsed as they dug into the soft soil. The propeller impacted the ground before the aircraft stopped; it faced north when it rested. The left wing sustained substantial damage. The right wing and the tailwheel had remained intact.

Figure 4: The path created by the aircraft's wheels in the wheat field. (Source: Operator)

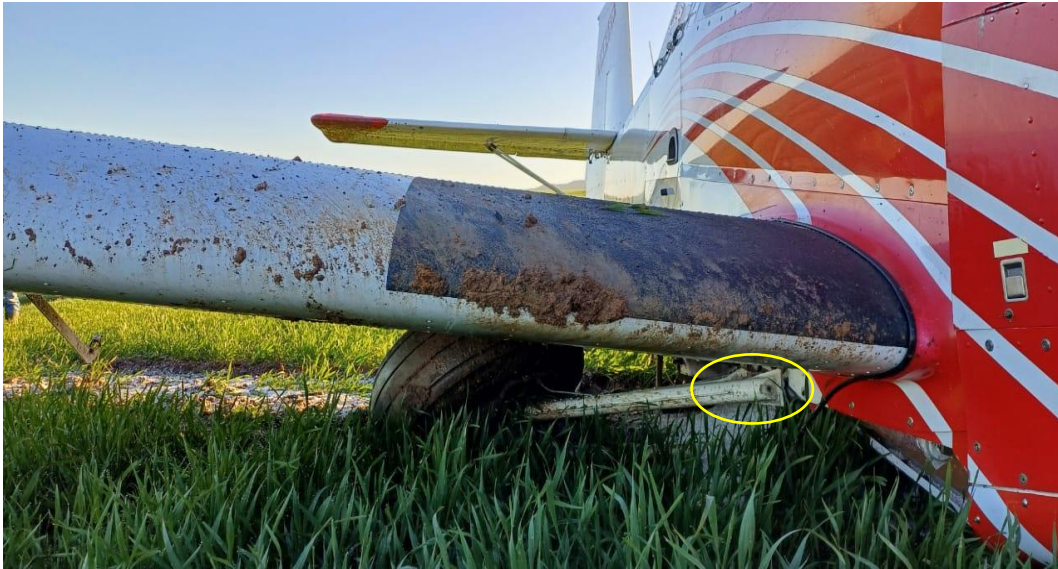
Figure 5: The front view of the broken right main gear. (Source: Operator)

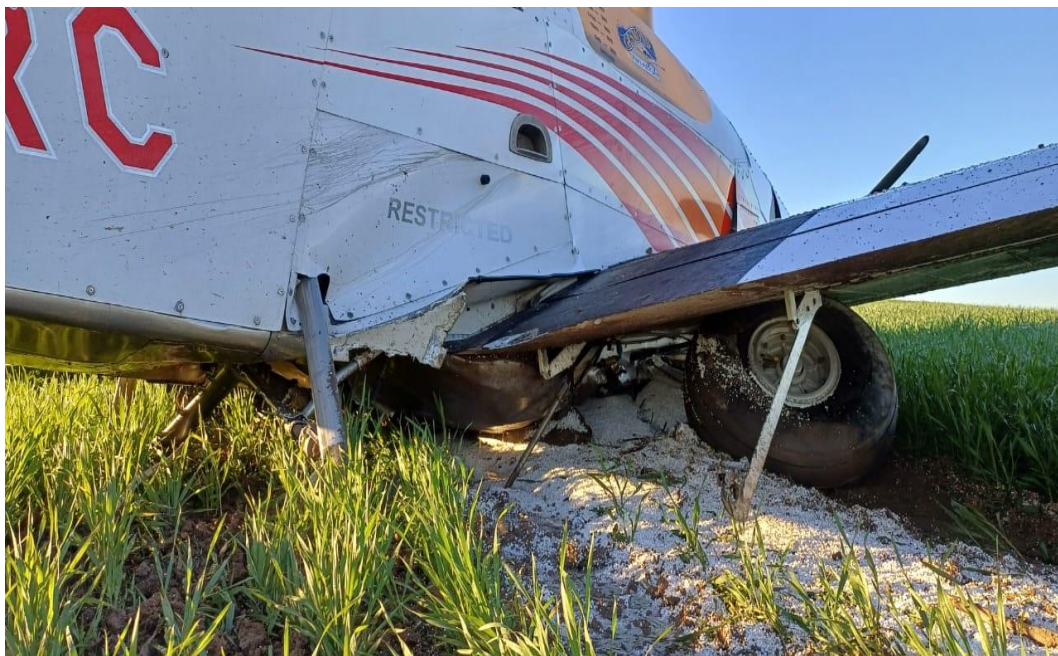
Figure 6: Rear view of the right-wing trailing edge and right main gear. (Source: Operator)

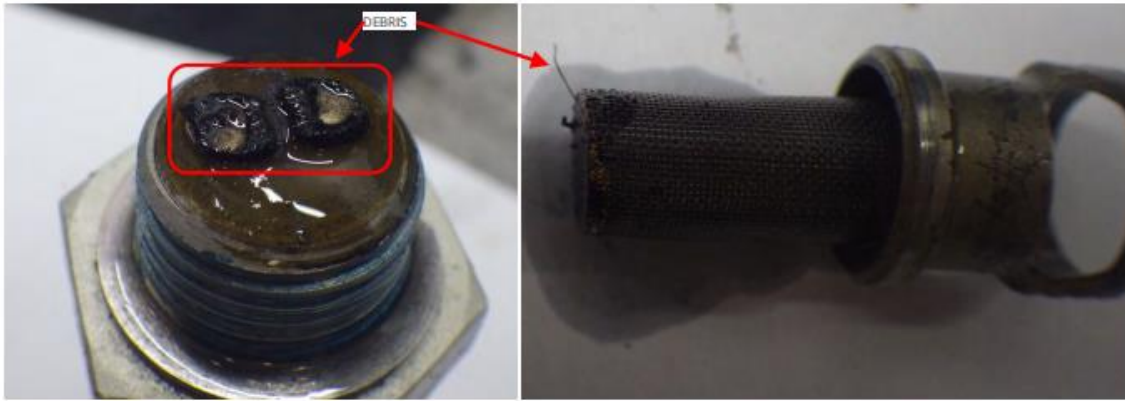
1.16.4 The main oil filter and its cavity were contaminated with debris. The auxiliary gearbox (AGB) magnetic plug was contaminated with magnetic debris. The AGB chip detector and AGB chip detector screen were contaminated with debris (See Figure 8).

Figure 8: The auxiliary gearbox chip detector and chip detector screen. (Source: Engine manufacturer)

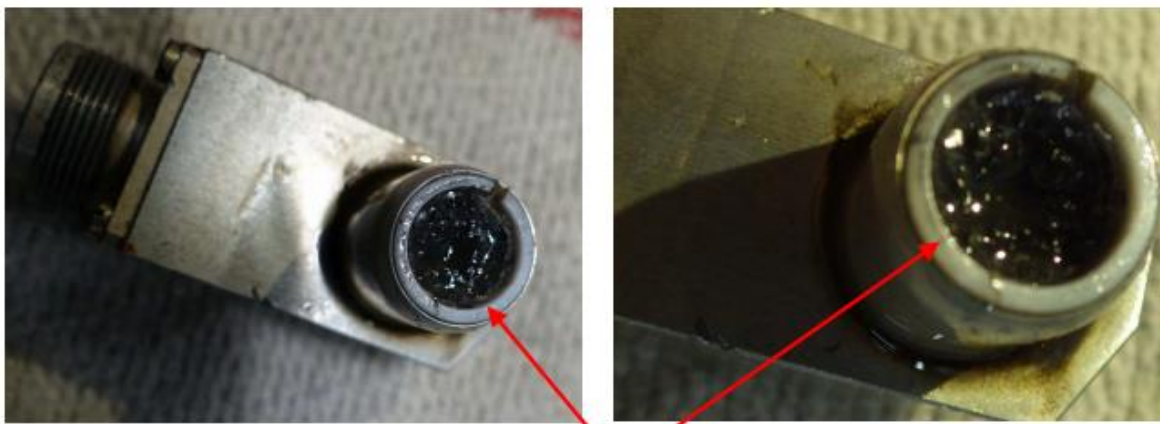
1.16.5 The reduction gearbox (RGB) chip detector was contaminated with debris (See Figure 9).

Figure 9: RGB Chip detector with arrows pointing to debris. (Source: Engine manufacturer)

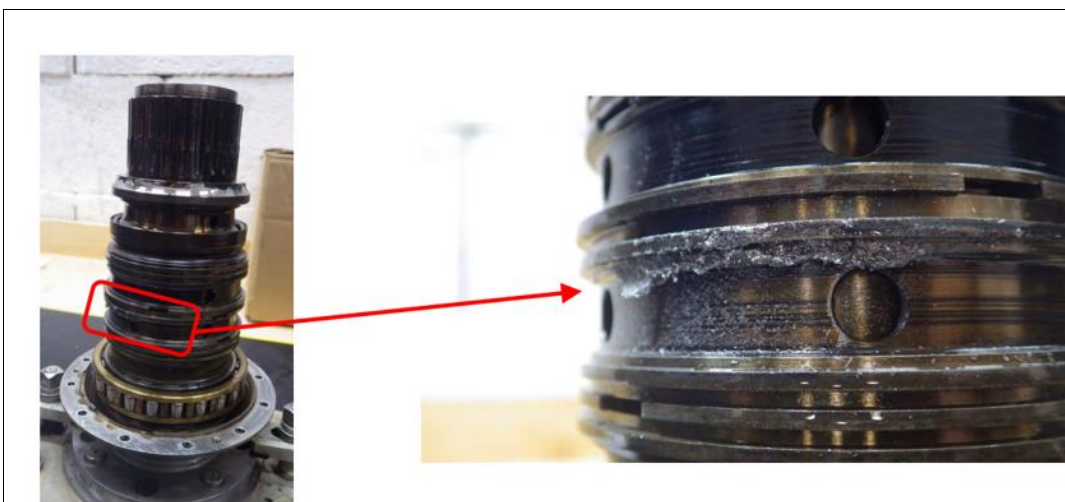
1.16.6 Debris was observed around the oil control channel in the propeller shaft which connects the oil pressure from the propeller governor to the propeller (see Figure 10).

Figure 10: Propeller governor drive shaft assembly shows debris on the oil control channel. (Source: Engine manufacturer)

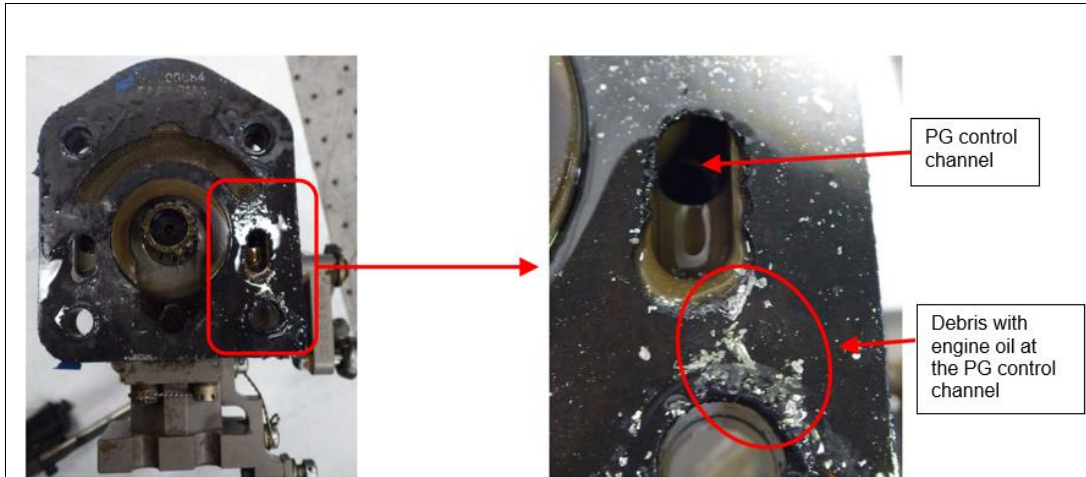
1.16.7 The propeller governor drive shaft is designed to shear during overload to avoid damaging the gears in the reduction gearbox (RGB) when the rotation of the propeller governor is blocked. The propeller governor drive shaft did not shear as designed, but it was damaged, which contributed to the damage of the gears in the RGB after the propeller governor had stopped operating (see Figure 11).

Figure 11: The propeller governor flange and gasket after the removal of the propeller governor. (Source: Engine Manufacturer)

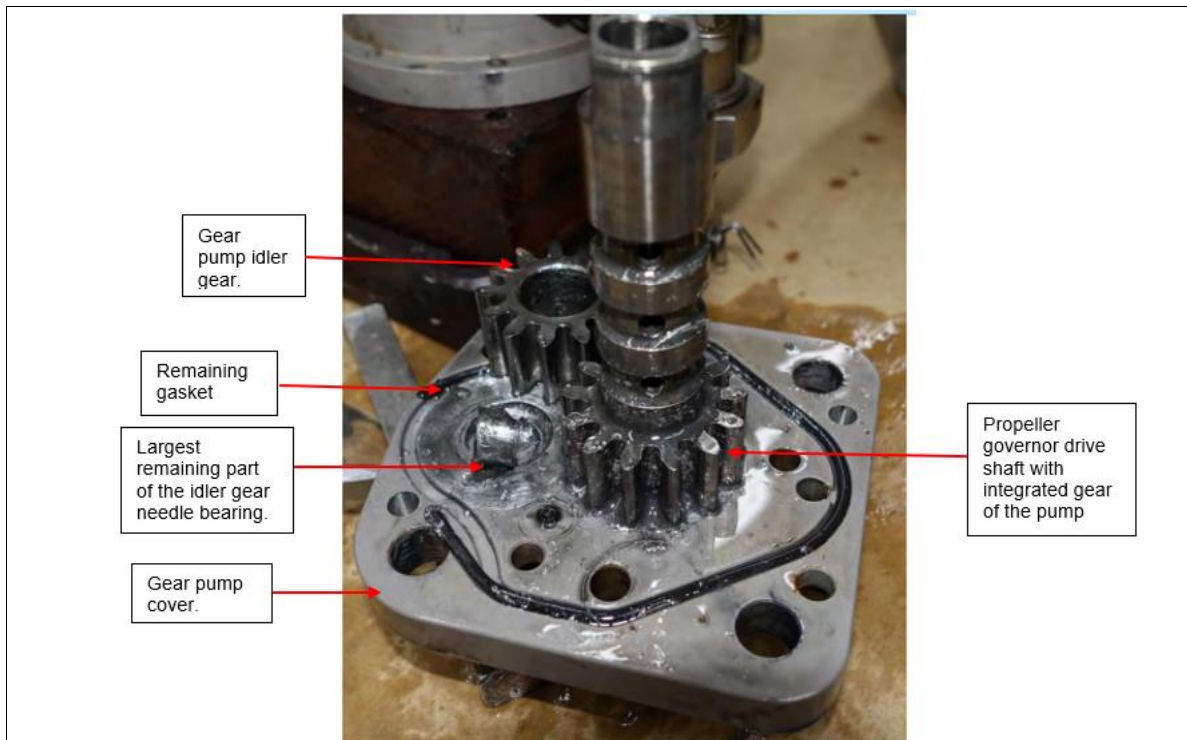
1.16.8 The idler gear of the gear pump was misaligned due to the destruction of the gear pump's idler gear needle bearing. The misalignment caused excessive rubbing and damage to the body and cover of the gear pump (see Figure 12 below).

Figure 12: The disassembled propeller governor gear pump. (Source: Engine Manufacturer)

1.16.11 The propeller governor manufacturer also performed a separate investigation. The propeller governor report stated that there was contamination in the needle-bearing race, which led to the crack on the cage or idler gear-bearing needle, and thus, the damage to the bearing. This damage caused the idler to move out of the axis which caused misalignment. As a result, the pin was bent, and the governor body and the relief valve were damaged. This misalignment caused the teeth of the drive shaft and idler to jam, creating a shock load.

NOTE: Corrective action available, see EASA_AD_2022-0234_1. Corresponding ASB-000411 introduces new models of Propeller Governor P-W11-4 and P-W11-5 and provides instruction for replacement of Propeller Governors P-W11-1 with P-W11-4 and P-W11-2 with P-W11-5 for single engine application, see Attachment no. 3. EASA AD issued on 15th December 2022 with compliance time of 40 months.

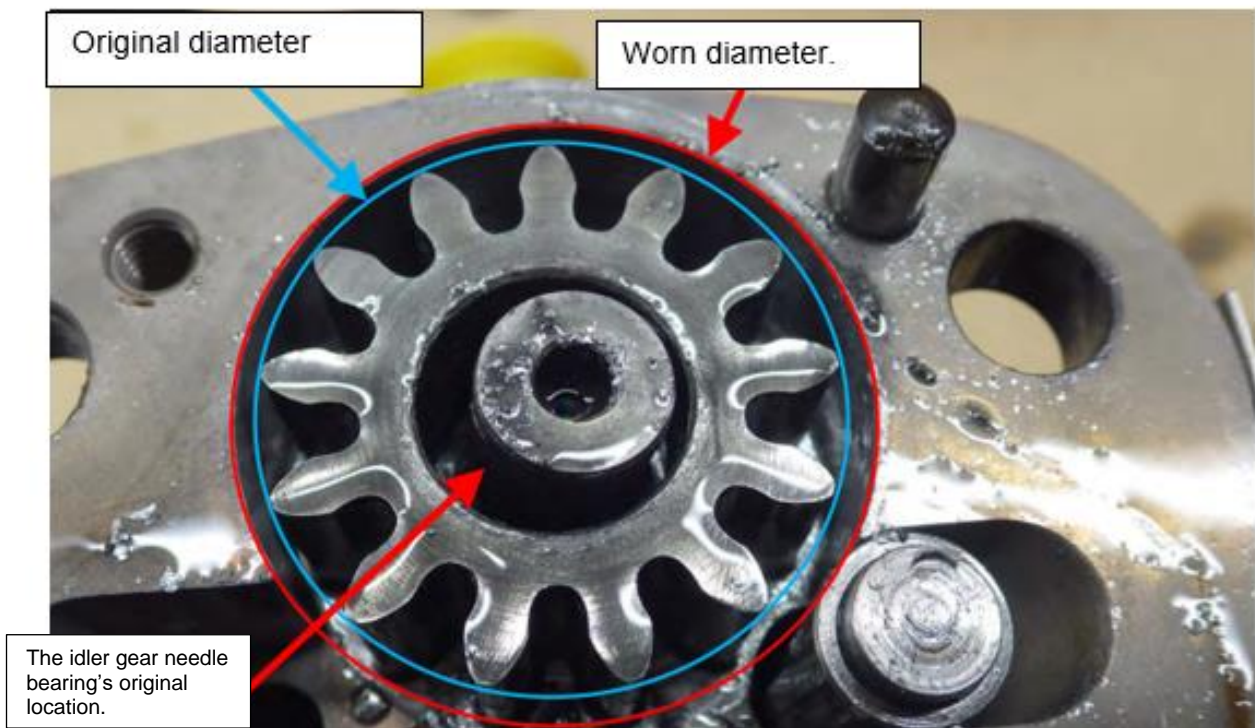
Figure 13: The damaged propeller governor gear pump body.
