AIRCRAFT ACCIDENT REPORT AND EXECUTIVE SUMMARY

Reference:		CA18/2/3/10351	
Aircraft Registration	ZS-GMD	Date of Accident	15 July 2023	Time of Accident	1030Z		
Type of Aircraft	UFM-13 Lambada		Type of Operation	Private (Part 94)			
Pilot-in-command Licence Type	National Pilot Licence (NPL)		Age	60	Licence Valid	No	
Pilot-in-command Flying Experience	Total Flying Hours		2 708.3	Hours on Type	5.5		
Last Point of Departure	Orient Airfield (FAOI) in Magaliesburg, Gauteng Province						
Next Point of Intended Landing	Orient Airfield (FAOI) in Magaliesburg, Gauteng Province						
Damage to Aircraft	Substantial						
Location of the accident site with reference to easily defined geographical points (GPS readings if possible)							
Approximately 100 metres (m) south-west of Runway 36 at GPS 26°02'42.70" South 027°35'47.66" East, at an elevation of 5 122 feet (ft)							
Meteorological Information	Surface Wind: 260V360 at 9 knots, Visibility: 9999m, Temperature: 13°C, Dew Point: 3°C: QNH 1029 hPa

During a climb, the TMG's attitude reached a high critical angle-of-attack which resulted in a stall from which the pilot could not recover.

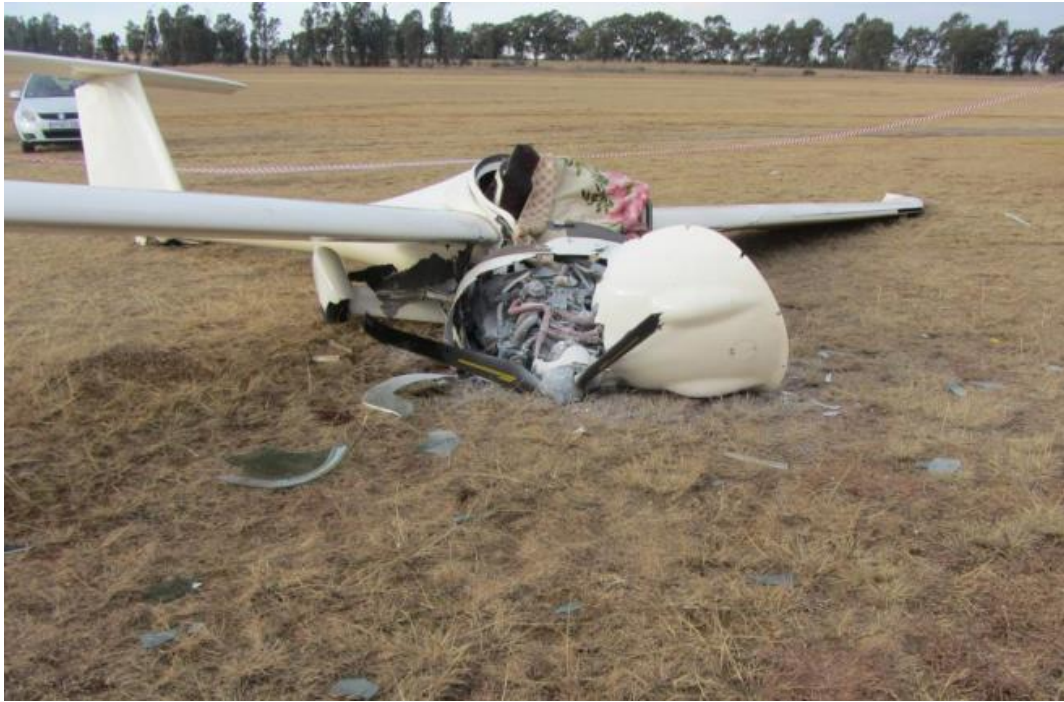
1.3.1. The TMG sustained substantial damage.

Figure 2: The damaged TMG after the accident.

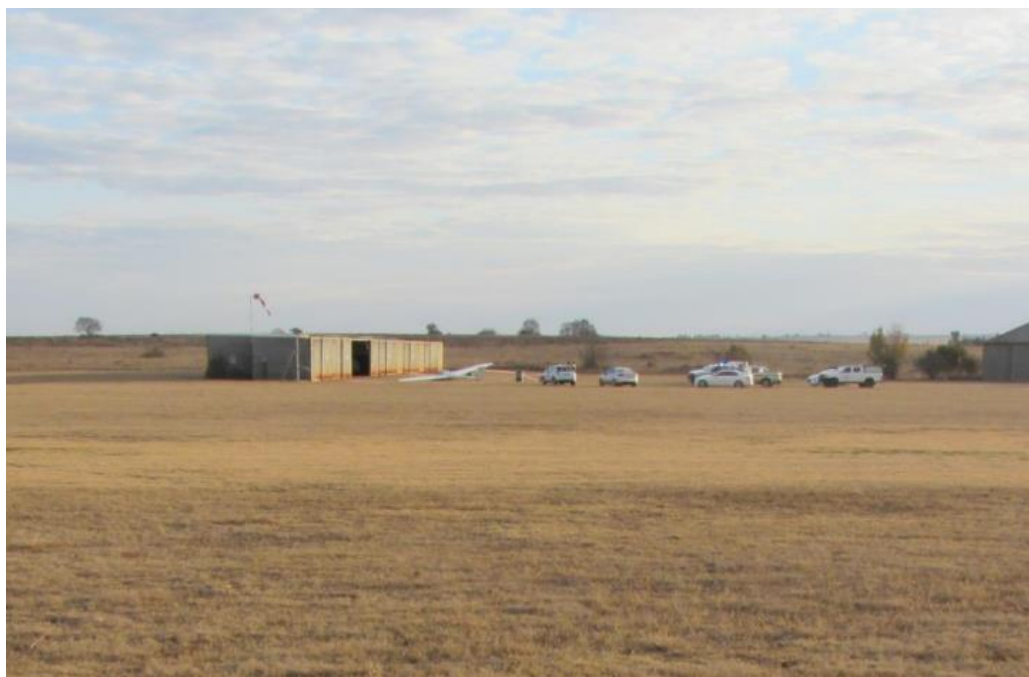
1.12.1 The accident occurred after take-off, approximately 162m from the edge of RWY 36 at FAOI. The TMG's resting position was at the front of row B hangars; it faced north-westerly about 8m from the hangars. The wreckage distribution was contained in an approximate 10m radius. The nose section was heavily damaged with twists to the right. The TMG was found resting in a left-wing low position due to the damaged main landing gear assembly.

Figure 4: The view of the accident site from Runway 36.

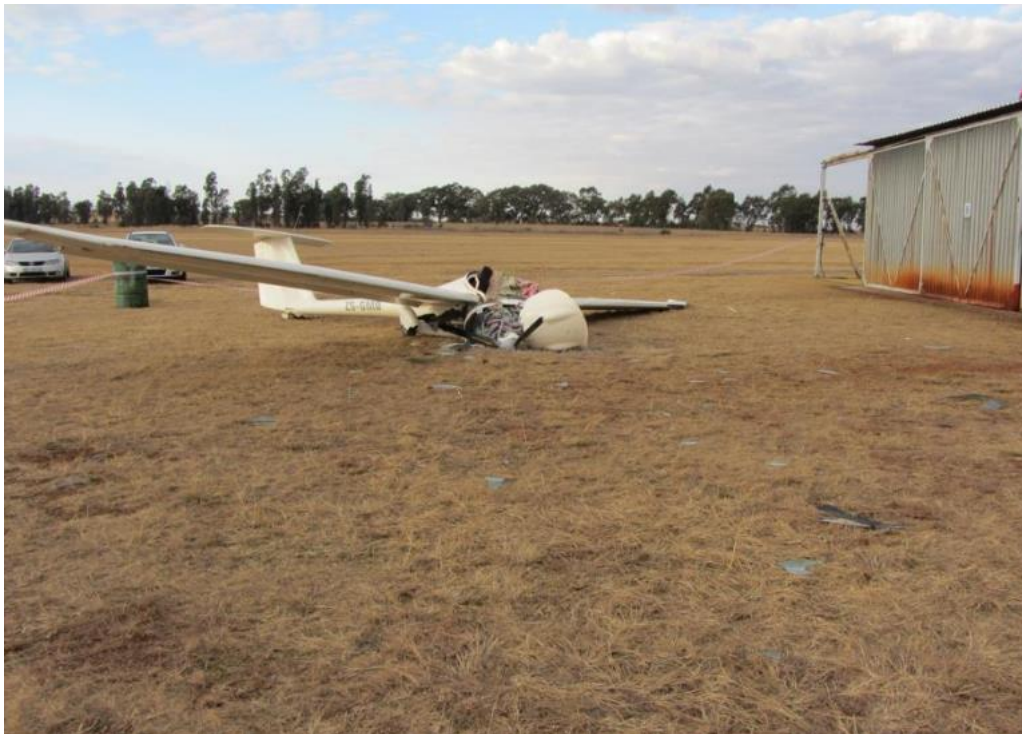
The fuselage structure was heavily disturbed, and the wings were still attached to the fuselage. The empennage was attached to the frame, however, the tail wheel suffered impact damage. The Perspex canopy shattered, and pieces of Perspex material were found in front

Figure 5: The damaged fuselage.

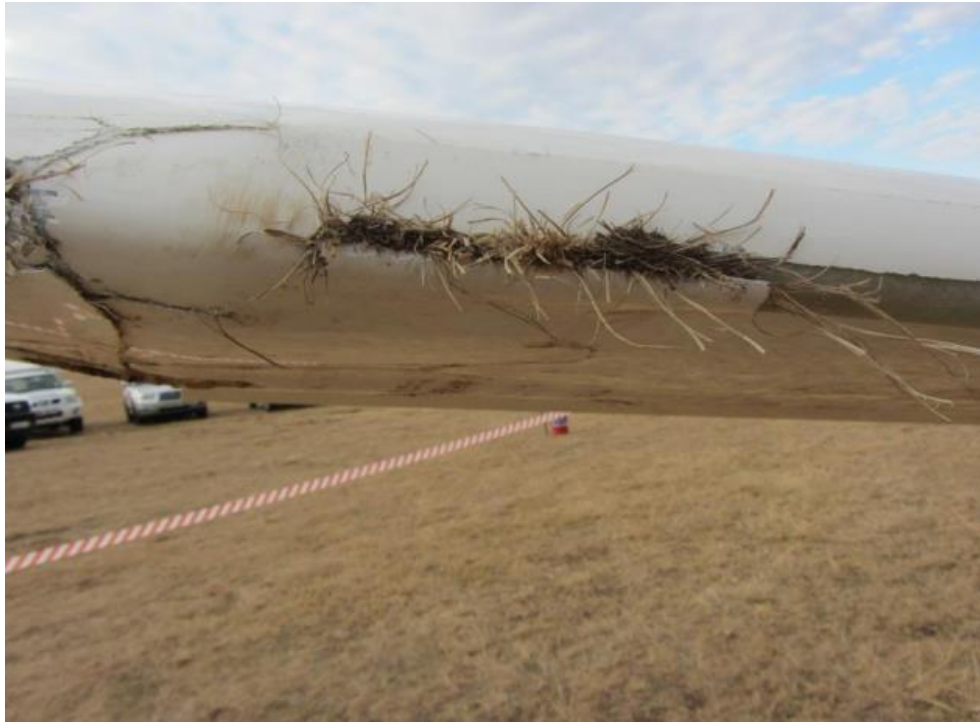
of the TMG. The wings outboard section exhibited signs of contact with the ground as dirt and grass was visible on the leading edges. A large piece of the left-wing outboard leading-edge skin was missing as a result of impact; cracks were observed on the upper surface skin chordwise. The grass around the left wing was moist with a strong smell of fuel, consistent with Unleaded 95 Octane. The main landing gear had dislodged from the attachment points and was found under the TMG. Carbon fibre split spanwise on the strut surface; however, the strut did not separate although the left main wheel hub was damaged.

Figure 6: Dirt and grass on the outboard section leading edge of the left wing.

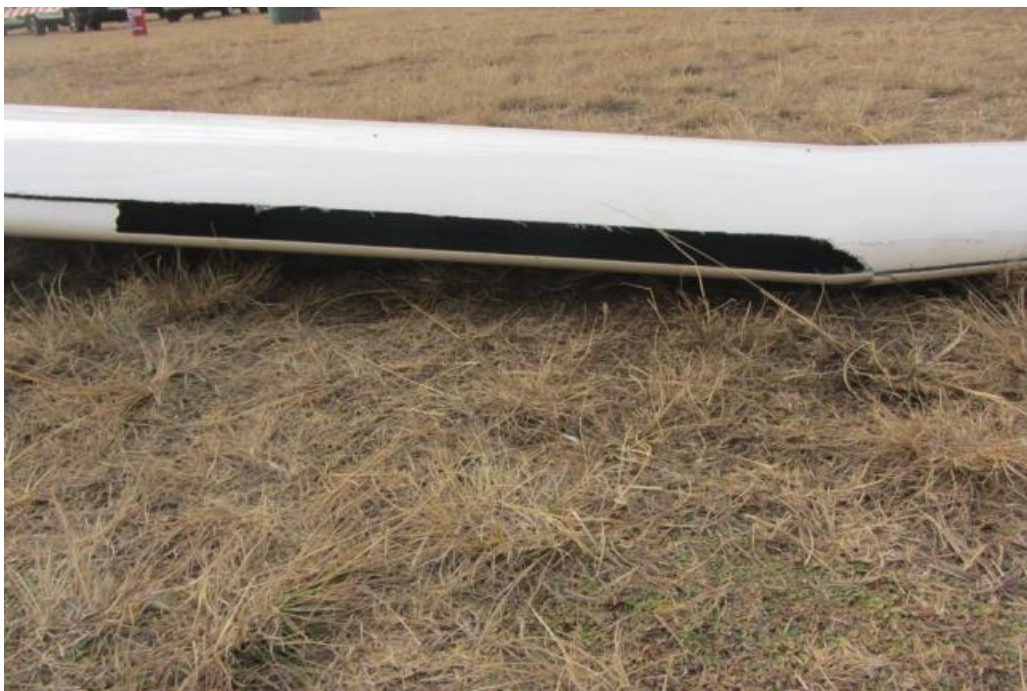
Figure 7: Damage on the right-side wing leading edge.

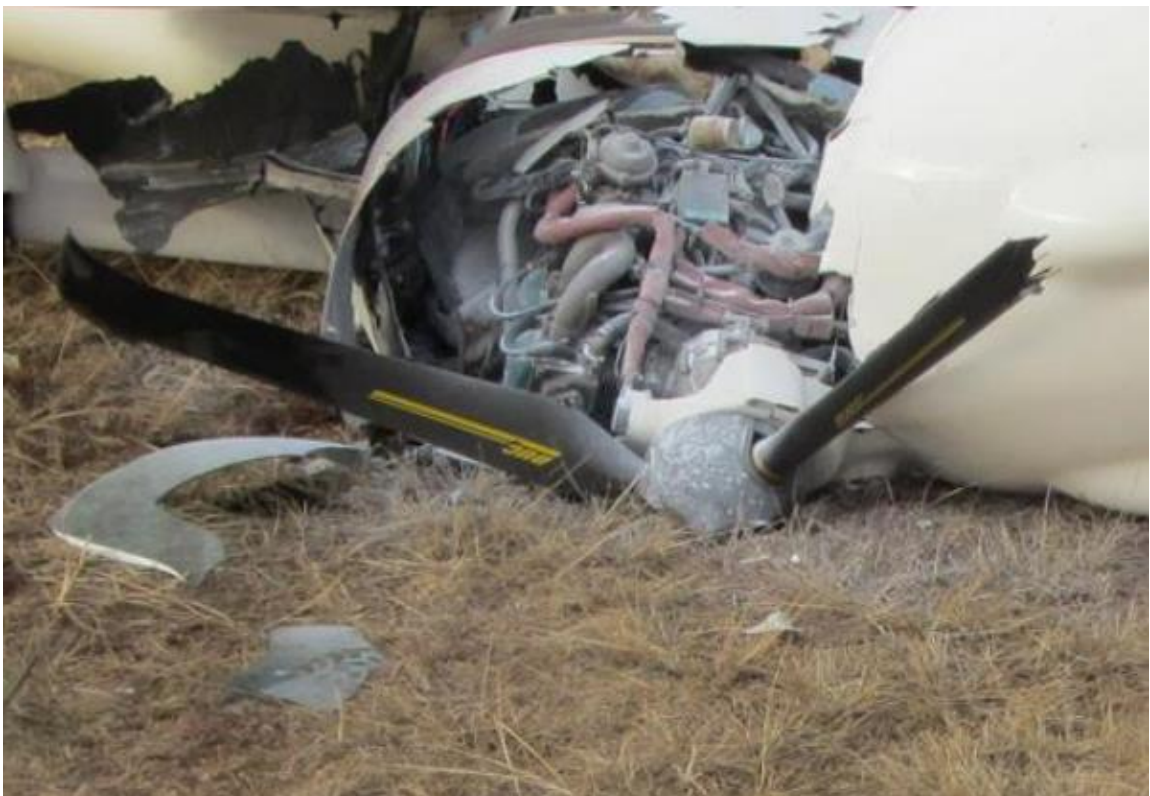
Figure 8: The damaged nose section.

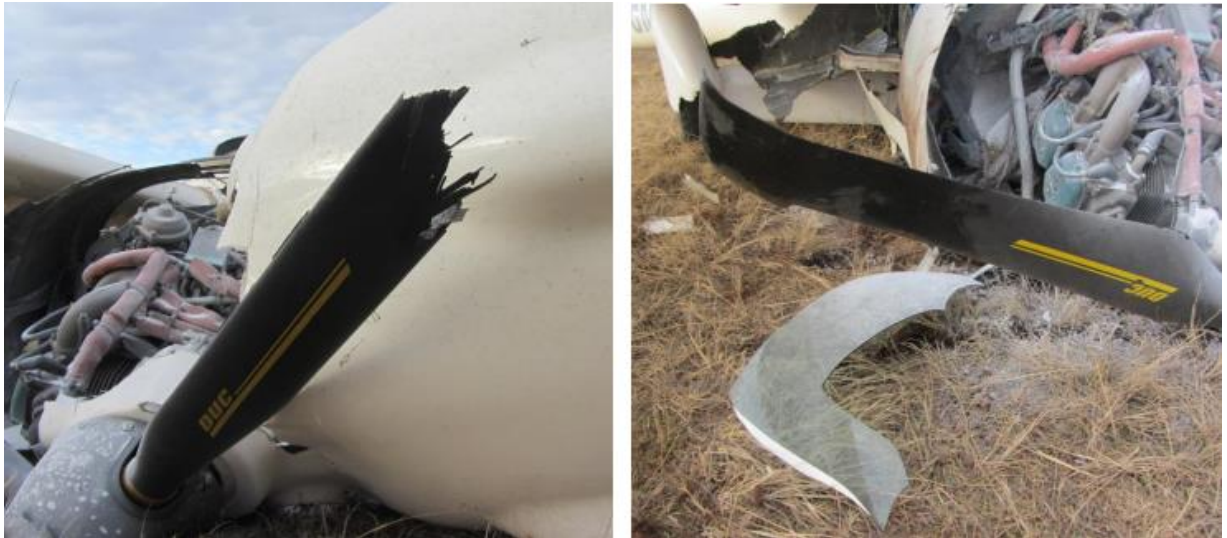
Figures 9 and 10: Damage sustained by the propeller blades.

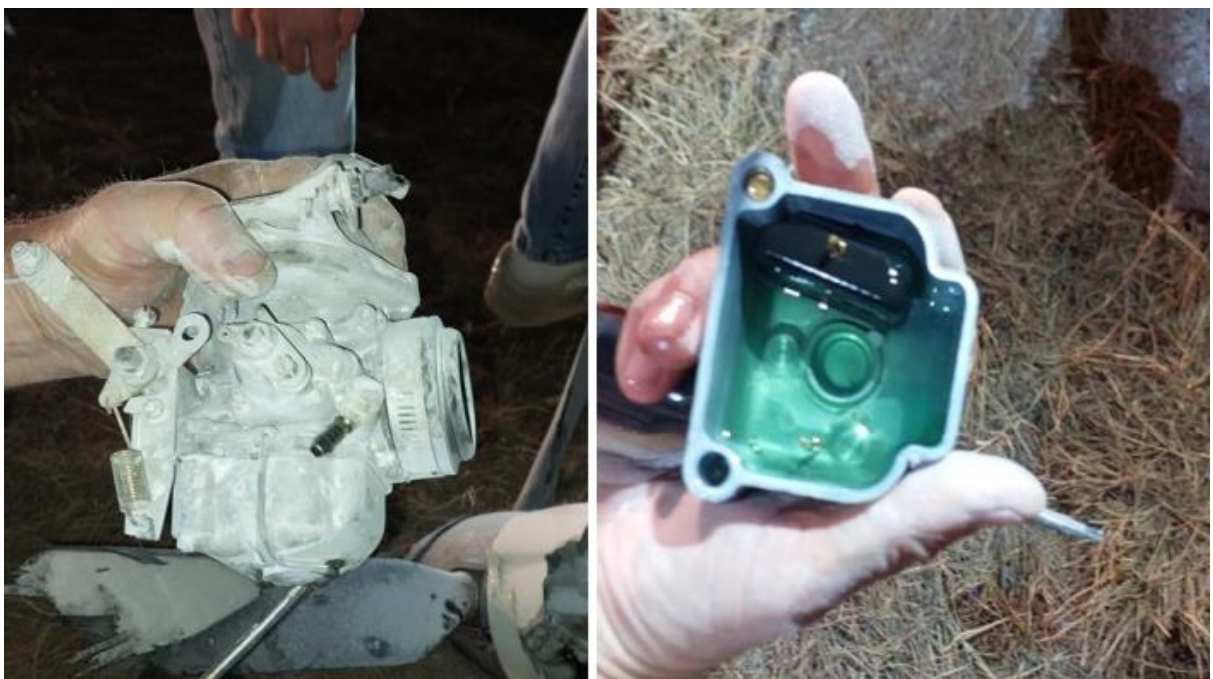
The engine was still intact in the cradle. The throttle control cables were still attached to the carburettor. External examination of the engine did not reveal any anomalies prior to impact. Two of the propeller blades exhibited signs of rotational damage, the first blade had dislodged from the hub and had broken mid-section, whilst the second blade broke off at mid-section at an almost similar distance as the first blade. The one piece was located forward of the main wreckage and the other piece was not found. The third blade was found still intact. The spinner was intact but was flattened during the accident. The carburettors were still attached to the engine; they were removed by the AP in the presence of the investigators. During the removal of the fuel pipe, fuel leaked from it. The bowls contained ample fuel, and the floats were still present inside the bowls (see Figures 11 and 12).

Figures 11 and 12: Carburettor (left) and bowl with fuel (right).

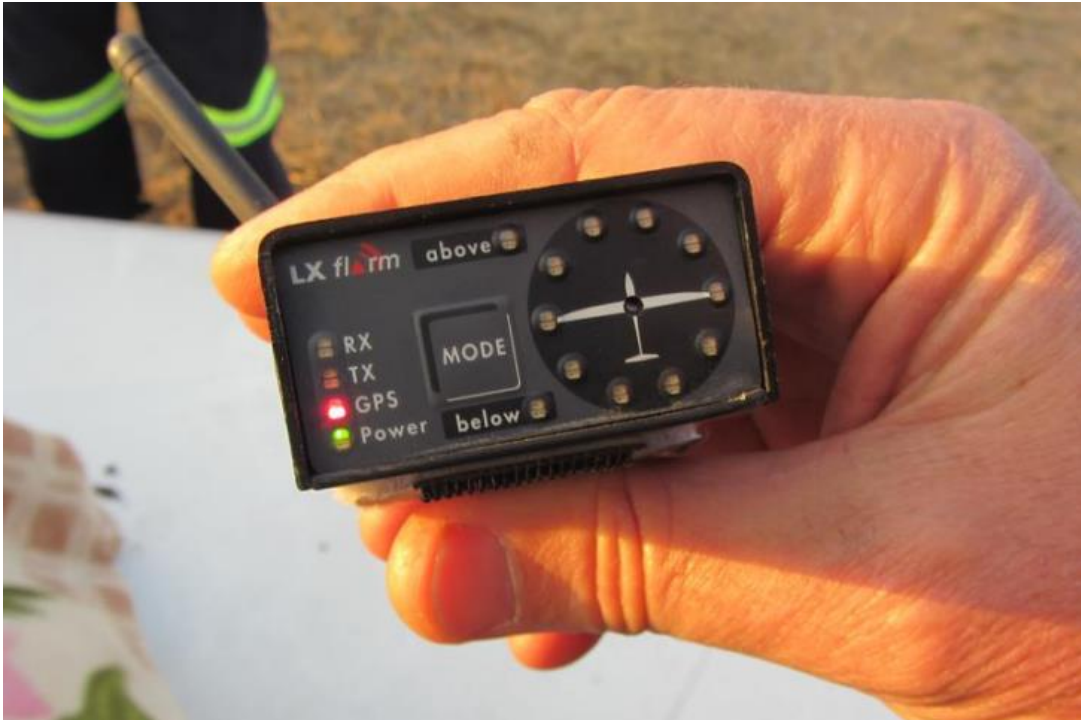
1.12.5 A detachable flight alarm (FLARM) instrument (attached using a Velcro) located behind the pilot's seat was on-board the TMG. The FLARM was not switched on before the flight. After it was removed from its position, it was switched on and the battery was serviceable (see Figure 13).

Figure 13: FLARM unit after being switched on.
