**LIMITED OCCURRENCE INVESTIGATION REPORT – FINAL**

<b>Reference Number</b>	CA18/2/3/10354						
<b>Classification</b>	Accident		<b>Date</b>	16 July 2023		<b>Time</b>	1206Z
<b>Type of Operation</b>	Private (Part 91)						
<b>Location</b>							
<b>Place of Departure</b>	Plot 31, Wheatlands, Randfontein, Gauteng Province		<b>Place of Intended Landing</b>	Plot 31, Wheatlands, Randfontein, Gauteng Province			
<b>Place of Occurrence</b>	Plot 31 in Wheatlands, Randfontein, Gauteng Province						
<b>GPS Co-ordinates</b>	<b>Latitude</b>	26° 10' 41.06" S	<b>Longitude</b>	27° 37' 20.71" E	<b>Elevation</b>	5 735 feet	
<b>Aircraft Information</b>							
<b>Registration</b>	ZS-RTN						
<b>Make; Model; S/N</b>	Robinson; R44 Raven I (Serial Number: 0873)						
<b>Damage to Aircraft</b>	Substantial		<b>Total Aircraft Hours</b>	8 066.2			
<b>Pilot-in-command</b>							
<b>Licence Type</b>	Private Pilot Licence (PPL)		<b>Gender</b>	Male		<b>Age</b>	43
<b>Licence Valid</b>	No		<b>Total Hours</b>	491.7		<b>Total Hours on Type</b>	491.7

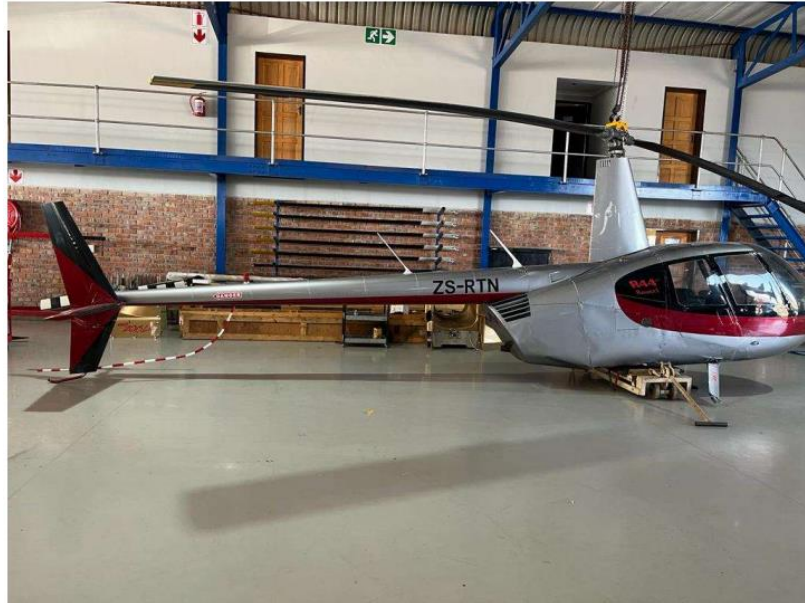
<b>Total Hours 30 Days</b>	0.1		<b>Total Flying on Type Past 90 Days</b>	5.9			
<b>People On-board</b>	1+3		<b>Injuries</b>	0		<b>Fatalities</b>	0
					<b>Other (on ground)</b>	0	
<b>What Happened</b>							
<p>On Monday afternoon at approximately 1200Z, a pilot and three passengers on-board a Robinson helicopter R44 Raven I with registration ZS-RTN were involved in an accident after take-off from Plot 31 in Wheatlands, Randfontein, Gauteng province. The flight was conducted under visual meteorological conditions (VMC) by day and under the provisions of Part 91 of the Civil Aviation Regulations (CAR) 2011 as amended.</p> <p>According to the pilot, he conducted a pre-flight inspection with no anomalies noted. Thereafter, he boarded the helicopter with the three passengers with the intention to conduct a private flight in the vicinity. After engine start, the pilot initially conducted a hover to complete the power check procedure. Thereafter, he initiated a forward transition to continue with the flight. However, the helicopter experienced low rotor revolutions per minute (RPM), followed by the warning horn. Soon after, the helicopter sank and impacted the ground hard with the left skid gear, which broke off. The helicopter came to a stop a few metres from the first contact point. The pilot turned off the master switch and requested the passengers to disembark from the helicopter. The helicopter sustained damage to the left skid gear and the vertical tail fin, which was substantial. No injuries were reported during the accident.</p>

**Figure 1:** The helicopter after delivery to the AMO facility. (Source: AMO)

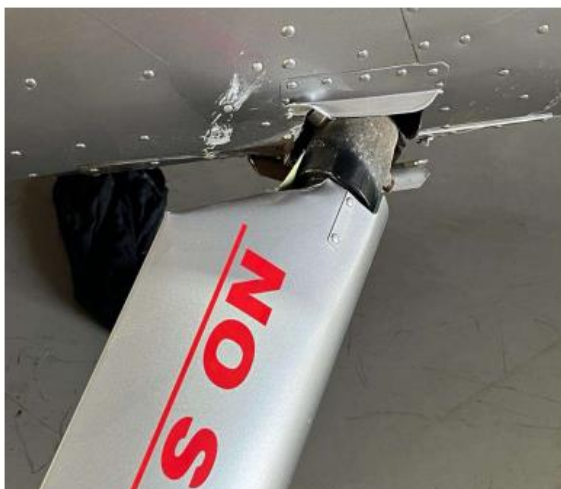
**Figure 2:** Damaged skid attachment.

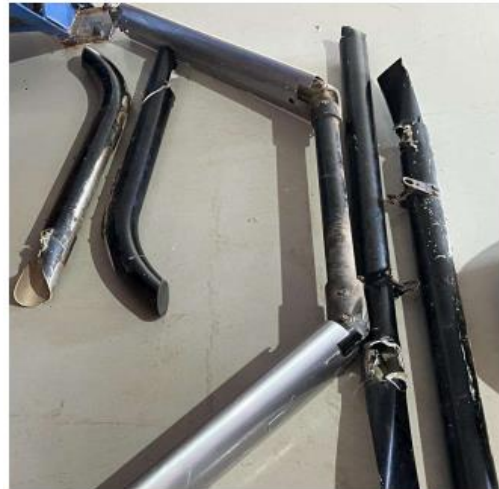
**Figure 3:** Broken left skid gear.

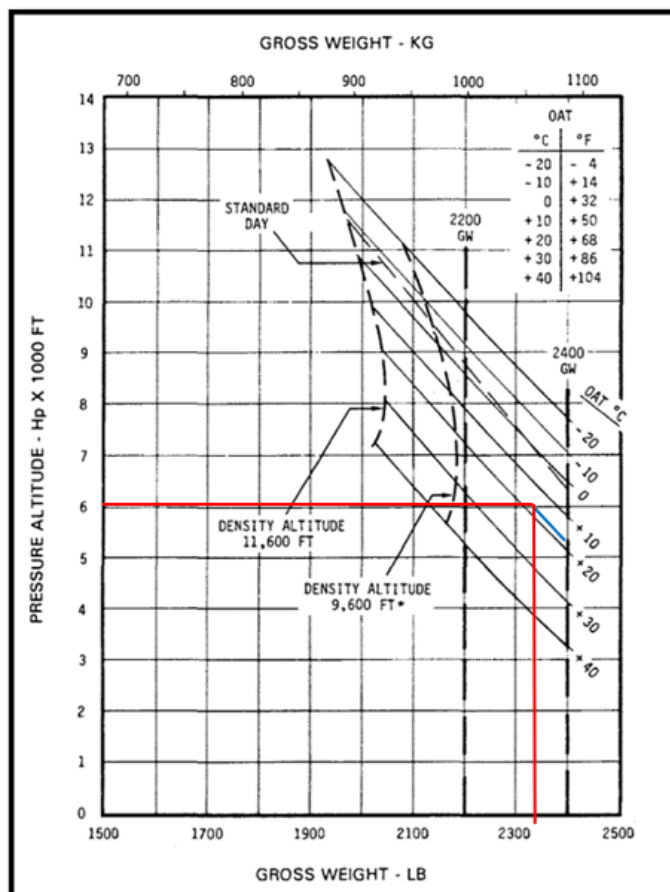
Chart 2: In ground effect (IGE) hover vs. gross weight.

According to the in-ground effect vs. gross weight in Chart 2, using the weight of the helicopter of 2339 pounds (lbs) as calculated by the pilot (Figure 4) and the temperature of 18°C at the time of the accident, the helicopter could hover at a pressure altitude of approximately 6000 feet.

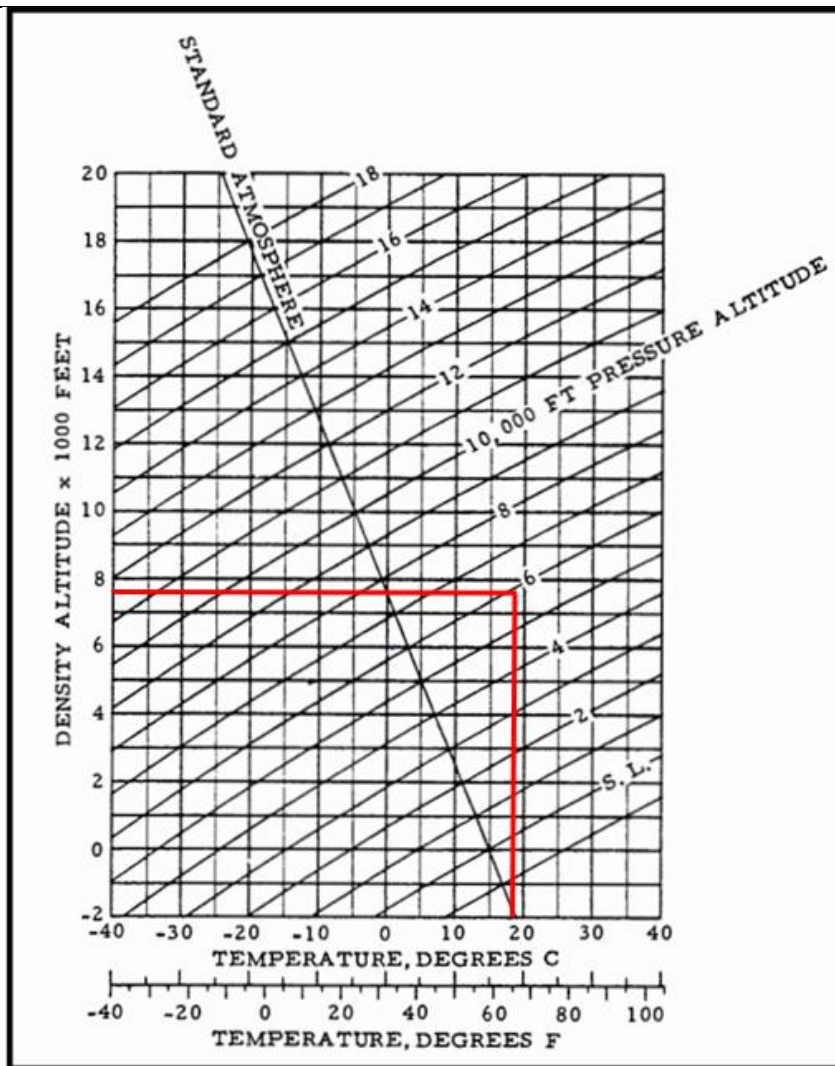
Chart 3: Density altitude chart.

Pressure was determined to be approximately 6 000 lbs. Using the density altitude chart in Chart 3, with the pressure altitude of 6 000 lbs and the temperature of 18°C, density altitude was determined to be approximately 7 600 ft.
