**LIMITED OCCURRENCE INVESTIGATION REPORT – FINAL**

<b>Reference Number</b>	CA18/2/3/10355						
<b>Classification</b>	Accident	<b>Date</b>	27 July 2023			<b>Time</b>	0700Z
<b>Type of Operation</b>	Training (Part 141)						
<b>Location</b>							
Place of Departure	Hoedspruit Civil Aerodrome (FAHT), Limpopo Province			Place of Intended Landing	Hoedspruit Civil Aerodrome (FAHT), Limpopo Province		
Place of Occurrence	15 metres west of Runway (RWY) 35 at Hoedspruit Civil Aerodrome (FAHT)						
GPS Co-ordinates	Latitude	24° 20' 56.37" S	Longitude	030° 56' 48.12" E	Elevation	1 761 ft	
<b>Aircraft Information</b>							
Registration	ZU-IOZ						
Make; Model; S/N	Savannah Aircraft Africa; Savannah S (Serial Number: 18-11-54-0643)						
Damage to Aircraft	Substantial			Total Aircraft Hours	797		
<b>Pilot-in-command</b>							
Licence Type	Student Pilot Licence (SPL)		Gender	Male		Age	22
Licence Valid	Yes	Total Hours	14.5		Total Hours on Type	14.5	
Total Hours 30 Days	14.5		Total Flying on Type Past 90 Days	14.5

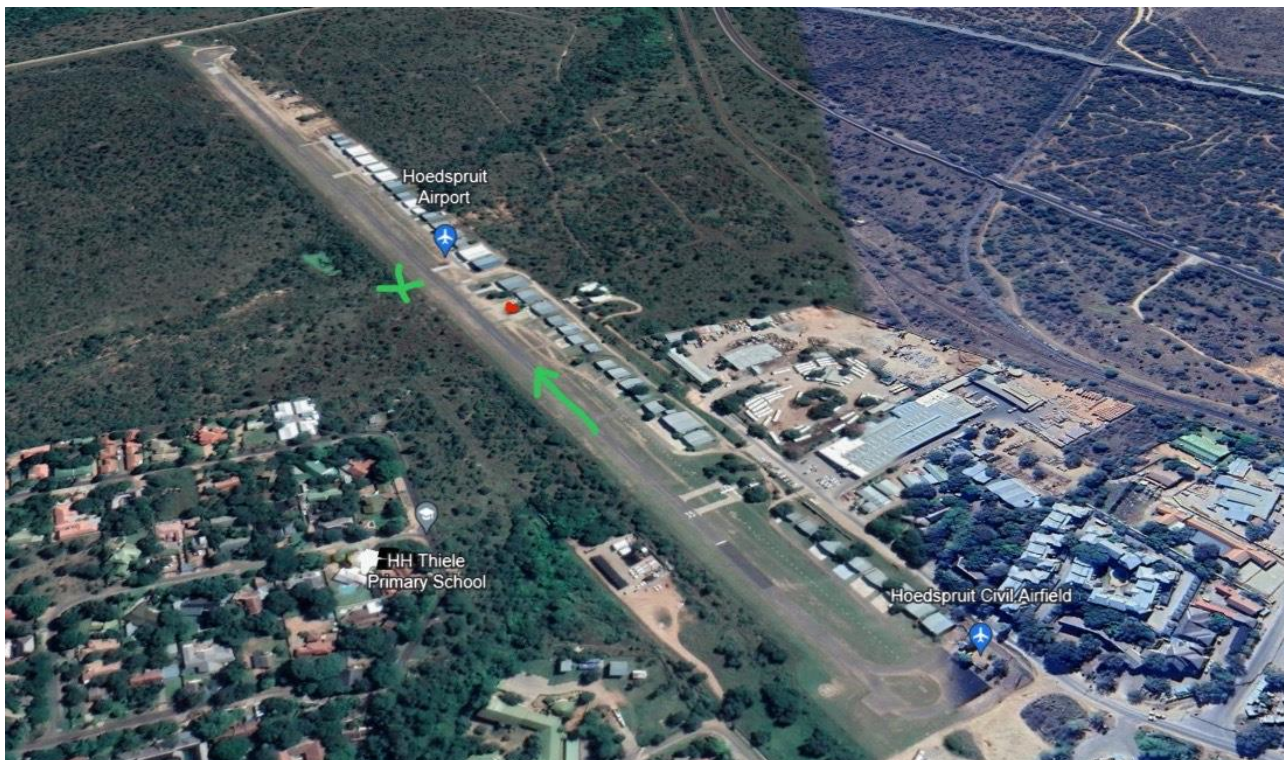
**Figure 1:** An overview of FAHT (the green arrow indicates direction of landing; the green cross shows aircraft position and the red dot indicates instructor position). (Source: Google Earth)

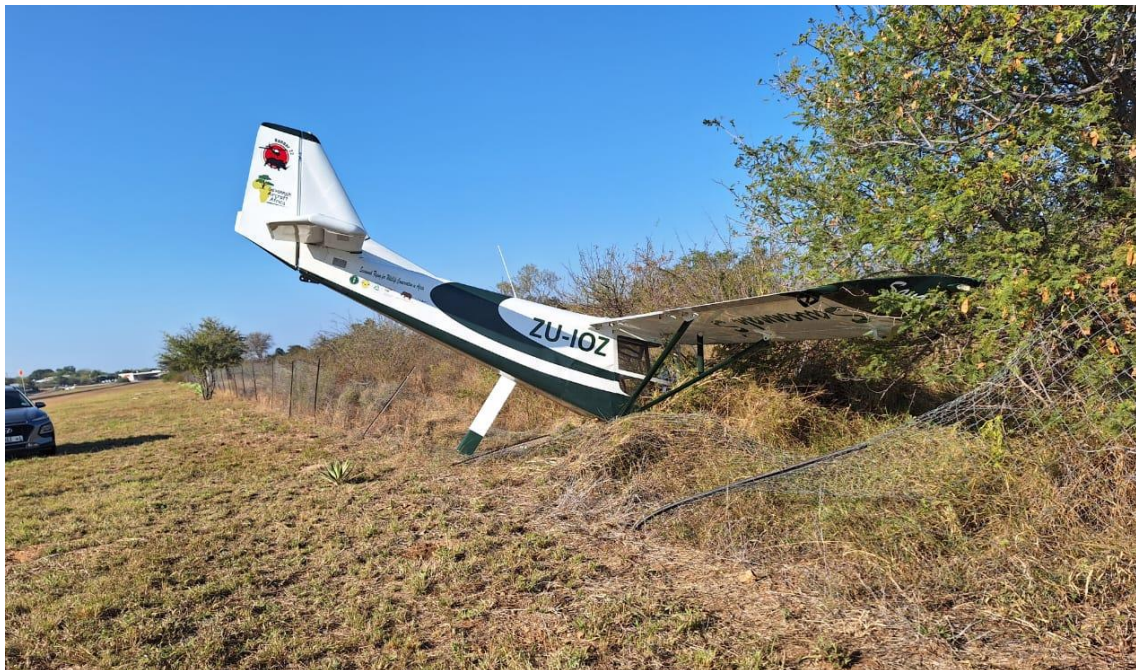
The student pilot was not injured, and the aircraft sustained substantial damage to the propeller, nose gear, underside engine cowling and wings during the landing sequence.

**Figure 3:** The aircraft as it came to rest. (Source: Pilot)
