LIMITED OCCURRENCE INVESTIGATION REPORT – FINAL

Reference Number	CA18/2/3/10356						
Classification	Accident	Date	02 August 2023		Time	1115Z	
Type of Operation	Private (Part 94)						
Location							
Place of Departure	Ceres Airfield (FACE), Western Cape Province		Place of Intended Landing		Robertson Airfield (FARS), Western Cape Province.		
Place of Occurrence	On Runway 28 at Robertson Airfield, Western Cape Province						
GPS Co-ordinates	Latitude	33°48.65' S	Longitude	019°54.60' E	Elevation	640 ft	
Aircraft Information							
Registration	ZU-ELZ						
Make; Model; S/N	Flight Design GMBH, CTSW (Serial number: 07-01-12)						
Damage to Aircraft	Substantial			Total Aircraft Hours	858		
Pilot-in-command							
Licence Type	National Pilot Licence (NPL)		Gender	Male		Age	62
Licence Valid	Yes	Total Hours	1 380		Total Hours on Type	1 380	
Total Hours 30 Days	1.2		Total Flying on Type Past 90 Days		39		
People On-board	1+0	Injuries	0	Fatalities	0	Other (on ground)	0

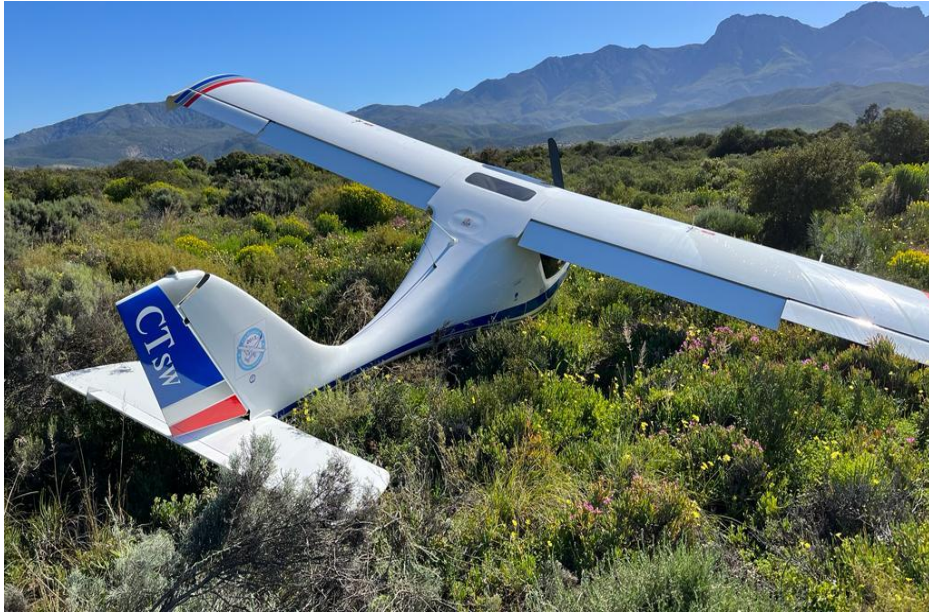
Figure 1: The ZU-ELZ aircraft at the accident site. (Source: Operator)

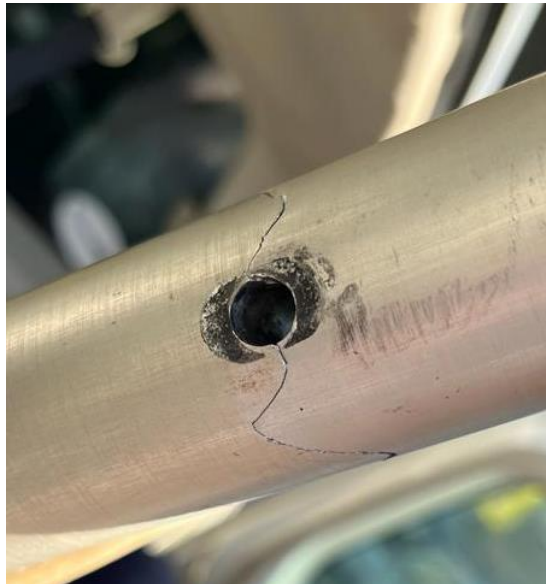
Figure 2: The two halves of the main landing gear connect at the lower attachment.

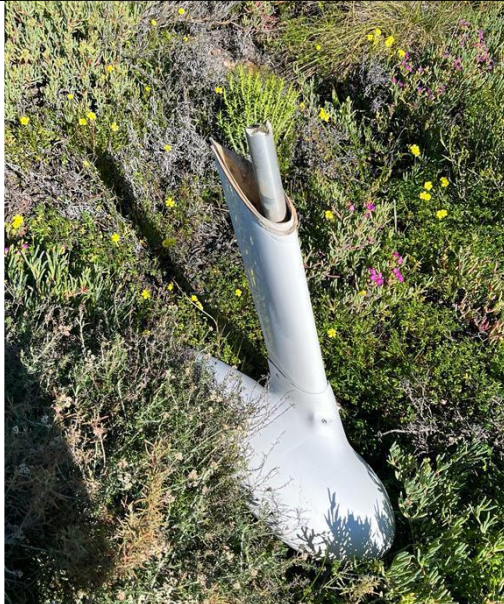
Figure 3: The right main landing strut that broke off during the landing roll. **Figure 4:** The yellow circles indicate a fatigue surface area which was not detected during maintenance. (Source: Operator)

The right main landing gear failed during the landing roll due to a fatigue crack that may have been caused by galvanic corrosion at the main landing gear lower attachment point, which caused the aircraft to veer off to the right of the runway.

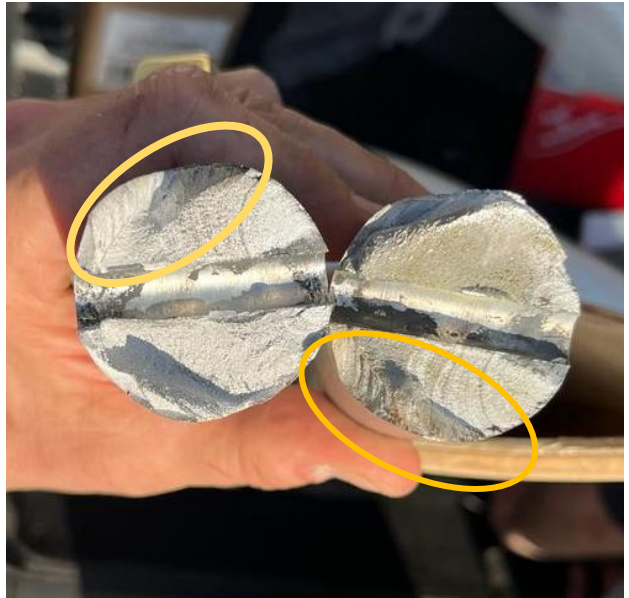
7. Figure 7 indicated that the AP followed the manufacturer's maintenance requirements as outlined on Figure 6, but not the Service Bulletin that was issued on 15 October 2008 which dictated that the bracelet be removed to allow proper inspection on the area where the fatigue crack originated. This was not in line with South African Civil Aviation Technical Standards (SA-CATS) Part 44.01.2 (1 e and f) requirements. There were no records found that the dye penetrant inspection was conducted during the annual inspection.

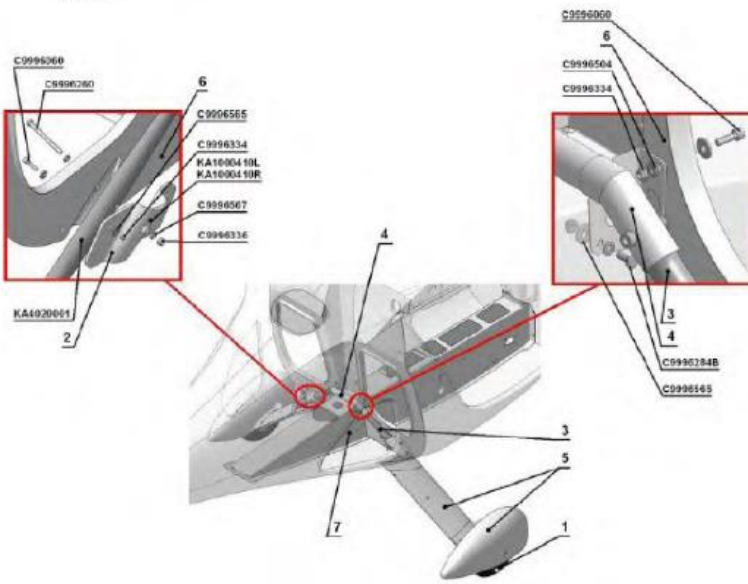
Figure 5: Schematic layout of the main landing gear. (Source: Operator)

3) Check the bulkhead (Fig. 3, item 6) and tunnel (Fig. 3, item 7) made of composites for damages, dents, cracks, delamination at the areas of landing gear attachments.

4) Inspect the main struts KA4020001 (Fig. 3, item 3) for bending, damages, dents, cracks on the surface and especially at the mounting holes areas, integrity and circularity of the mounting holes.

5) Inspect annually for all stated above with removal of all the parts obscuring (strut fairing (Fig. 3, item 5) and so on) the ones being inspected. Inspect the main wheel attachment KA4020100R(L) for bending, damages, dents, cracks on the surface and especially at the mounting holes areas, integrity and circularity of the mounting holes. In case of hard landing inspect immediately after landing.
