LIMITED OCCURRENCE INVESTIGATION REPORT – FINAL

Reference Number	CA18/2/3/10357						
Classification	Accident		Date	4 August 2023		Time	1015Z
Type of Operation	Private (Part 94)						
Location							
Place of Departure	Cape Winelands Aerodrome (FAWN), Western Cape Province		Place of Intended Landing		Cape Winelands Aerodrome (FAWN), Western Cape Province		
Place of Occurrence	Runway 05 at Cape Winelands Aerodrome (FAWN), Western Cape Province						
GPS Co-ordinates	Latitude	33°46'28" S	Longitude	018°44'40" E	Elevation	399 ft	
Aircraft Information							
Registration	ZU-AWH						
Make; Model; S/N	Flight Design GMBH, Bushbaby (Serial Number: 0012)						
Damage to Aircraft	Substantial			Total Aircraft Hours	273.9		
Pilot-in-command							
Licence Type	National Pilot Licence (NPL)		Gender	Male		Age	39
Licence Valid	Yes	Total Hours	156.7		Total Hours on Type	2.5	
Total Hours 30 Days	6.1		Total Flying on Type Past 90 Days			6.1	
People On-board	1+0	Injuries	0	Fatalities	0	Other (on ground)	0

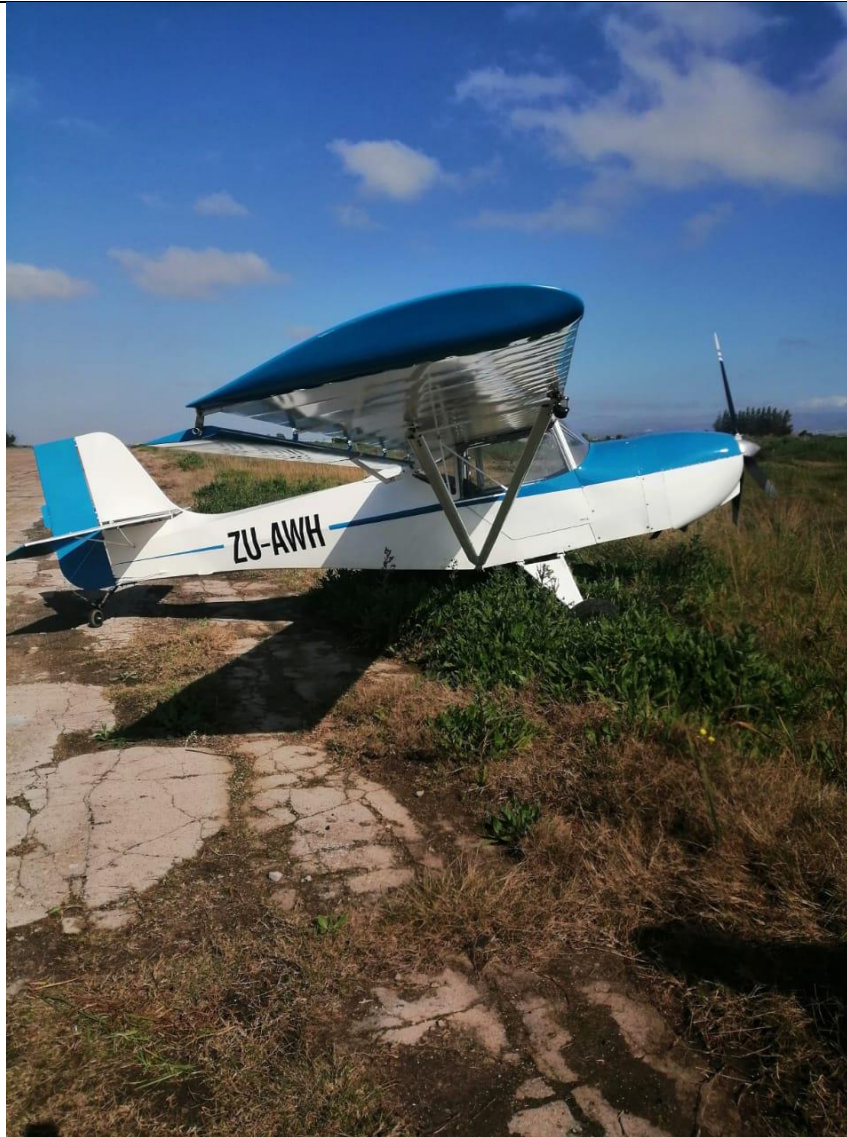
What Happened							
<p>On Friday, 4 August 2023, a pilot on-board a Bushbaby light aircraft with registration ZU-AWH took off from the Cape Winelands Aerodrome (FAWN), Western Cape province, to the local general flying area with the intention to land back at the same take-off aerodrome. The flight was conducted under visual meteorological conditions (VMC) by day and under the provisions of Part 94 of the Civil Aviation Regulations (CAR) 2011 as amended.</p> <p>The pilot reported that he conducted a pre-flight check on the aircraft and no anomalies were noted. The aircraft took off from Runway (RWY) 05 at FAWN, and the flight was uneventful. On the return flight from the general flying area whilst the aircraft was on final approach, the pilot lined up for landing on RWY 05. According to the pilot, the aircraft touched down and, during the ground roll, it veered off to the left of the runway due to a gust of wind from right. As a result, the aircraft ground looped before it stopped. The length of RWY 05 is 900m x 20m. The pilot managed to disembark from the aircraft without injuries. The aircraft sustained damage to the cowling, propeller (which bent) and the landing gear (which was misaligned).</p>

Figure 1: The aircraft as it came to rest. (Source: Pilot)

9. It is likely that the pilot lost directional control of the aircraft which veered off to the left of the runway and ground looped before it stopped.
Probable Cause(s)
It is likely that the pilot lost directional control of the aircraft and it veered off to the left of the runway and ground looped before it stopped.
Contributing Factor(s)
Landing with a tail wind.
Safety Action(s)
None.
Safety Message
To avoid injury or damage to property, pilots are advised to be vigilant at critical phases of flight such as take-offs and landings.
About this Report
<p><i>The decision to conduct a limited investigation is based on factors including whether the cause is known and the evidence supporting the cause is clear, the level of safety benefit likely to be obtained from an investigation and that will determine the scope of an investigation. For this occurrence, a limited investigation has been conducted, and the Accident and Incident Investigations Division (AIID) has relied on the information submitted by the affected person/s and organisation/s to compile this limited report. The report has been compiled using information supplied in the initial notification, as well as from follow-up desk top enquiries to bring awareness of potential safety issues to the industry in respect of this occurrence, as well as possible safety action/s that the industry might want to consider in preventing a recurrence of a similar occurrence.</i></p> <p><i>All times given in this report are Co-ordinated Universal Time (UTC) and will be denoted by (Z). South African Standard Time is UTC plus 2 hours.</i></p>
