LIMITED OCCURRENCE INVESTIGATION REPORT – FINAL

Reference Number	CA18/2/3/10358						
Classification	Accident	Date	13 August 2023	Time	1325Z		
Type of Operation	Private Flight (Part 91)						
Location							
Place of Departure	Prince Albert Airport (FAPC), Western Cape Province		Place of Intended Landing	Prince Albert Airport (FAPC), Western Cape Province			
Place of Occurrence	Prince Albert Airport (FAPC) Runway 19						
GPS Co-ordinates	Latitude	33°11'20" S	Longitude	022°01'06.74" E	Elevation	1801 feet (ft)	
Aircraft Information							
Registration	ZS-TKP						
Make; Model; S/N	Cessna 177 RG (Serial Number: 177RG-0797)						
Damage to Aircraft	Substantial		Total Aircraft Hours	4379.3			
Pilot-in-command							
Licence Type	Airline Transport Pilot Licence		Gender	Male		Age	45
Licence Valid	Yes	Total Hours	6722		Total Hours on Type	17.1	
Total Hours past 30 Days	0.8		Total Flying Hours on Type Past 90 Days	3.9			
People On-board	1 + 1	Injuries	0	Fatalities	0	Other (on ground)	0

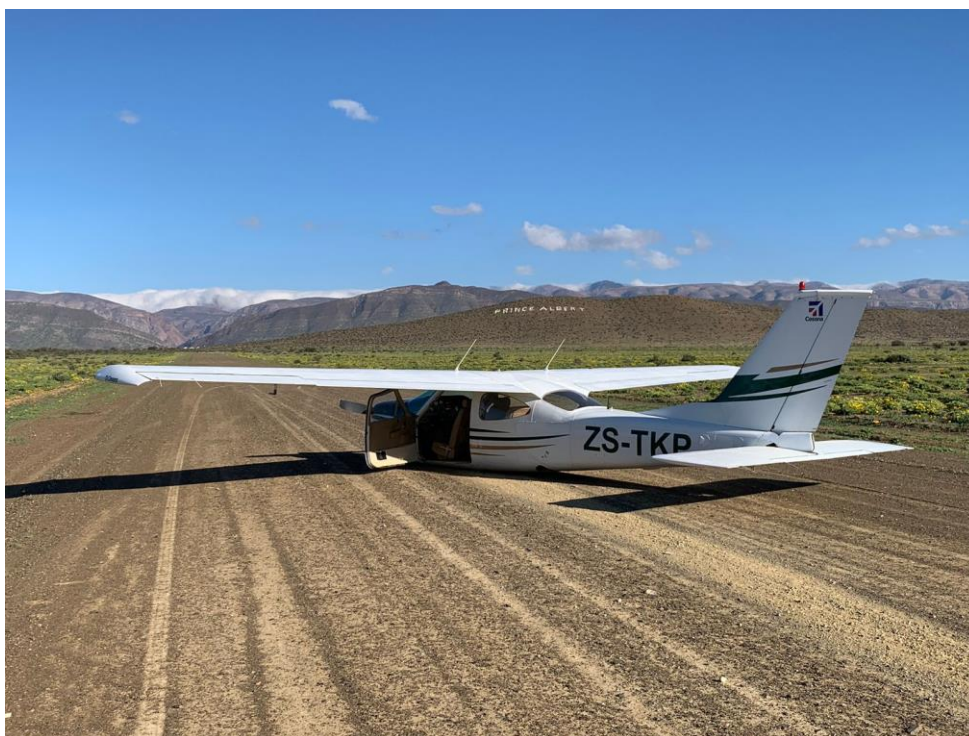
What Happened							
<p>On 13 August 2023, a pilot on-board a Cessna 177 RG aircraft with registration ZS-TPK took off on a private flight from Prince Albert Airport (FAPC) in the Western Cape province with the intention to land at the same airport. Visual meteorological conditions (VMC) by day prevailed at the time of the flight which was conducted under the provisions of Part 91 of the Civil Aviation Regulations (CAR) 2011 as amended.</p> <p>According to the pilot, he was on a sightseeing flight. On his return, he joined the circuit without any anomalies. He stated that on final approach the flaps were set on 30° when he landed the aircraft. As the aircraft touched down, he realised that the landing gears were not extended. The aircraft maintained the centreline but the nose turned towards the left before it came to a stop. The pilot mentioned that he made an omission in reading and carrying out the landing items on the checklist (Pilot's Operating Handbook). The pilot stated that he did not hear the warning horn in the cockpit. The passenger who has no flying experience did not remember hearing anything resembling a sounding of a horn. The aircraft sustained substantial damage to the underbelly and the propeller blades, and no injuries were reported.</p>

Figure 2: The final resting position of the aircraft. (Source: Pilot)

The pilot forgot to lower the landing gears due to not reading or completing the landing checklist items prescribed in the Pilot's Operating Handbook.
