**LIMITED OCCURRENCE INVESTIGATION REPORT – FINAL**

<b>Reference Number</b>	CA18/2/3/10359						
<b>Classification</b>	Accident	<b>Date</b>	12 August 2023	<b>Time</b>	1440Z		
<b>Type of Operation</b>	Private (Part 94)						
<b>Location</b>							
Place of Departure	Vereeniging Airfield (FAVV), Gauteng Province		Place of Intended Landing	Vereeniging Airfield (FAVV), Gauteng Province			
Place of Occurrence	On the grass next to Runway 21, Vereeniging Airfield (FAVV)						
GPS Co-ordinates	Latitude	26°33.78'S	Longitude	27°57.68'E	Elevation	4 847ft	
<b>Aircraft Information</b>							
Registration	ZU-AKE						
Make; Model; S/N	Piper Aircraft Corporation; PA 22-150 Tri-pacer (Serial Number: 22-6033)						
Damage to Aircraft	Substantial		Total Aircraft Hours	375.33			
<b>Pilot-in-command</b>							
Licence Type	Airline Transport Pilot Licence (ATPL)		Gender	Male		Age	41
Licence Valid	Yes	Total Hours	7134		Total Hours on Type	29.8	
Total Hours 30 Days	7		Total Flying on Type Past 90 Days	28

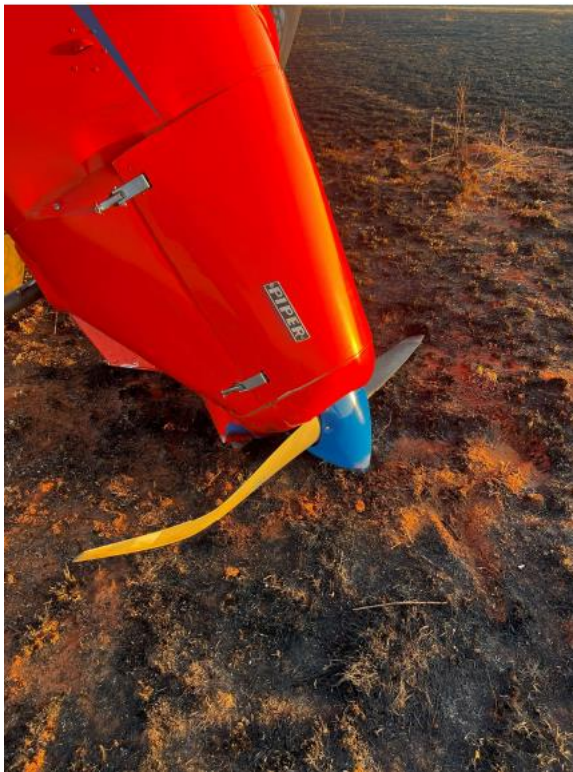
Post-accident, a visual inspection was conducted and the following damage was recorded: bent propeller, dented spinner, bent engine mounts, dented cowlings, damaged boot cowl, dented firewall, dented exhaust, buckled lift struts, as well as dented left wing, leading edge and left wing tip.

**Figure 1:** The bent propeller blades.

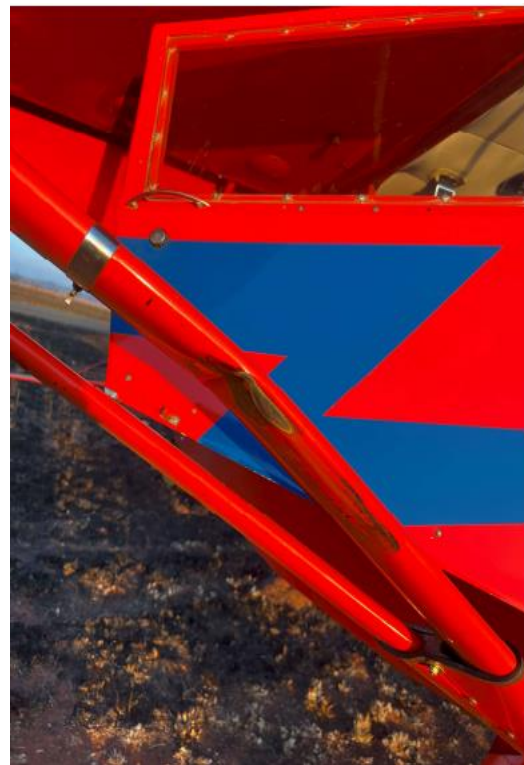
**Figure 2:** Buckled struts.

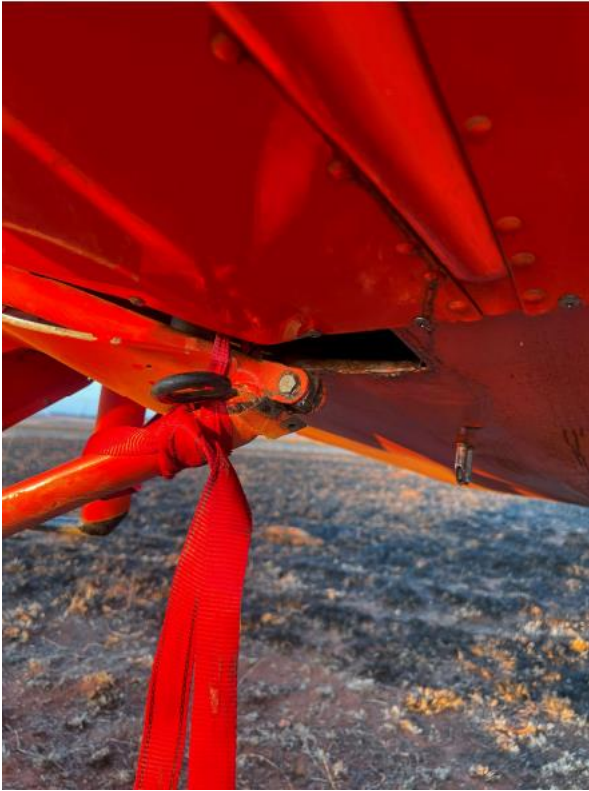
**Figure 3:** Right-side landing gear with the broken Hydrasorb shock absorbers. In the picture, a rope is tied to prevent the collapse of the landing gear.

The cause of the failure was evident during the visual inspection of the right-side landing gear. The right-side Hydrasorb shock absorbers failed on the mounting boss. A fatigue failure of the mounting boss had an existing crack with extensive evidence of rust, pitting corrosion and dirt (see Figures 5 and 6). It appeared that the Hydrasorb shock absorber had a crack for an extended period prior to the current landing in this accident. Only a small portion of the original diameter of the boss was still intact.

The failure of the bottom mounting boss caused the right-side landing gear to disconnect from the suspension, which caused it to fully collapse when weight was placed on the gear. The left-side main landing gear Hydrasorb shock unit was intact with its external shock cord rings wrapped around its tee flanges. *“The Hydrasorb shock absorbers, in combination with shock chords, absorb and dissipate landing loads within the shock strut assemblies”*. (Source: PA-22 Owner’s Manual)

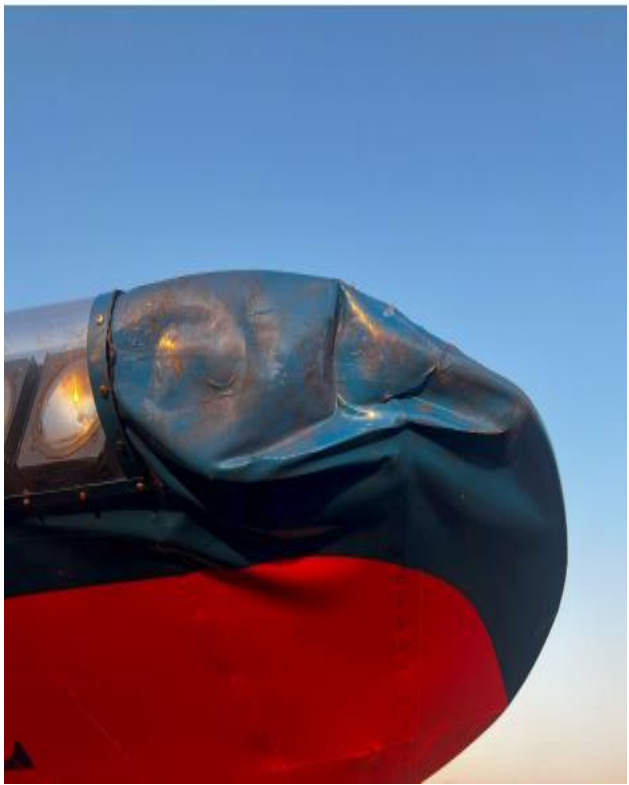
**Figure 4:** Dented left wing tip.

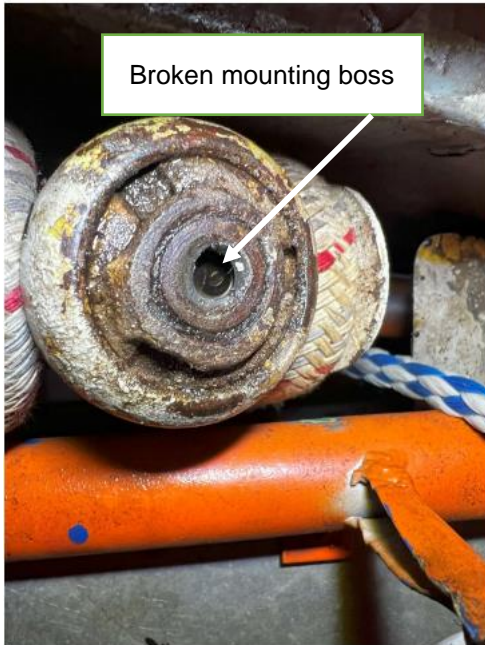
**Figure 5:** Mounting boss where it broke off.

5. The Hydrasorb shock absorbers had a crack for an extended period prior to the current landing accident. Only a small portion of the original diameter of the boss was still intact.

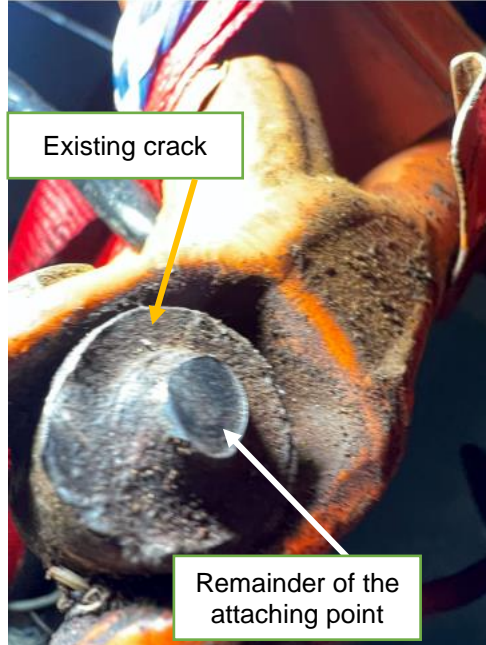
**Figure 6:** Sheared off mounting boss where it attaches to the gear leg.

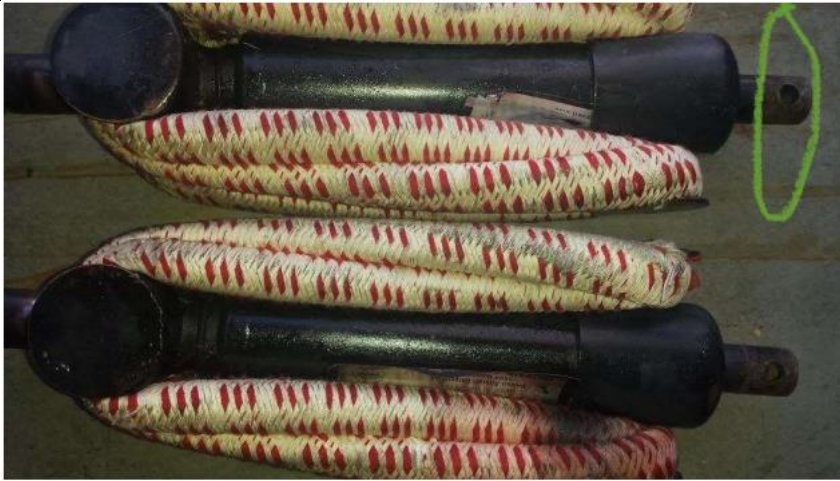
**Figure 8:** Example of an assembled Hydrasorb shock absorber with bungies; a circle indicates a failed mounting boss.
