LIMITED OCCURRENCE INVESTIGATION REPORT – FINAL
--

Reference Number	CA18/2/3/10360						
Classification	Accident	Date	15 August 2023		Time	1123Z	
Type of Operation	Training (Part 141)						
Location							
Place of Departure	Rand Airport (FAGM), Gauteng Province		Place of Intended Landing		Rand Airport (FAGM), Gauteng Province		
Place of Occurrence	Kromvlei (FAD 183), located 7.8nm southwest of FAGM						
GPS Co-ordinates	Latitude	26°21'32.90"S	Longitude	28° 4'58.49"E	Elevation	5018.4 ft	
Aircraft Information							
Registration	ZS-RVG						
Make; Model; S/N	Robinson; R44 Raven II (Serial Number: 10640)						
Damage to Aircraft	Substantial			Total Aircraft Hours	7 080.2		
Pilot-in-command							
Licence Type	Airline Transport Pilot Licence (ATPL) Helicopter		Gender	Male		Age	73
Licence Valid	Yes	Total Hours	23 327.4		Total Hours on Type	2 501.5	
Total Hours 30 Days	14		Total Flying on Type Past 90 Days	29.0			
People On-board	2+0	Injuries	1	Fatalities	0	Other (on ground)	0

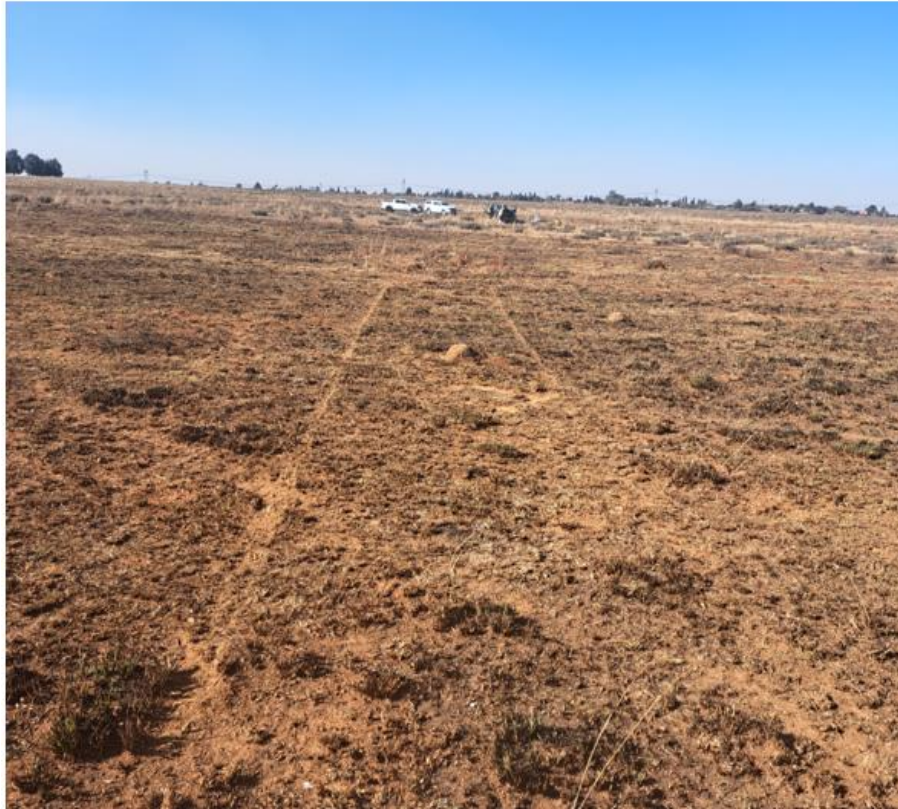
Figure 1: Run-on landing at 074° heading.

9.	The maximum crosswind for the helicopter type is 17 knots. On the day of the accident, the crosswind was 12.6 knots.	
Probable Cause		
Loss of control of the helicopter during an attempt to recover from a stuck cyclic exercise whilst at 9 feet AGL. The helicopter settled on the ground and then skidded for 150m before the left skid collided with an anthill and it entered a dynamic rollover.		
Contributing Factor(s)		
None.		
Safety Action(s)		
None.

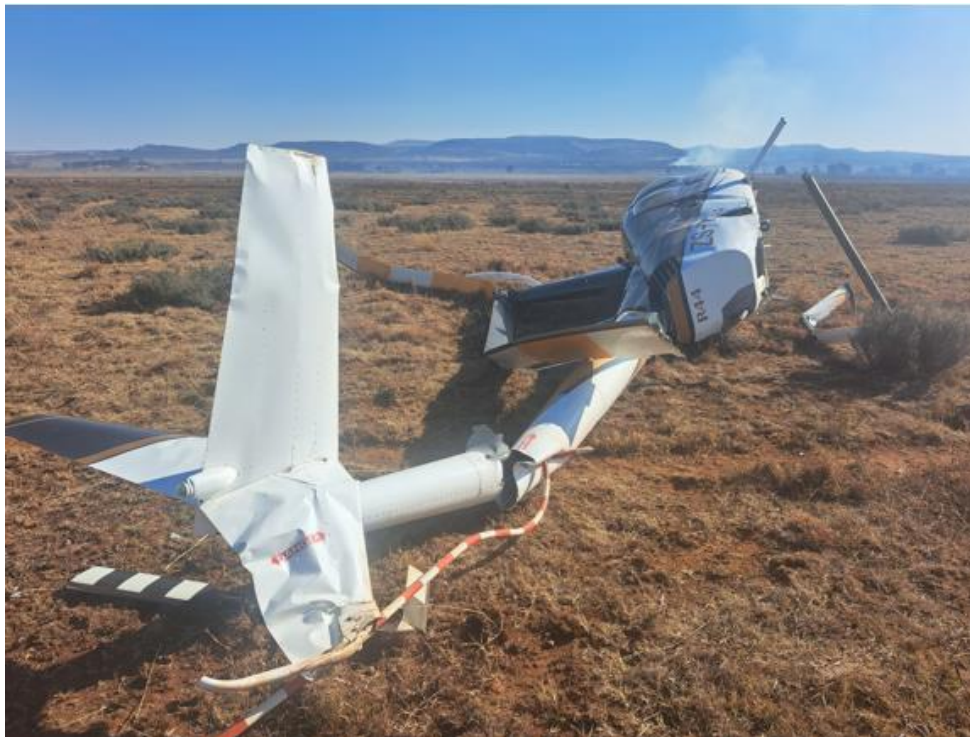
Figure 2: The helicopter came to rest on its left side.

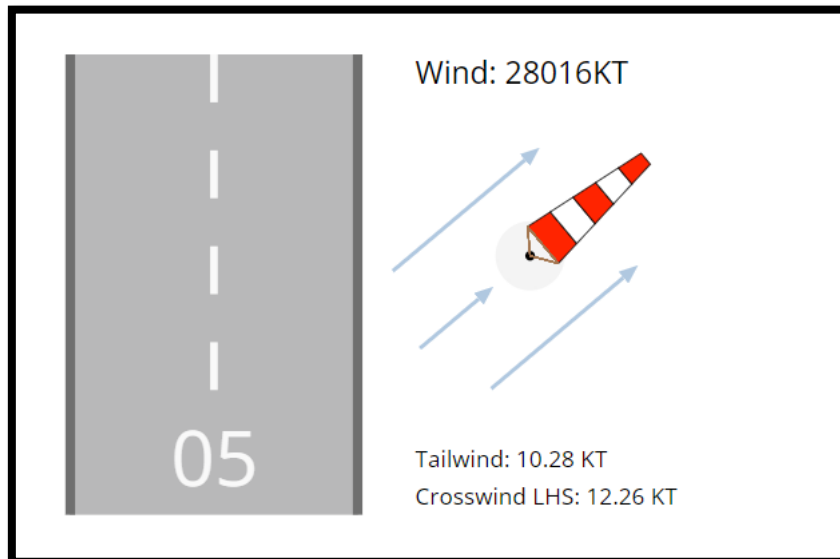
Figure 4: Crosswind and tailwind determination. (Source: <https://aerotoobox.com/crosswind>)
