AIRCRAFT ACCIDENT REPORT AND EXECUTIVE SUMMARY

Reference:		CA18/2/3/10361	
Aircraft Registration	ZU-EIB	Date of Accident	29 August 2023		Time of Accident	1055Z	
Type of Aircraft	Tri Cubby			Type of Operation	Private (Part 94)		
Pilot-in-command Licence Type	Private Pilot Licence		Age	66	Licence Valid	Yes	
Pilot-in-command Flying Experience	Total Flying Hours		415.0		Hours on Type	Unknown	
Last Point of Departure	Swellendam Aerodrome (FASX), Western Cape Province						
Next Point of Intended Landing	Worcester Aerodrome (FAWC), Western Cape Province						
Damage to Aircraft	Destroyed						
Location of the accident site with reference to easily defined geographical points (GPS readings if possible)							
Ridgemont Farm near Robertson (GPS position: 33°50'21.64" South 019°46'21.99" East)							
Meteorological Information	Surface wind: 020°/13kt; temperature: 31°C; dew point: 10°C; visibility: CAVOK						
Number of People On-board	1+0	Number of People Injured	0	Number of People Killed	1	Other (On Ground)	0

Reference Number : CA18/2/3/10361
Occurrence Category : Accident (Category 1)
Type of Operation : Private (Part 94)
Name of Operator : Private Flight
Aircraft Registration : ZU-EIB

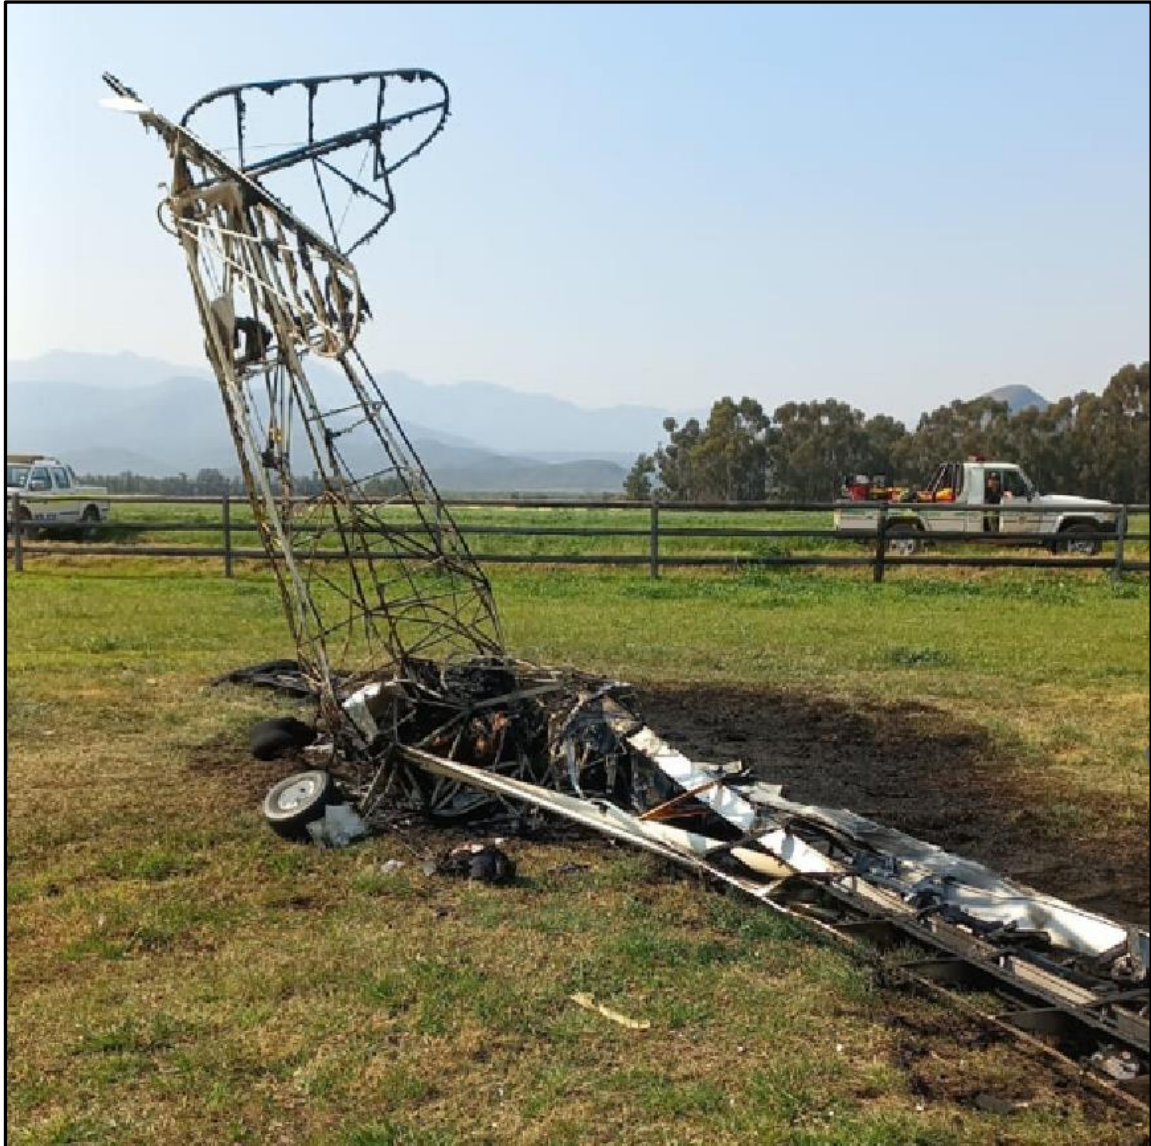
1.3.1 The aircraft was destroyed by the fuel-fed post-impact fire that erupted during the accident.

Figure 2: The aircraft after the accident.

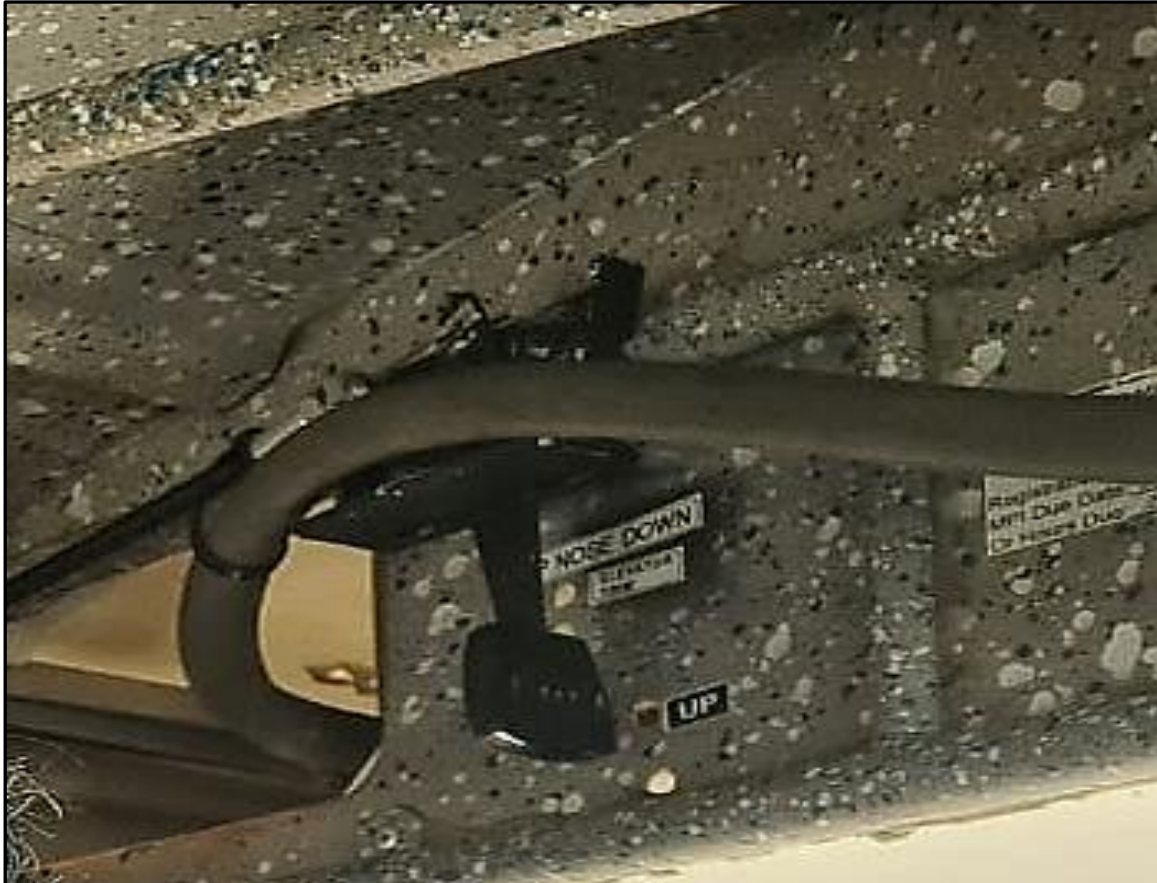
Figure 4: Trim tap at nose-up position settings. (Source: Technical Expert)

On 27 August 2023, the pilot was not aware that the aircraft was 305kg and that the total weight was 504.5kg, which was 54.5kg over the weight indicated for the aircraft. Some Cubby information indicates the aircraft's weight was increased to 500kg with a decrease in the G-loading. The CG was also ahead of the 18% to 33% CG range. *The Figure 4 photo was taken during the flight on 27 August 2023, and it indicates that the elevator trim setting was approximately neutral.*

It is possible that the elevator and elevator trim tab were rigged in a way that a nose-up force was created with the elevator trim in a neutral position. The flight on 27 August 2023 was an easy flight with no unusual attitudes other than climb, straight and level flight, turns and descend. The control inputs were observed as usual for such a type of aircraft during flight.

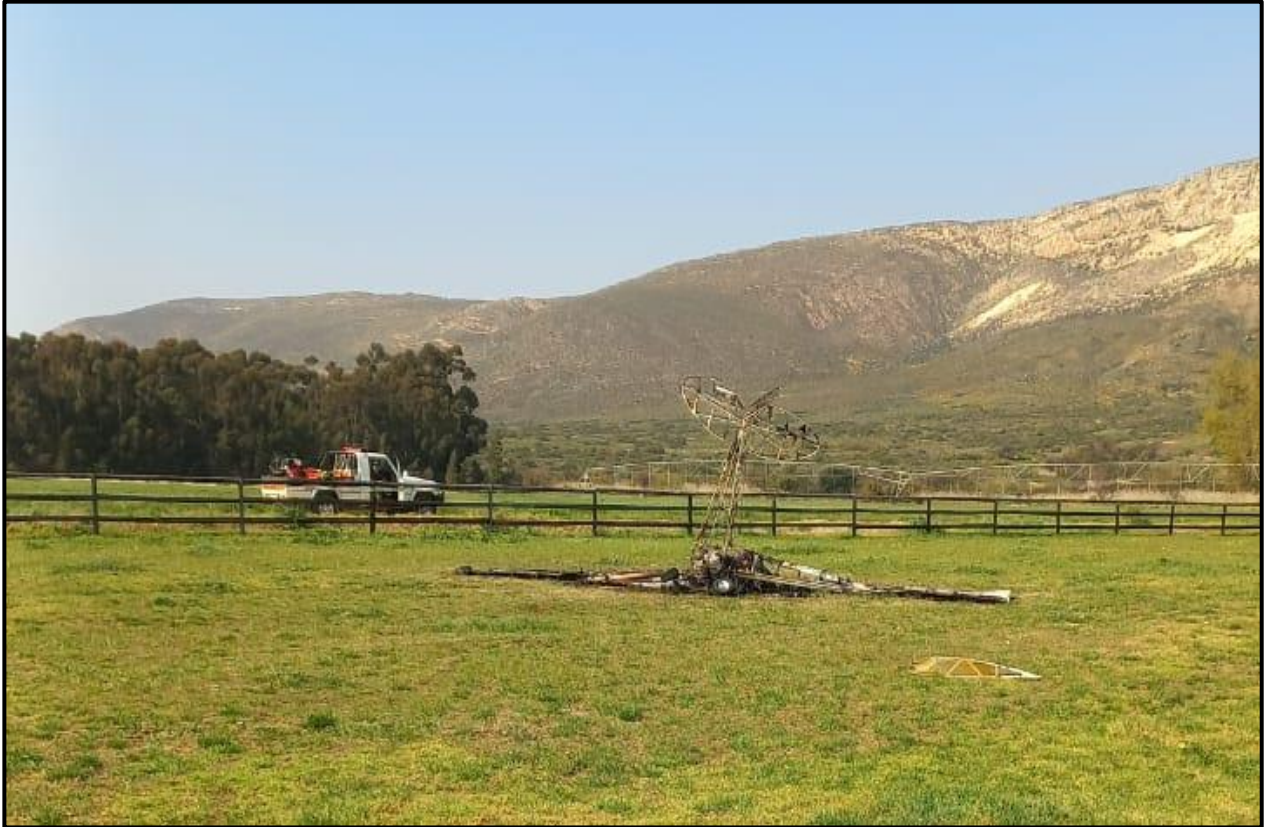
1.12.1 The aircraft impacted the ground in a high-speed nose-down attitude in a south-easterly direction, which was the opposite direction to which the aircraft was flying. There were no skid marks or any other damage apart from the aircraft being consumed by the post-impact fuel-fed fire. The aircraft wreckage remained in a nose-down attitude (tail in the air). The attitude at which the aircraft remained is indicative of a nose-dive impact. Emergency Medical Services (EMS) personnel had cut several structural beams to retrieve the deceased. During the on-site investigation by the AIID team, the EMS personnel availed themselves to point out the areas and parts that they had cut.

Figure 7: The aircraft as it came to rest.

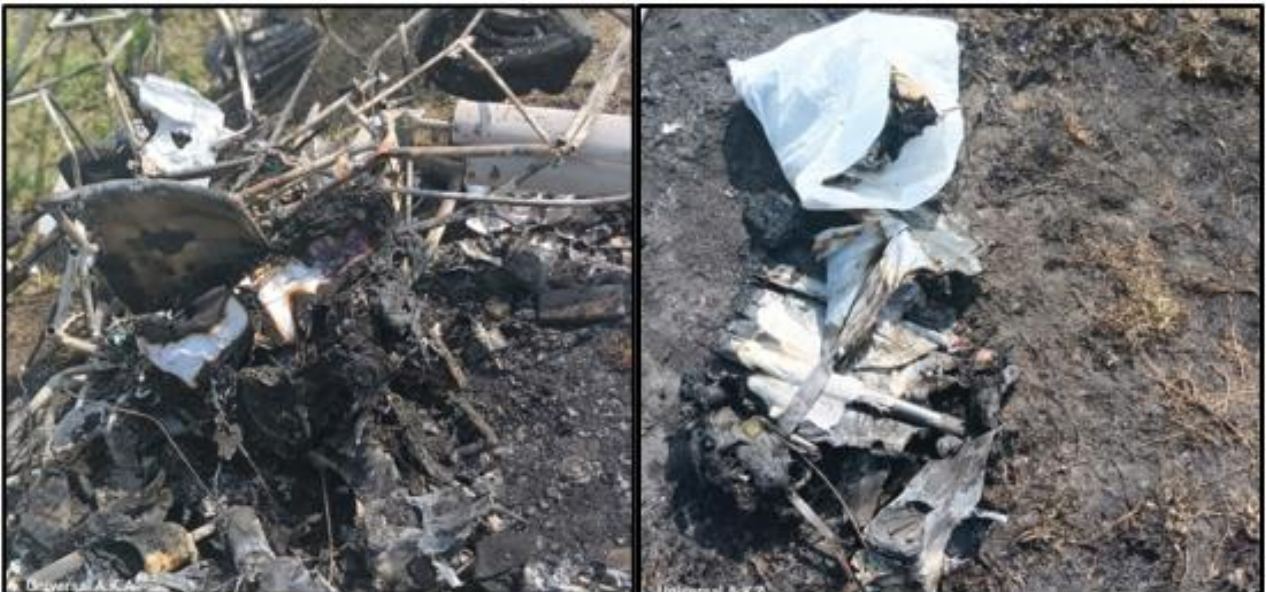
Figure 8: Evidence of luggage found in the front cockpit seat. (The left picture shows the luggage as it was found on the aircraft and the right picture shows the remaining parts of the luggage bag).

1.12.3 Evidence of luggage and books was found in the front seat, leaning against the front control stick (column), although the fire had consumed most of it.

- 3.3.1. The aircraft encountered mountain wave turbulence during the flight which caused an abrupt flight manoeuvre. As a result, the luggage in the front cockpit seat shifted and rested on the front control column, further pushing it forward. This prevented the pilot from pulling back the controls, which caused the aircraft's nose to pitch down and enter a nose-dive until it impacted the ground.

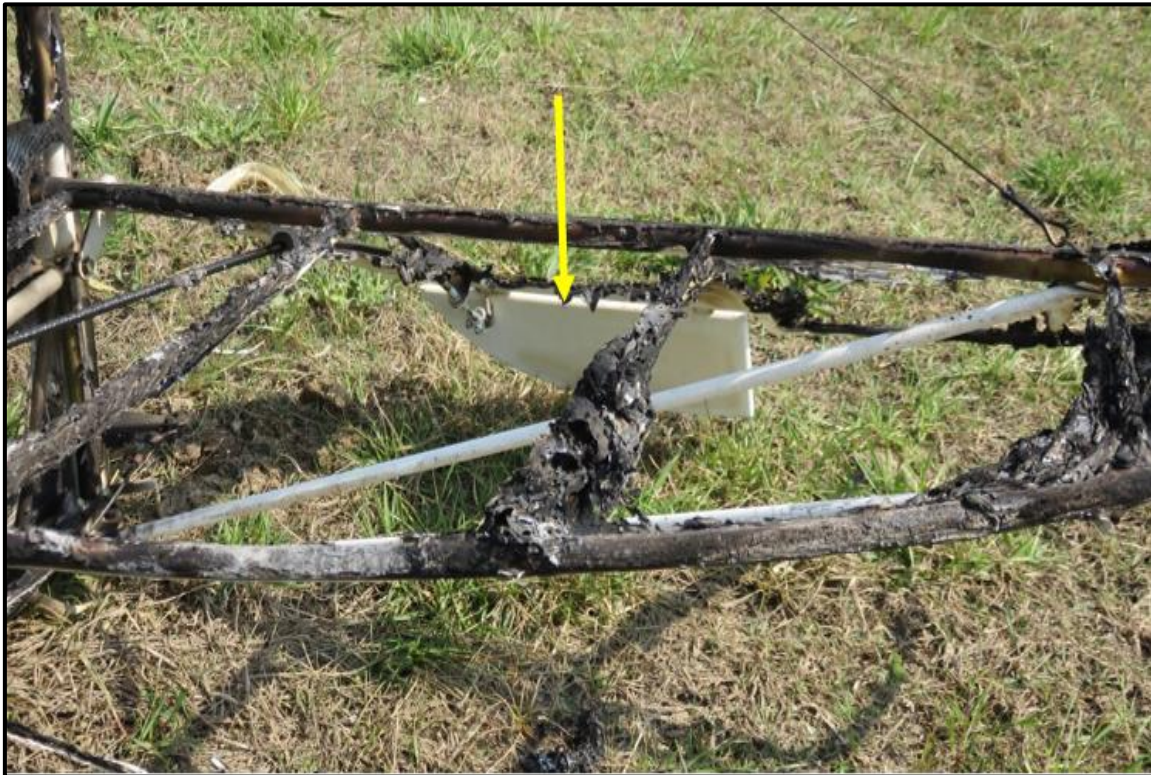
1.12.2 No evidence could be found that the structural integrity of the aircraft was compromised, and all the flight controls were accounted for. The elevator trim was found in the full nose-up position (see Figure 9). The two rudder cables that were replaced before the accident flight were found intact and securely connected (see Figure 10). The right rudder cable was, however, cut by the EMS personnel and this was pointed out to the investigators.

Figure 9: The elevator trim tab in the full nose-up position.

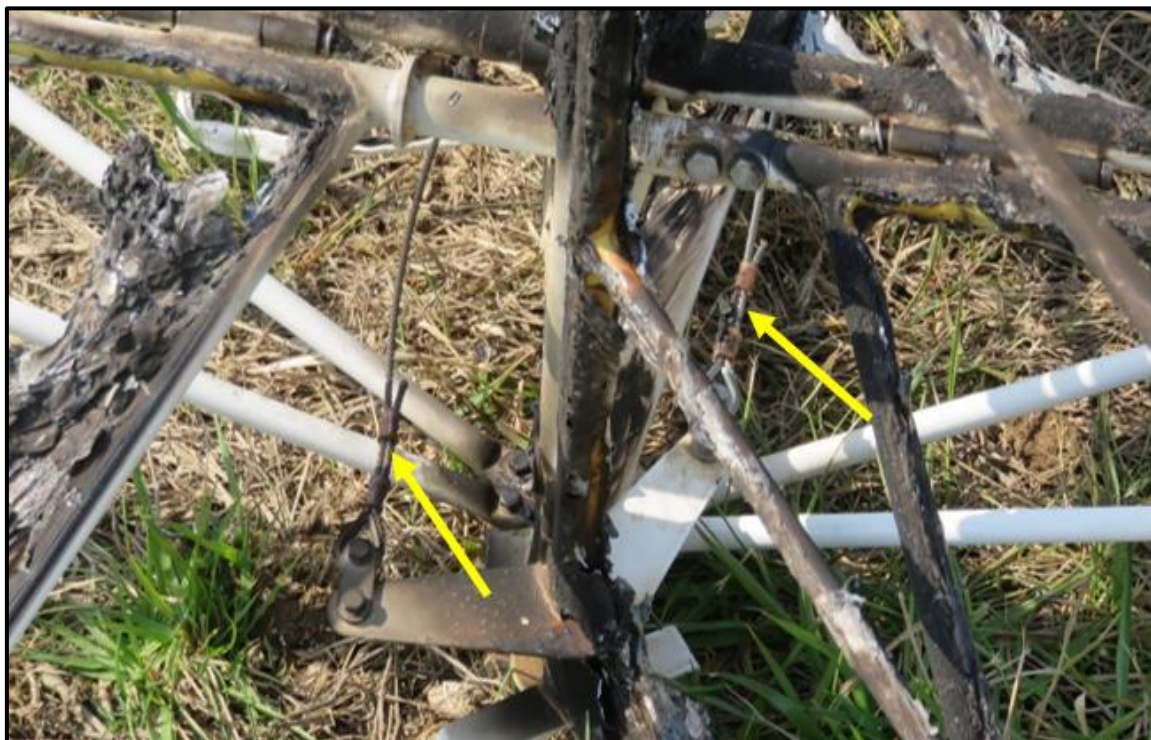
Figure 10: The two rudder cables were secured on both sides of the rudder attachments.
