| <b>AIRCRAFT ACCIDENT REPORT AND EXECUTIVE SUMMARY</b> |

| | | | | <b>Reference:</b> | | CA18/2/3/10362 | |
| <b>Aircraft Registration</b> | ZU-IHA | <b>Date of Accident</b> | 2 September 2023 | | <b>Time of Accident</b> | 1618Z | |
| <b>Type of Aircraft</b> | Apollo T | | <b>Type of Operation</b> | | Private (Part 105) | | |

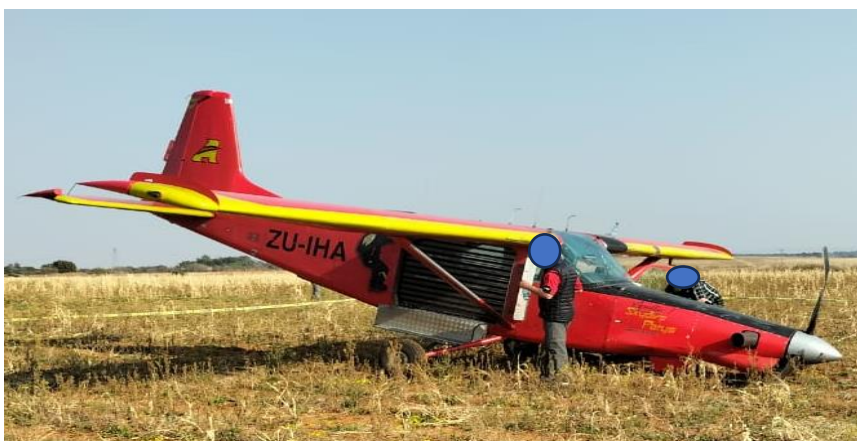
1.3.1. The aircraft sustained substantial damage.

Figure 2: The aircraft post-accident. (Source: Pilot)

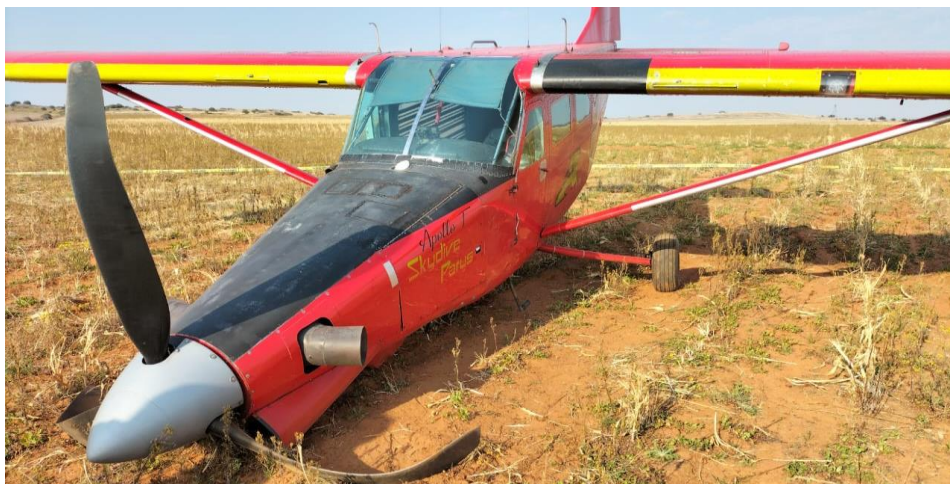
1.12.1. The pilot performed a forced landing on a maize field approximately 0.83 nautical miles (nm) west of FATP. During the landing roll, the nose gear strut attachment bolts sheared off, and the nose gear collapsed which caused the propeller blades to strike the ground.

1.12.2. The left-side main landing gear leg bent slightly backwards. However, the aircraft came to rest in an upright position. The airframe and the cockpit cabin area remained intact. The aircraft sustained damage to the engine intake, the lower engine cowling, and all the propeller blades.

**Figure 7:** The aircraft at the accident site. (Source: Pilot)

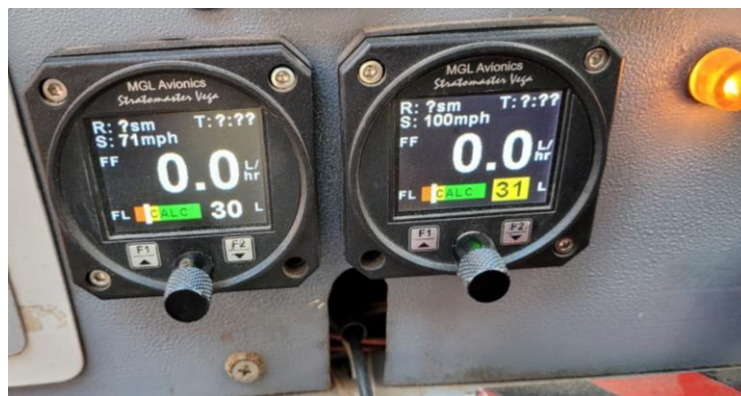
1.16.1 Post-accident examination of the aircraft by the AP at the accident site indicated that the fuel caps above the wings were in place and properly locked into position. The oil and fuel systems showed no evidence of a disconnection or a leak. The engine power lever was found to have been correctly connected to the FCU with no evidence of restrictions from the cockpit. The fuel condition lever showed nothing abnormal. The fuel gauges indicated 30l on the left-side tank and 31l on the right tank.

**Figure 8:** The fuel gauges showing the amount of fuel in the tanks post-accident. (Source: Pilot)

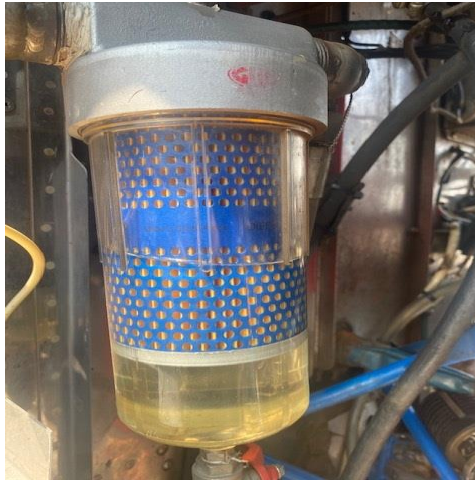
1.16.2 Fuel was drained from the tanks and was found to be of the correct grade and free of contaminants. After opening the engine cowlings, no evidence of damage was found on the engine casing/components. The main fuel filter was half and the filter element was free of obstruction. The fuel purge system was found pressurised and the fuel shutoff valve was in the open position. Fuel was found in all lines throughout the engine. During the investigation, no evidence of abnormalities was found in the FCU or fuel pumps. No evidence of malfunction in the fuel system was found. Damage to the propeller blades indicated that there was little or no rotation at the time the propeller impacted the ground.

**Figure 9:** The engine main fuel filter. (Source – Aircraft Maintenance Organisation)

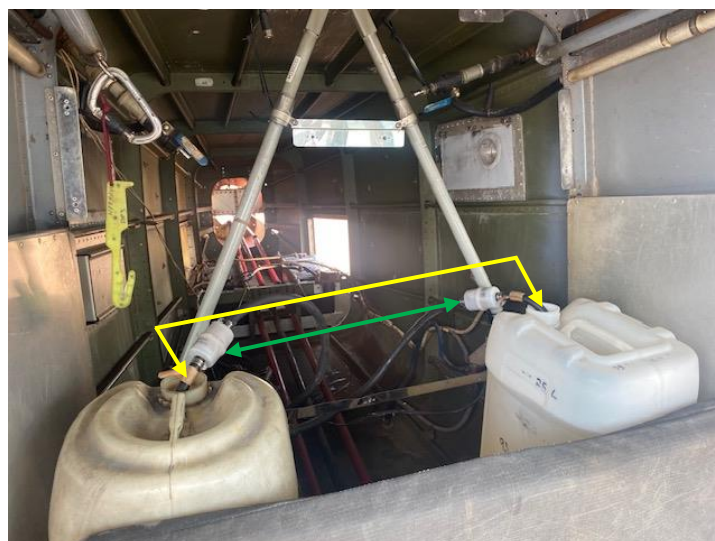
1.16.4 On Monday morning, 9 October 2023, engineers at the AMO removed a damaged propeller from the engine flange. Later a serviceable propeller was fitted to allow the engine ground run by engineers in the presence of the investigator-in-charge (IIC). With the wings removed from the fuselage, fuel supply pipes which normally connect to the wing tanks were dipped into 25l containers (depicting left and right tanks) containing Jet A1 fuel to allow the engine ground run.

**Figure 10:** Fuel pipes dipped into the two 25l containers with fuel filters visible on each side.

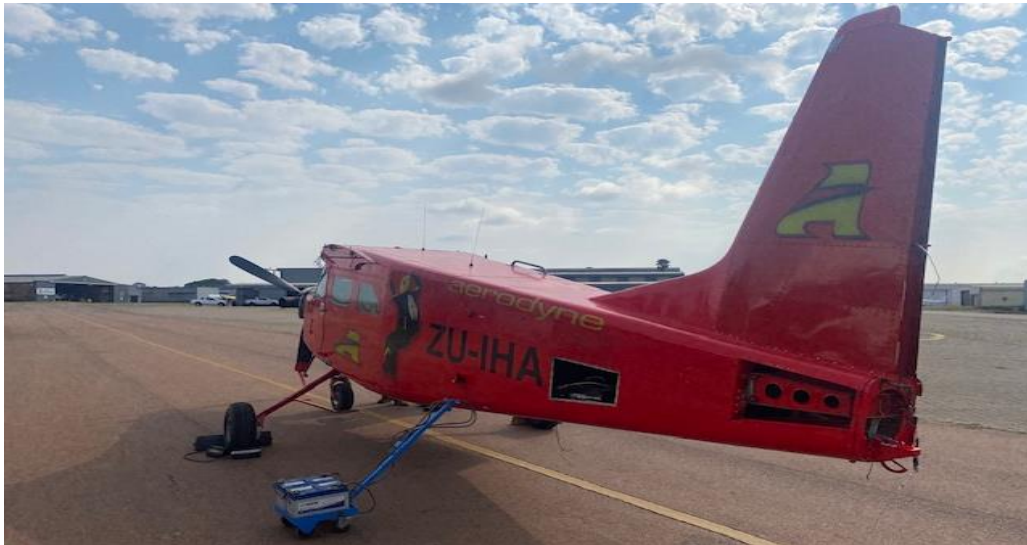
1.16.5 Later, the engine was started and was allowed to warm up before power was increased in stages. The engine met all the parameters IAW the EMM. A hot engine start was also performed, and no irregularities were found. No signs of erroneous fuel gauge readings were observed during the engine run. The fuel tanks were inspected for possible blockages such as rags, and nothing was found.

**Figure 11:** The aircraft during the engine ground run.
