LIMITED OCCURRENCE INVESTIGATION REPORT – FINAL
--

Reference Number	CA18/2/3/10363						
Classification	Accident	Date	5 September 2023		Time	1330Z	
Type of Operation	Private (Part 91)						
Location							
Place of Departure	Springs Aerodrome (FASI), Gauteng Province		Place of Intended Landing	Springs Aerodrome (FASI), Gauteng Province			
Place of Occurrence	Kimberley Aerodrome (FAKM), Northern Cape Province						
GPS Co-ordinates	Latitude	28°48'06.3" S	Longitude	024°45'48.5" E	Elevation	3950 ft	
Aircraft Information							
Registration	ZS-EKI						
Make; Model; S/N	Piper; PA-28-140 Cherokee (Serial Number: 28-21124)						
Damage to Aircraft	Substantial			Total Aircraft Hours	5729.70		
Pilot-in-command							
Licence Type	Private Pilot Licence (PPL)		Gender	Male		Age	26
Licence Valid	Yes	Total Hours	102.4		Total Hours on Type	88.8	
Total Hours Past 30 Days	27.0		Total Flying Hours on Type Past 90 Days	34.3			
People On-board	1 + 1	Injuries	0	Fatalities	0	Other (on ground)	0

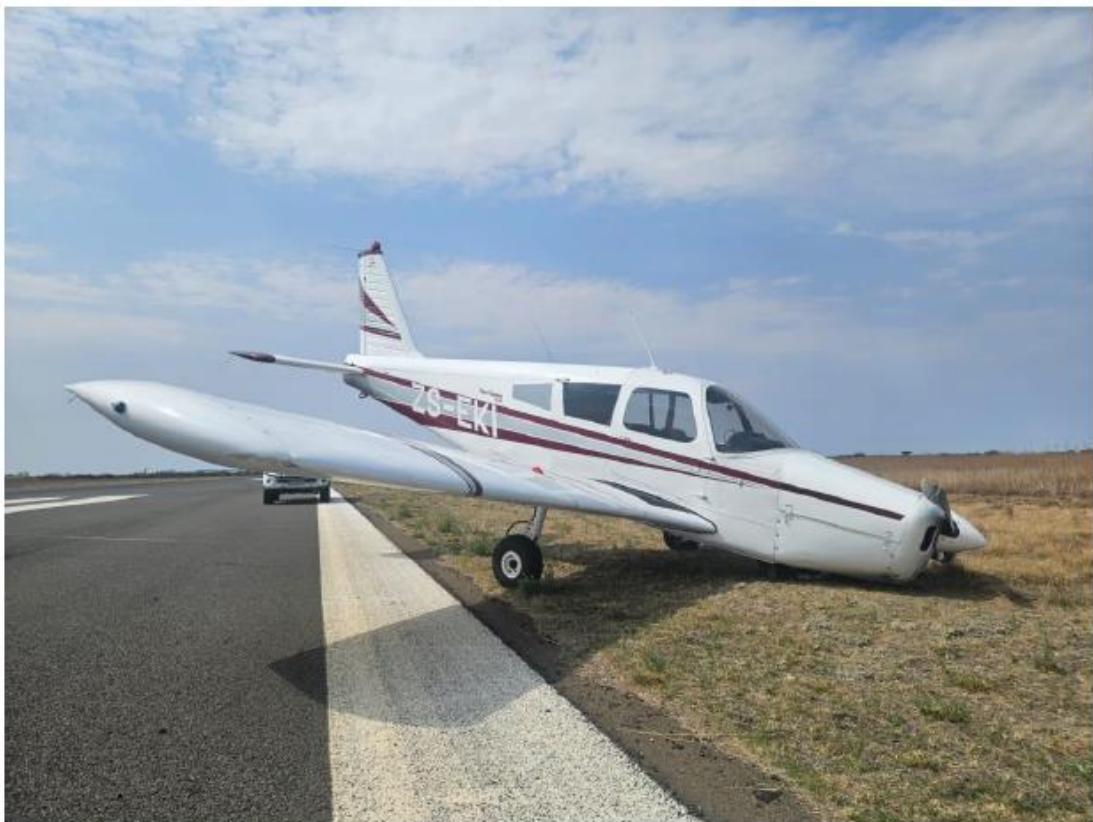
Figure 2: The aircraft as it came to rest after the accident. (Source: Pilot)

Unstable approach which resulted in loss of directional control of the aircraft after touchdown on Runway 28.
