**LIMITED OCCURRENCE INVESTIGATION REPORT – FINAL**

<b>Reference Number</b>	CA18/2/3/10364						
<b>Classification</b>	Accident	<b>Date</b>	8 September 2023	<b>Time</b>	1040Z		
<b>Type of Operation</b>	Private (Part 91)						
<b>Location</b>							
<b>Place of Departure</b>	Rietfontein Farm Rustenburg District, North West Province		<b>Place of Intended Landing</b>		Prins Farm Rustenburg District, North West Province		
<b>Place of Occurrence</b>	Prins Farm Rustenburg District, North West Province						
<b>GPS Co-ordinates</b>	<b>Latitude</b>	25°26'05.10" S	<b>Longitude</b>	026°52'55.43" E	<b>Elevation</b>	3 560 ft	
<b>Aircraft Information</b>							
<b>Registration</b>	ZS-RKK						
<b>Make; Model; S/N</b>	Robinson Helicopter; R44 Raven II (Serial Number: 11338)						
<b>Damage to Aircraft</b>	Destroyed		<b>Total Airframe Hours</b>		2 080.0		
<b>Pilot-in-command</b>							
<b>Licence Type</b>	Private Pilot Licence		<b>Gender</b>	Male		<b>Age</b>	47
<b>Licence Valid</b>	No	<b>Total Hours</b>	4 800.0		<b>Total Hours on Type</b>	4 800.0

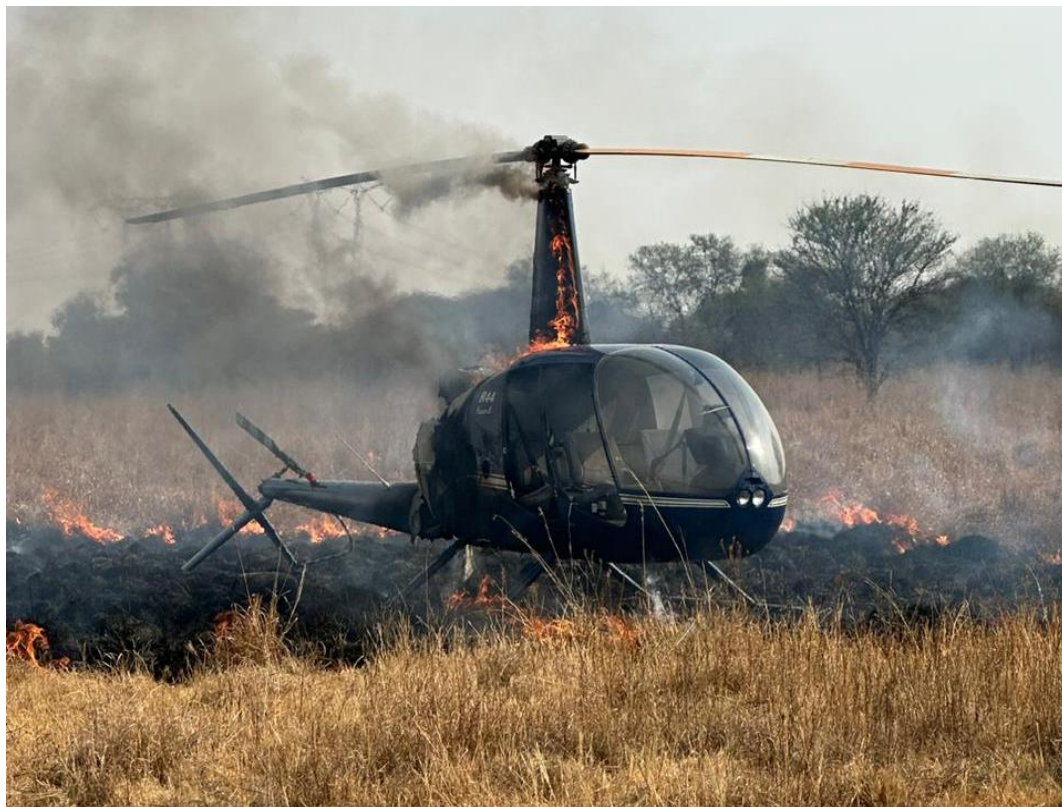
**Figure 1:** The helicopter on fire. (Source: Pilot)

The pilot landed the helicopter on tall dry grass which ignited on contact with the hot exhaust; the helicopter was consumed by the fire.

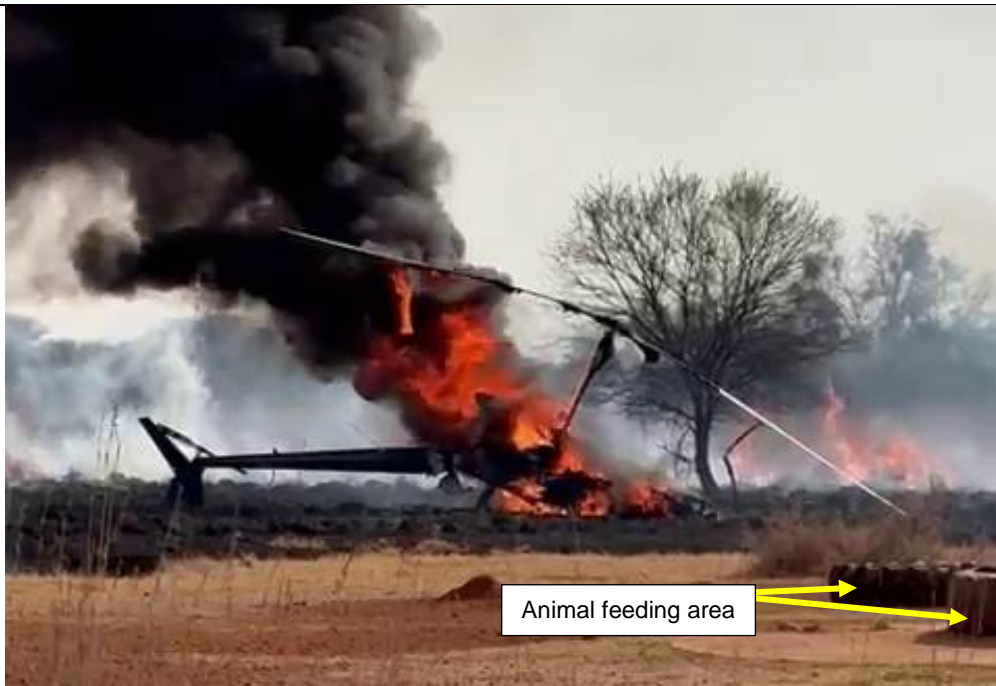
**Figure 2:** A still picture extracted from a video footage with the helicopter and dry grass on fire.

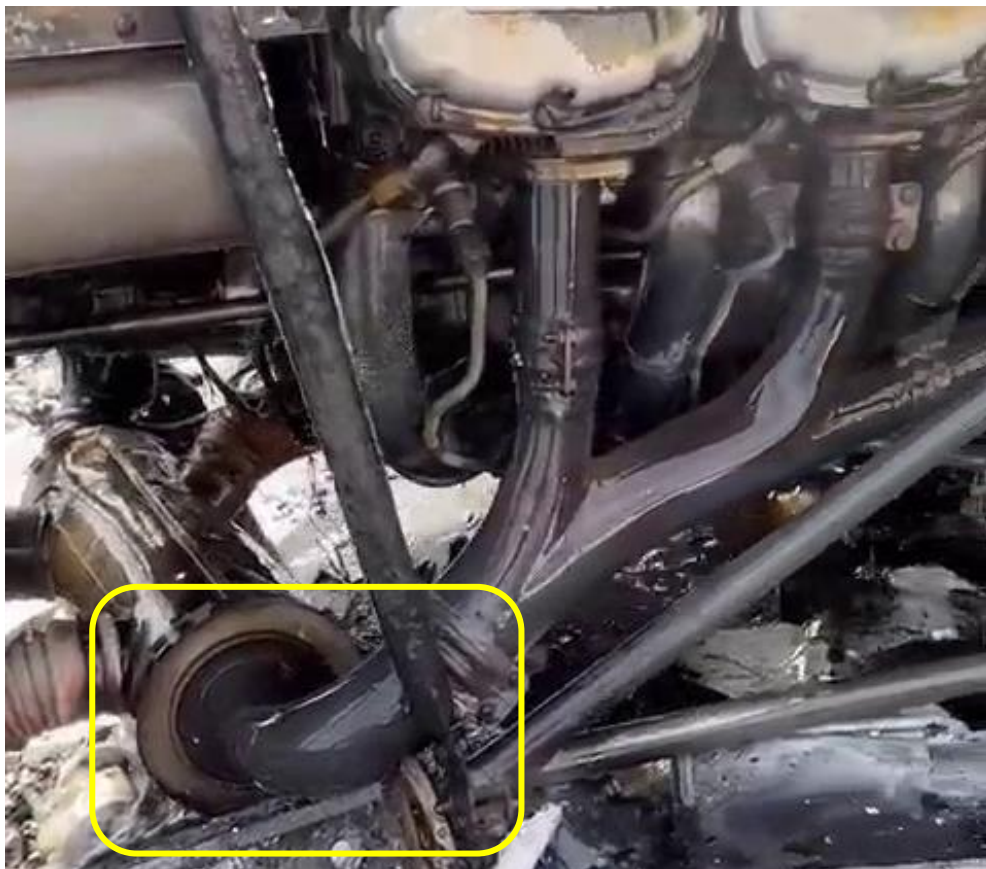
A still picture from the video footage indicated the absence of the exhaust muffler and tailpipe shielding.

**Figure 3:** A still picture taken from a video footage of the exhaust system whilst the fire was being doused.

- 2.5 The Service Bulletin SB-46 dated 15 November 2002, which require the installation of the exhaust Muffler and Tailpipe Shield Kit D318-1, was not complied with.
- 2.6 According to the pilot, the flight folio was in the helicopter and was consumed by the fire.
- 2.7 It was noted that the pilot's door (right front) as well as the cabin door (behind the pilot) were removed for the purpose of this flight.
- 2.8 The helicopter was involved in a serious incident on 11 May 2022 (Accident and Incident Investigations Division (AIID) Reference number CA18/3/2/1386) during a game capture operation when the weights on the net that is fired using a net gun on-board the helicopter damaged one of the main rotor blades. The pilot landed safely following the occurrence.

<b>Safety Action(s)</b>
None.
<b>Safety Message and/or Safety Recommendation/s</b>
It is recommended to the Director of Civil Aviation to issue a mandatory compliance directive to ensure all Robinson R22 and R44 helicopters operating in South Africa are fitted with the Muffler and Tailpipe Shield Kit as per Service Bulletin SB-46 to prevent a recurrence of this accident and the destruction of property associated with such an occurrence.
<b>About this Report</b>
<p><i>The decision to conduct a limited investigation is based on factors including whether the cause is known and the evidence supporting the cause is clear, the level of safety benefit likely to be obtained from an investigation and that will determine the scope of an investigation. For this occurrence, a limited investigation has been conducted, and the Accident and Incident Investigations Division (AIID) has relied on the information submitted by the affected person/s and organisation/s to compile this limited report. The report has been compiled using information supplied in the initial notification, as well as from follow-up desk top enquiries to bring awareness of potential safety issues to the industry in respect of this occurrence, as well as possible safety action/s that the industry might want to consider in preventing a recurrence of a similar occurrence.</i></p> <p><i>All times given in this report are Co-ordinated Universal Time (UTC) and will be denoted by (Z). South African Standard Time is UTC plus 2 hours.</i></p>

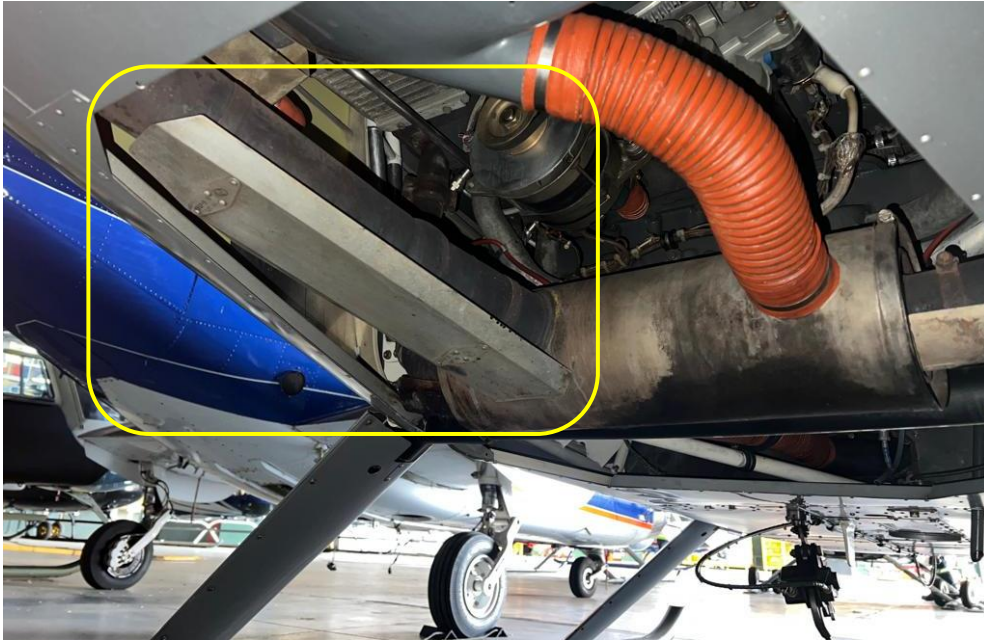
**Figure 4:** The tailpipe shield in the yellow window.

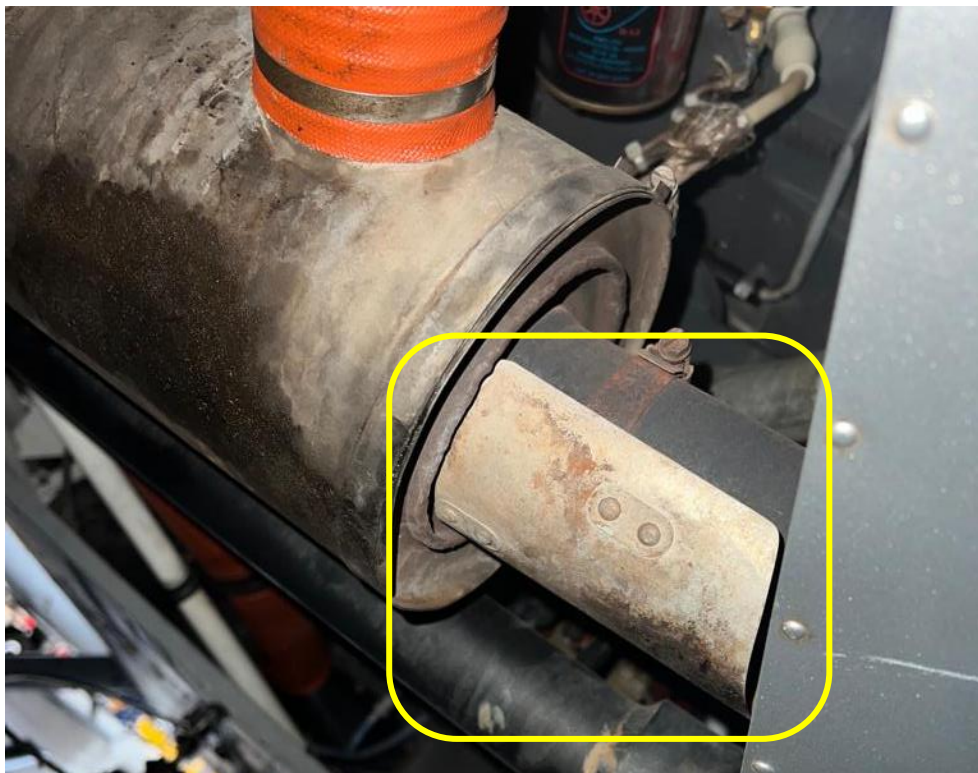
**Figure 5:** The muffler shield (right side) in the yellow window.

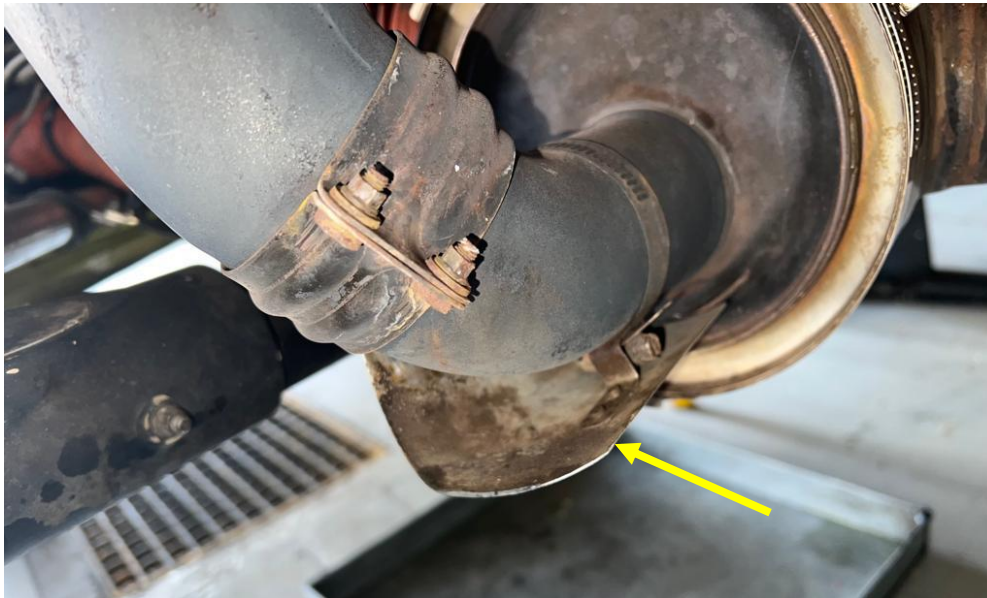
**Figure 6:** A different view of the muffler shield.
