**LIMITED OCCURRENCE INVESTIGATION REPORT – FINAL**

<b>Reference Number</b>	CA18/2/3/10365						
<b>Classification</b>	Accident	<b>Date</b>	15 September 2023	<b>Time</b>	1537Z		
<b>Type of Operation</b>	Training (Part 141)						
<b>Location</b>							
Place of Departure	Pietermaritzburg Aerodrome (FAPM) KwaZulu-Natal Province		Place of Intended Landing	Pietermaritzburg Aerodrome (FAPM) KwaZulu-Natal Province			
Place of Occurrence	Runway (RWY) 16 at Pietermaritzburg Aerodrome (FAPM)						
GPS Co-ordinates	Latitude	28° 43' 48" S	Longitude	032° 04' 48" E	Elevation	2 372 ft	
<b>Aircraft Information</b>							
Registration	ZU-JAR						
Make; Model; S/N	Sling 2 (Serial Number: 156)						
Damage to Aircraft	Substantial			Total Aircraft Hours	637.5		
<b>Pilot-in-command</b>							
Licence Type	Student Pilot Licence (SPL)		Gender	Female		Age	19
Licence Valid	Yes	Total Hours	24.8		Total Hours on Type	24.8	
Total Hours 30 Days	3.6		Total Flying on Type Past 90 Days	16.1

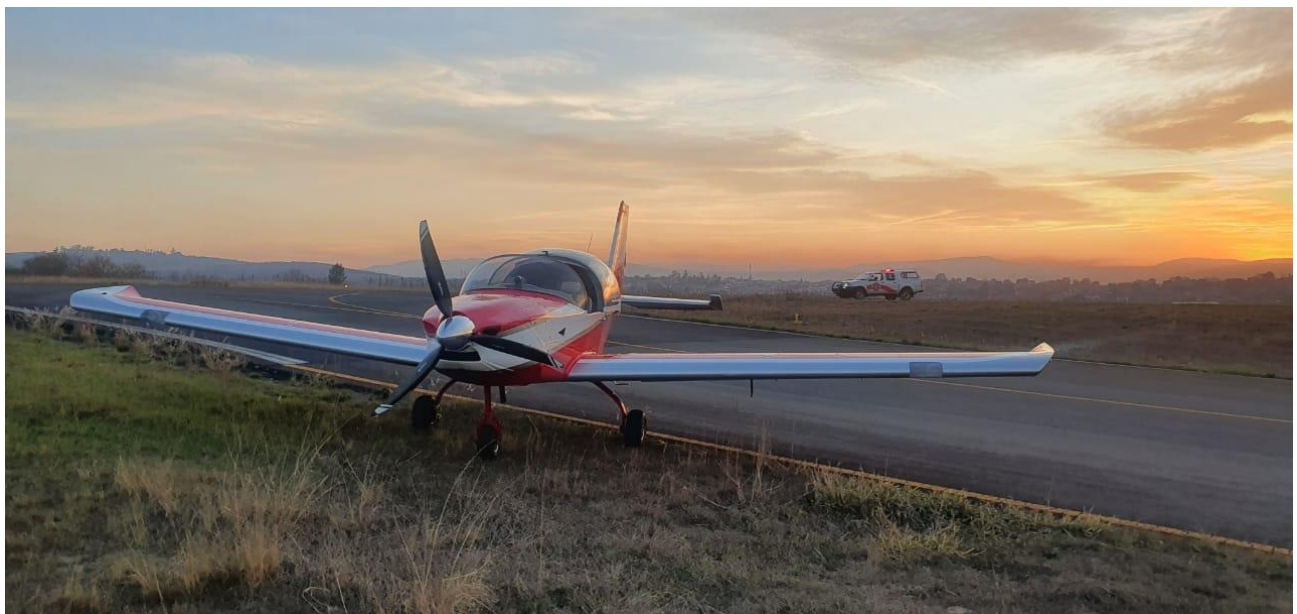
**Figure 2:** The aircraft after it came to a stop. (Source: Operator)

2.5	The aircraft was too high on final approach and the student pilot flared the aircraft too high before it bounced a few times. This was followed by loss of directional control.

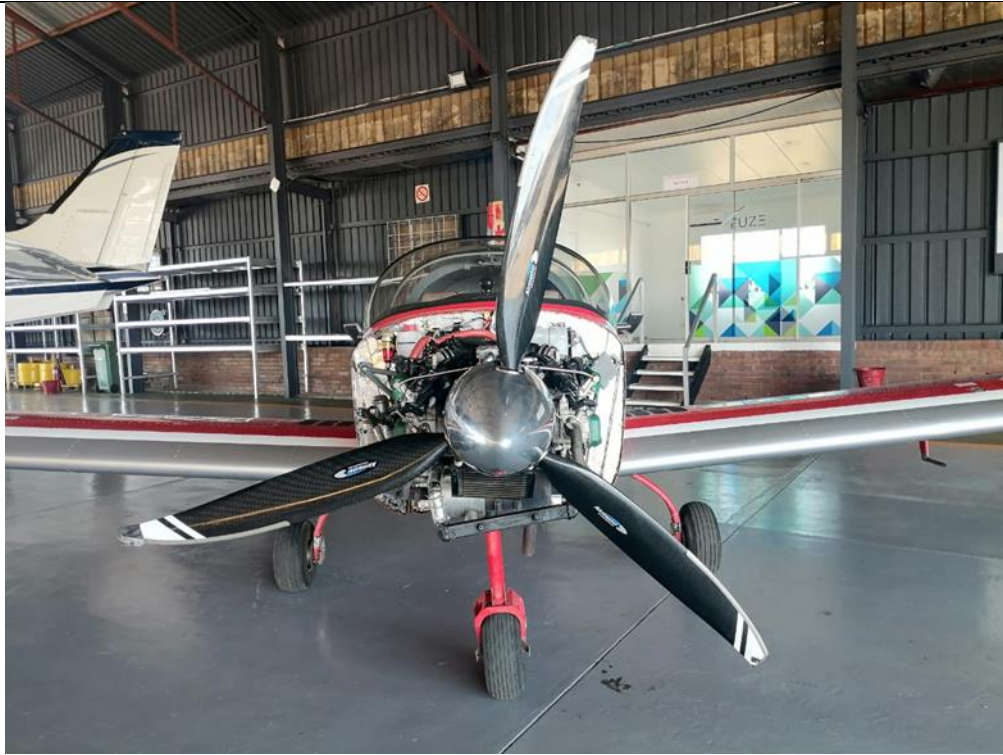
**Figure 3:** Damage to the propeller tips. (Source: Operator)

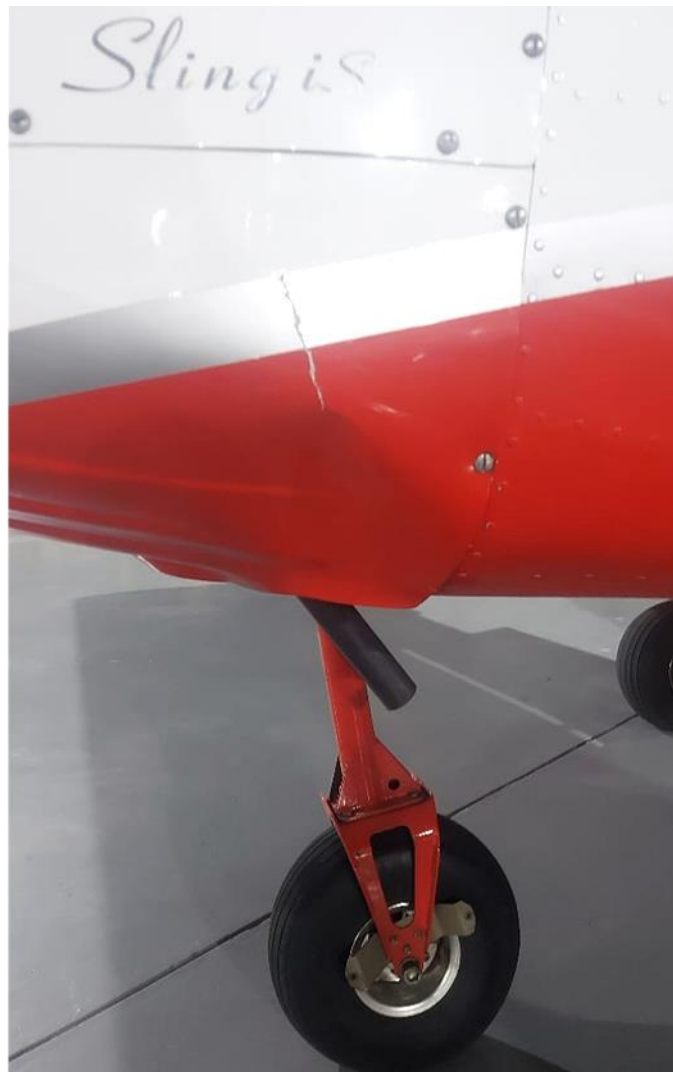
**Figure 4:** Damage to the nose gear. (Source: Operator)
