RPAS/UAS LIMITED OCCURRENCE INVESTIGATION REPORT – FINAL

Reference Number	CA18/2/3/10366							
Classification	Accident	Date	20 June 2023			Time	1645Z	
Type of Operation	Unmanned Aircraft System – Surveillance (Part 101)							
Location								
Place of Departure	Navigation Colliery Mine, Witbank, Mpumalanga Province		Place of Intended Landing		Navigation Colliery Mine, Witbank, Mpumalanga Province			
Place of Occurrence	Navigation Colliery Mine, Witbank, Mpumalanga Province							
GPS Co-ordinates	Latitude	25°54'33.6"S	Longitude	29°09'40.8"E	Elevation	5125ft		
Aircraft Information								
Registration	ZT-YLL		Class	3A				
Make; Model; S/N	DJI; MAVIC 2 Enterprise Advanced (Serial Number: MAV123)							
Damage to Aircraft	Substantial		Total UAS Hours		467.46			
Pilot-in-command								
Licence Type	Remote Pilot Licence (RPL)		Gender	Male		Age	33	
Licence Valid	Yes	Total Hours	535.12		Total Hours on Type	535.12		
Total Hours 30 Days	69		Total Flying on Type Past 90 Days		185.10

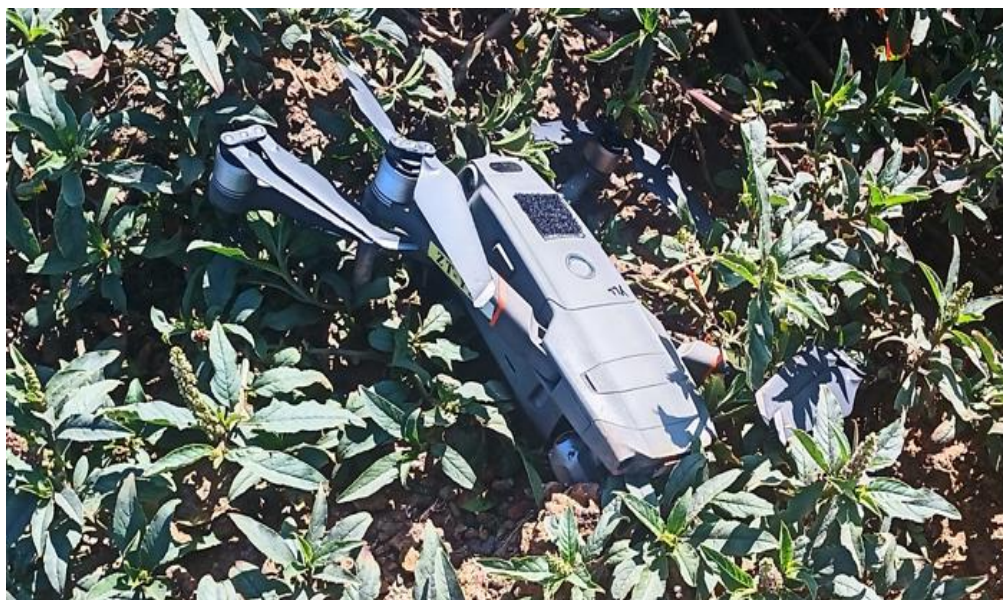
People Controlling	1	Injuries (On ground)	0		Fatalities	0	Fatalities (on ground)	0
What Happened								
<p>On Tuesday evening, 20 June 2023, an unmanned aircraft system (UAS) with registration ZT-YLL was engaged in a surveillance flight at Navigation Colliery Mine in Witbank, Mpumalanga province, when the accident occurred. The flight was conducted under beyond visual line of sight (BVLOS) rules and under the provisions of Part 101 of the Civil Aviation Regulations (CAR) 2011 as amended.</p> <p>The pilot stated that after conducting the pre-flight checks with no anomalies detected, he launched the UAS at 1630Z with 99% battery voltage and 60 minutes endurance. The pilot further reported that he engaged the Loiter mode (manually operated) and climbed to 394 feet (ft) above ground level (AGL) and conducted surveillance for approximately 2.6 kilometres (km) over a 15-minute period at West Diesel Dam. Whilst the UAS was at West Diesel Dam, the control room notified the pilot of the suspects at Bore 7, which was less than a kilometre from the West Diesel Dam. The pilot spotted the suspects on the north-east side. Whilst the pilot directed the armed response officials, the smart return home activated on the remote control and, moments later, the remote pilot station lost connection with the UAS. The pilot made his way to the last recorded location on the same night, but he could not find the UAS. The search continued the following morning and, at approximately 0900Z, the UAS was found crashed on the ground with three broken propeller blades.</p>

The post-accident investigation found that the terminals of the UAS's battery accumulated dust which resulted in the loss of battery connection and, thus, the UAS lost thrust and impacted the ground.

Figure 2: The RPA at the accident site. (Source: Operator)
