**LIMITED OCCURRENCE INVESTIGATION REPORT – FINAL**

<b>Reference Number</b>	CA18/2/3/10367						
<b>Classification</b>	Accident	<b>Date</b>	14 September 2023	<b>Time</b>	1030Z		
<b>Type of Operation</b>	Private (Part 91)						
<b>Location</b>							
Place of Departure	Port Alfred Aerodrome (FAPA), Eastern Cape Province			Place of Intended Landing	King Phalo Aerodrome (FAEL), Eastern Cape Province		
Place of Occurrence	FAEL						
GPS Co-ordinates	Latitude	33° 02' 09.15" S	Longitude	027° 49' 22.12" E	Elevation	415ft	
<b>Aircraft Information</b>							
Registration	ZU-JGM						
Make; Model; S/N	Cessna 185E (Serial Number: 185-1178)						
Damage to Aircraft	Substantial			Total Aircraft Hours	7752.2		
<b>Pilot-in-command</b>							
Licence Type	Private Pilot Licence (PPL)		Gender	Male	Age	69	
Licence Valid	Yes	Total Hours	3310.7	Total Hours on Type	182.7		
Total Hours 30 Days	3.5			Total Flying on Type Past 90 Days	12.5		
<b>People On-board</b>	1+0	<b>Injuries</b>	0	<b>Fatalities</b>	0	<b>Other (on ground)</b>	0

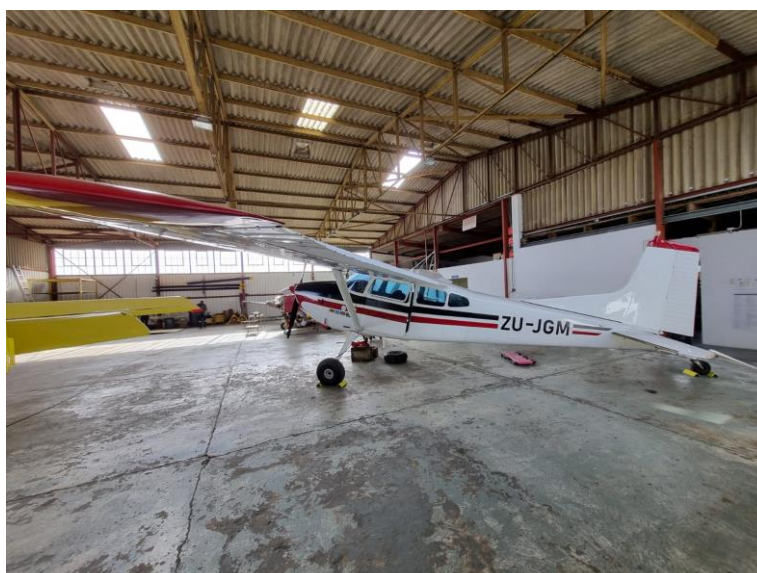
**Figure 2:** The aircraft parked at the hangar post-accident. (Source: Pilot)

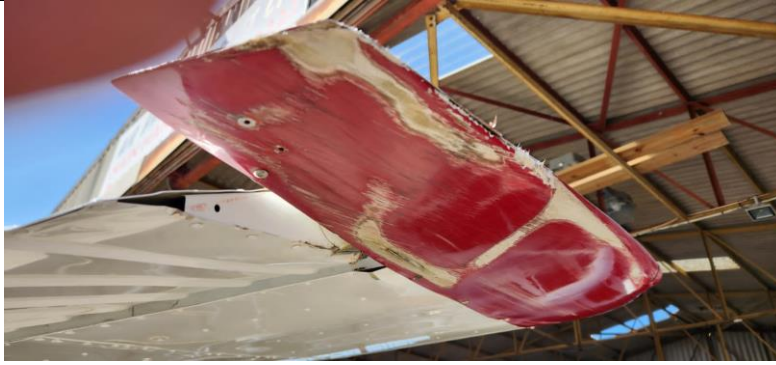
The aircraft sustained damage to the right-wing tip and horizontal stabiliser. The pilot was not injured.

**Figure 3:** The damaged right-wing tip. (Source: Pilot)

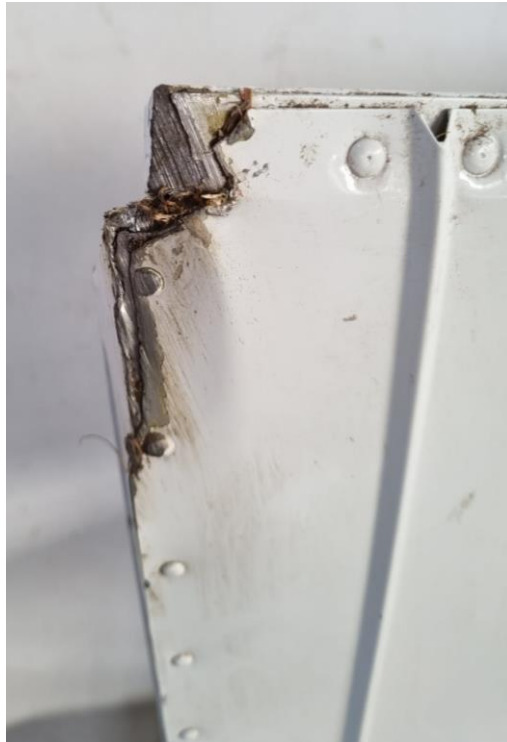
**Figure 4:** The damaged horizontal stabiliser. (Source: Pilot)

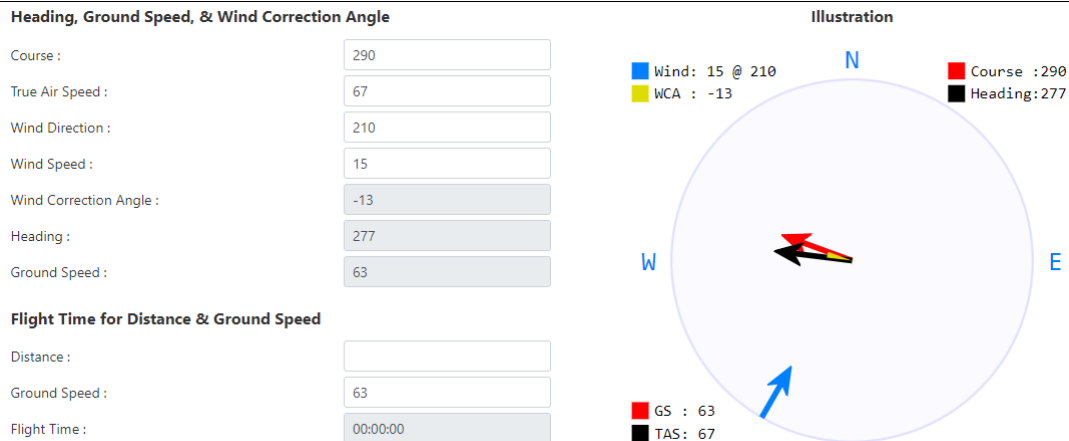
According to the pilot questionnaire, the cause of the accident was due to the crosswind component.

**Figure 5:** The crosswind component at the time of the flight. (Source: Online E6B computer)

The wind component calculator above indicates the left crosswind component of 13 knots at the time of the accident.
