LIMITED OCCURRENCE INVESTIGATION REPORT – FINAL

Reference Number	CA18/2/3/10368						
Classification	Accident	Date	27 September 2023		Time	0743Z	
Type of Operation	Private (Part 105)						
Location							
Place of Departure	Mossel Bay Aerodrome (FAMO), Western Cape Province			Place of Intended Landing	Mossel Bay Aerodrome (FAMO), Western Cape Province		
Place of Occurrence	On a private holding, 980 metres north-east of Mossel Bay Aerodrome (FAMO)						
GPS Co-ordinates	Latitude	34° 09' 04" S	Longitude	022° 04' 09" E	Elevation	536 ft	
Aircraft Information							
Registration	ZS-CXX						
Make; Model; S/N	Cessna 182-F (Serial Number: 182-54516)						
Damage to Aircraft	Substantial			Total Aircraft Hours	5 955.7		
Pilot-in-command							
Licence Type	Private Pilot Licence (PPL)		Gender	Male		Age	49
Licence Valid	Yes	Total Hours	729.2		Total Hours on Type	165.9	
Total Hours 30 Days	11.7		Total Flying on Type Past 90 Days	12.4			
People On-board	1+4	Injuries	0	Fatalities	0	Other (on ground)	0

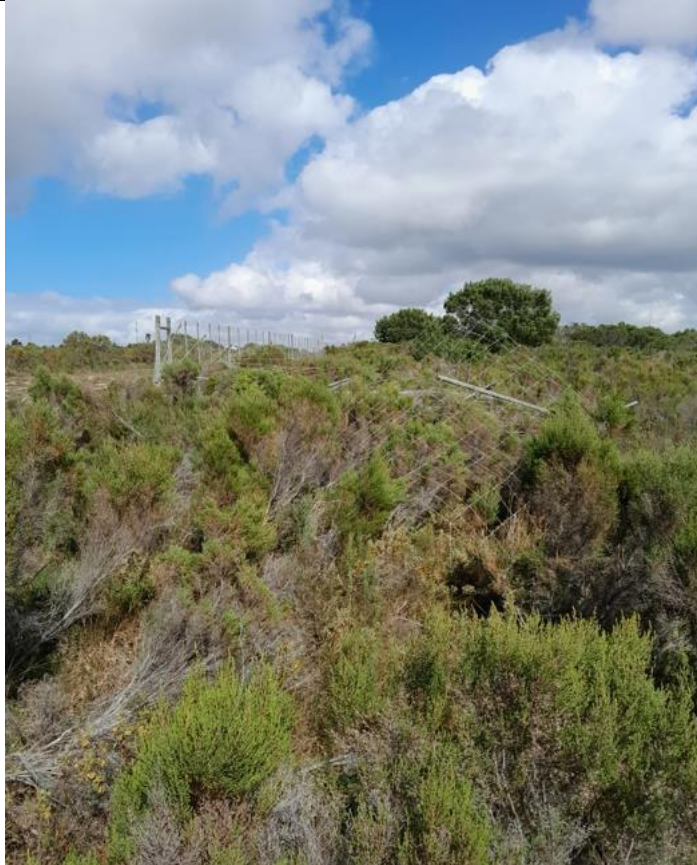
Figure 2: The fence that the aircraft impacted: (Source: Operator)

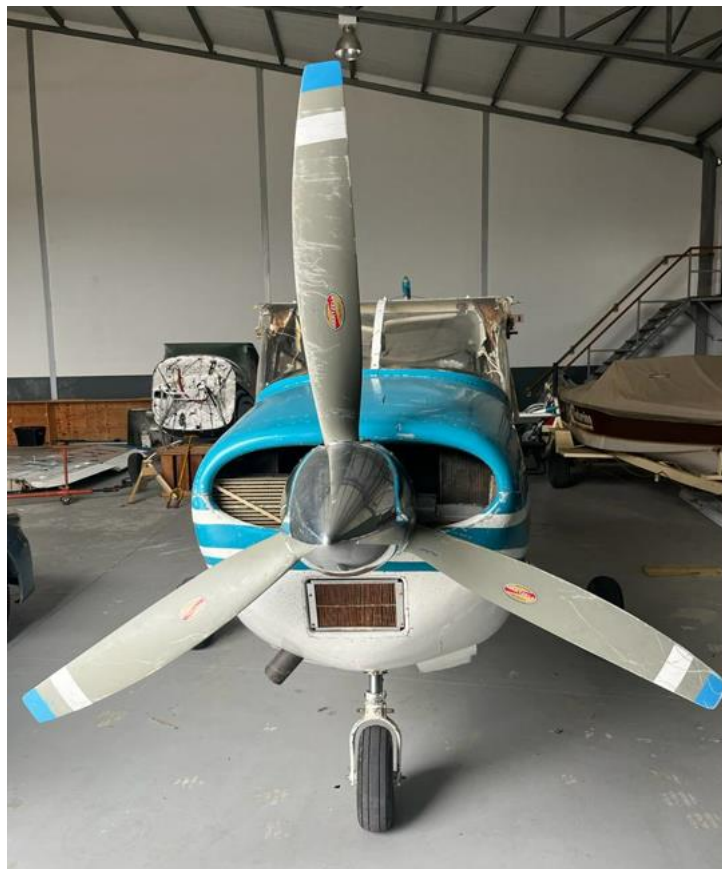
The aircraft maintenance organisation (AMO) recovered the aircraft after the accident. According to the technical report supplied by the AMO, the aircraft sustained damage to the left wing strut, left wing leading edge and propeller blades; there was no visible damage to the right wing. The engine was turned by hand several times, and there was no indication of internal damage. Both wing tanks were checked using a dipstick, and there was no evidence of fuel in the tanks.

Figure 3: The scratch marks on the propeller blades due to impact with the fence.

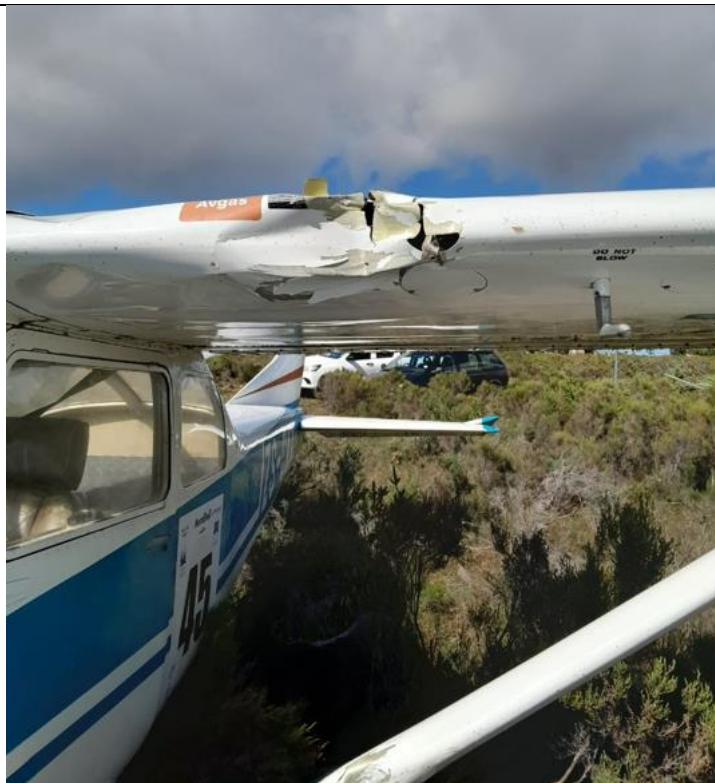
Figure 4: Damage sustained on the left-wing leading edge and strut. (Source: Operator)

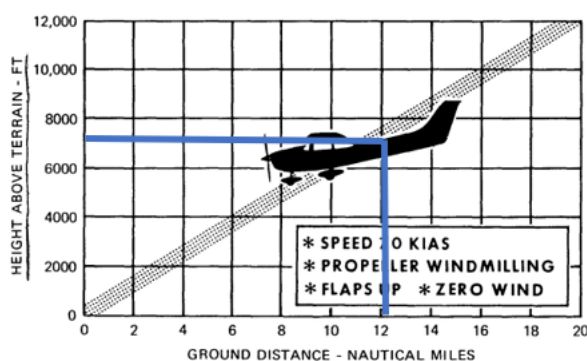
Chart 1: Maximum glide distance. (Source: POH)

At the time the engine stopped; the aircraft was at a height of 7 000 ft. According to Chart 1, the aircraft had approximately 12 nautical miles (nm) glide distance range available before touchdown (given that the indicated airspeed is kept at 70 knots with flaps up and with wind at zero degrees).

9. According to the maximum glide chart, the height at which the aircraft could glide without power is 12nm. The engine stopped whilst the aircraft was overhead Dana Bay which is 2.7nm from FAMO; thus, it is probable that the pilot landed the aircraft even though it had enough height and glide distance.
10. The wind speed at the time of the accident was not considered a factor for not opting for the glide approach.
11. According to the carburettor icing chart, the aircraft was flown in a weather condition with a high probability of serious carburettor icing at any power setting with a relative humidity of 70%. Carburettor icing was not considered to have had a bearing on the engine as the aircraft ran out of fuel.

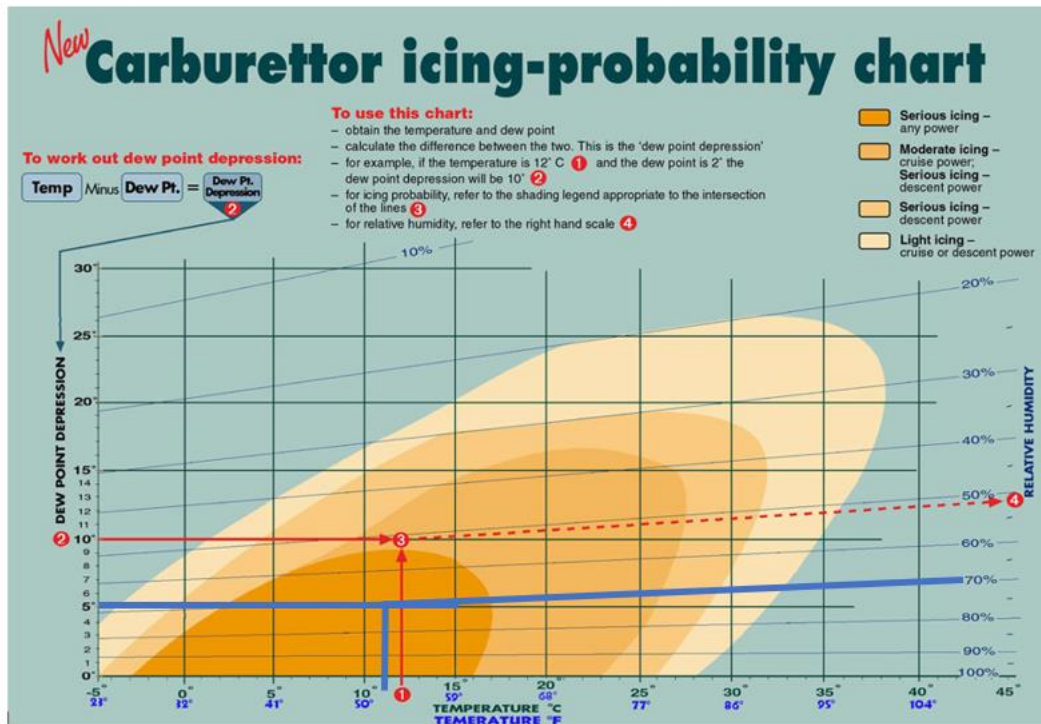
Chart 2: Carburettor icing chart.

According to the weather report supplied by the SAWS, the temperature at the time of the accident was 16° Celsius (C) with dew point at 11°C; this gives a dew point depression of 5°C. Therefore, this condition results in the relative humidity of 70% and, thus, places the aircraft in a serious icing condition at any power setting as depicted in Chart 2.
