**LIMITED OCCURRENCE INVESTIGATION REPORT – FINAL**

<b>Reference Number</b>	CA18/2/3/10369						
<b>Classification</b>	Accident	<b>Date</b>	1 October 2023	<b>Time</b>	0554Z		
<b>Type of Operation</b>	Private (Part 91)						
<b>Location</b>							
<b>Place of Departure</b>	Private Farm, Varksfontein, Limpopo Province		<b>Place of Intended Landing</b>	Wonderboom Airport (FAWB), Gauteng Province			
<b>Place of Occurrence</b>	On a private farm situated 0.8 nautical miles south-west of the take-off position						
<b>GPS Co-ordinates</b>	<b>Latitude</b>	24°0'27.09"S	<b>Longitude</b>	28°14'10.63"E	<b>Elevation</b>	4068 ft	
<b>Aircraft Information</b>							
<b>Registration</b>	ZS-MTM						
<b>Make; Model; S/N</b>	Cessna T210N (Serial Number: 210-64478)						
<b>Damage to Aircraft</b>	Substantial		<b>Total Aircraft Hours</b>	3252.3			
<b>Pilot-in-command</b>							
<b>Licence Type</b>	Commercial Pilot Licence		<b>Gender</b>	Male	<b>Age</b>	48	
<b>Licence Valid</b>	Yes	<b>Total Hours</b>	266.8	<b>Total Hours on Type</b>	266.8

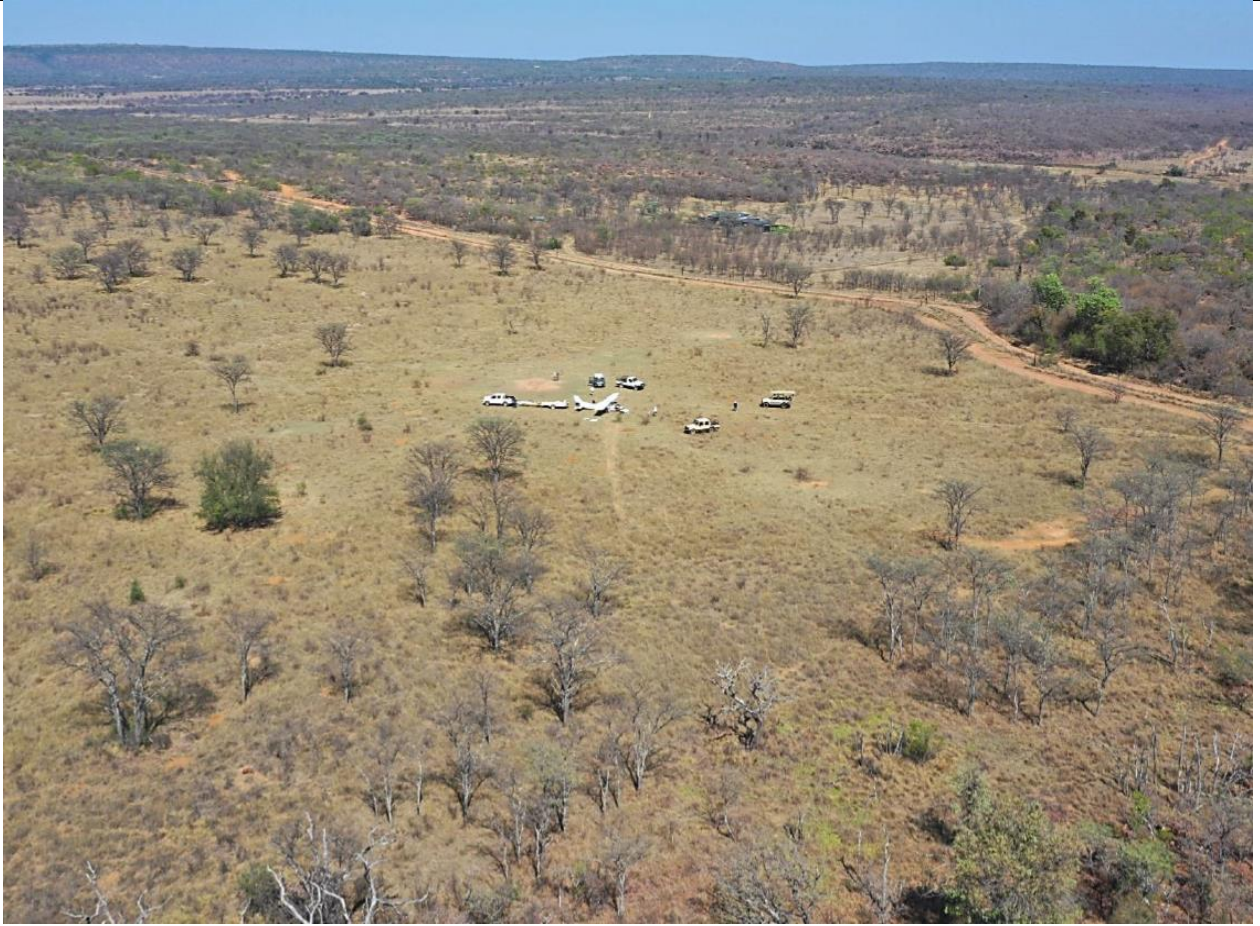
During the forced landing, the aircraft impacted three treetops with the bottom fuselage, followed by the left wing as the aircraft was losing height rapidly. The aircraft subsequently made contact with the ground and skidded on the grass for approximately 70 metres (m). The right-wing impacted a tree stem with the leading edge towards the wing tip which caused the aircraft to spin clockwise before it stopped facing north. The aircraft sustained substantial damage to the bottom fuselage, both wings' leading edge, the wing tip covers which detached, the right-side elevator, the nose section's engine cowlings and the propeller blades. After the accident, one of the passengers was able to disembark from the aircraft and assisted the pilot and the other passenger to vacate the aircraft. They rested under the left wing. The occupants sustained serious injuries; they were airlifted to Mediclinic in Limpopo province.

**Figure 2:** Aerial photo of the accident site. (Source: Insurance Assesor)

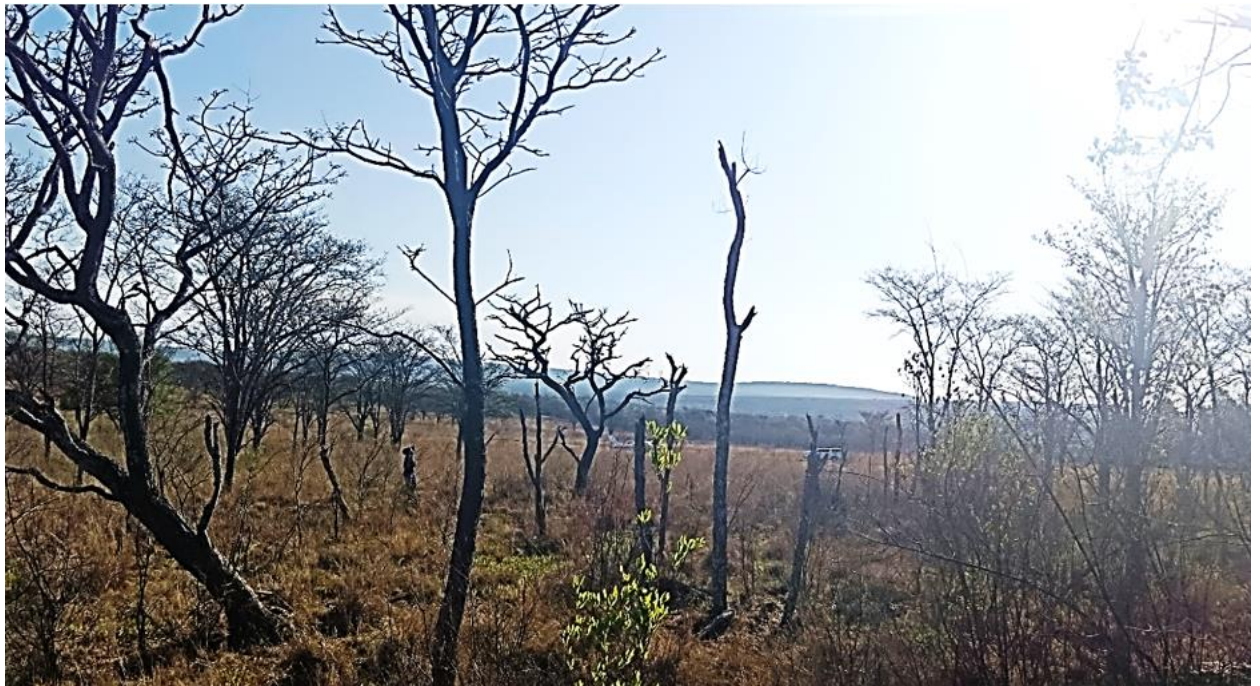
**Figure 3:** The first of the trees that the aircraft impacted.

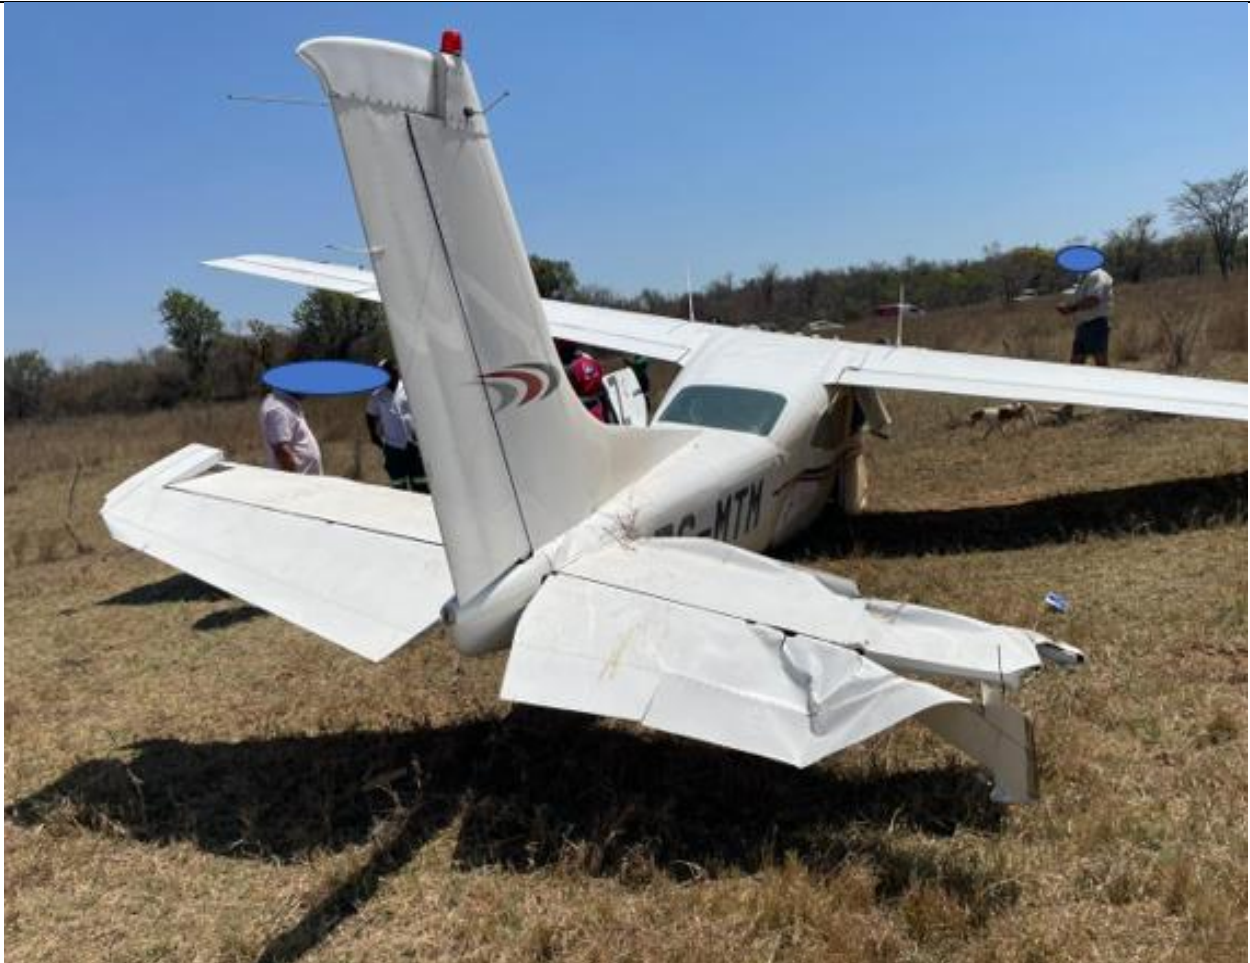
An on-site investigation revealed that the overall condition of the aircraft was intact. The aircraft was found resting on its belly and tilted to the right. The right-wing tip touched the ground, and the left-wing tip was high with all the landing gears fully retracted. No damage was noted on the fuel tanks and no fuel was found in them. The right-side elevator and the control surface sustained damage. No visible damage was noted on the engine. The cockpit inspection revealed the following: the landing gear lever was in the UP position; all flight controls were accounted for and there was continuity with no difficulties in movement; the throttle, although it was bent, it was operative with no restriction on the throttle cable movement.

**Figure 4:** The aircraft as it came to rest at the accident scene. (Source: Pilot)

In-flight engine stoppage due to fuel exhaustion which resulted in an unsuccessful forced landing.

Insufficient or no pre-flight as the aircraft was found without evidence of fuel on-board following the accident and there was no evidence of fuel leak or fuel tank damage.

To avoid injuries or damage to property, pilots are advised to always conduct a proper pre-flight inspection to prevent such accidents.
