LIMITED OCCURRENCE INVESTIGATION REPORT – FINAL

Reference Number	CA18/2/3/10370						
Classification	Accident	Date	30 September 2023	Time	1525Z		
Type of Operation	Commercial (Part 127)						
Location							
Place of Departure	One United Sports Ground in Pine Ridge, Mpumalanga Province		Place of Intended Landing	Burgersfort, Limpopo Province			
Place of Occurrence	On Gazania Street in Pine Ridge Suburb, Emalahleni, approximately 1 nautical mile (nm) north of FAWI, Mpumalanga province						
GPS Co-ordinates	Latitude	25°48'57.38" S	Longitude	029°11'.46.36" E	Elevation	4 908 feet	
Aircraft Information							
Registration	ZS-RXY						
Make; Model; S/N	Robinson Helicopter Company R44; Raven II (Serial Number: 10910)						
Damage to Aircraft	Substantial			Total Aircraft Hours	2 428.4		
Pilot-in-command							
Licence Type	Commercial Pilot Licence (CPL)		Gender	Male		Age	61
Licence Valid	Yes	Total Hours	1 657.2		Total Hours on Type	1 405.1	
Total Hours 90 Days	15.3		Total Flying on Type Past 30 Days		15.3

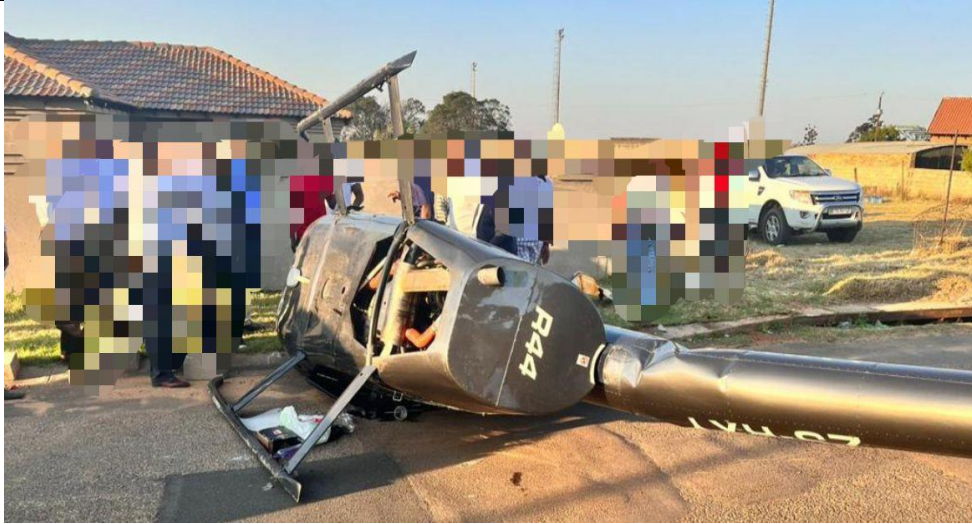
Whilst approximately 30 feet (ft) above ground level (AGL) at a forward speed of approximately 25 knots, the revolutions per minute (RPM) light illuminated which indicated low main rotor RPM, this was followed by the audio warning buzzer. The helicopter lost height and crash-landed on Gazania Street in Pine Ridge before it rolled over to the right. As it rolled, the rotor blades struck the ground. The helicopter came to rest on its right side. The pilot turned off the master and fuel switches. No pre- or post-impact fire was reported. All the occupants disembarked from the helicopter through the left front door and windscreen; they were taken to Emalahleni Hospital for medical assessment. They were later released from hospital; none of them was injured. The helicopter was substantially damaged.

Figure 2: The helicopter at the accident side. (Source: Operator)

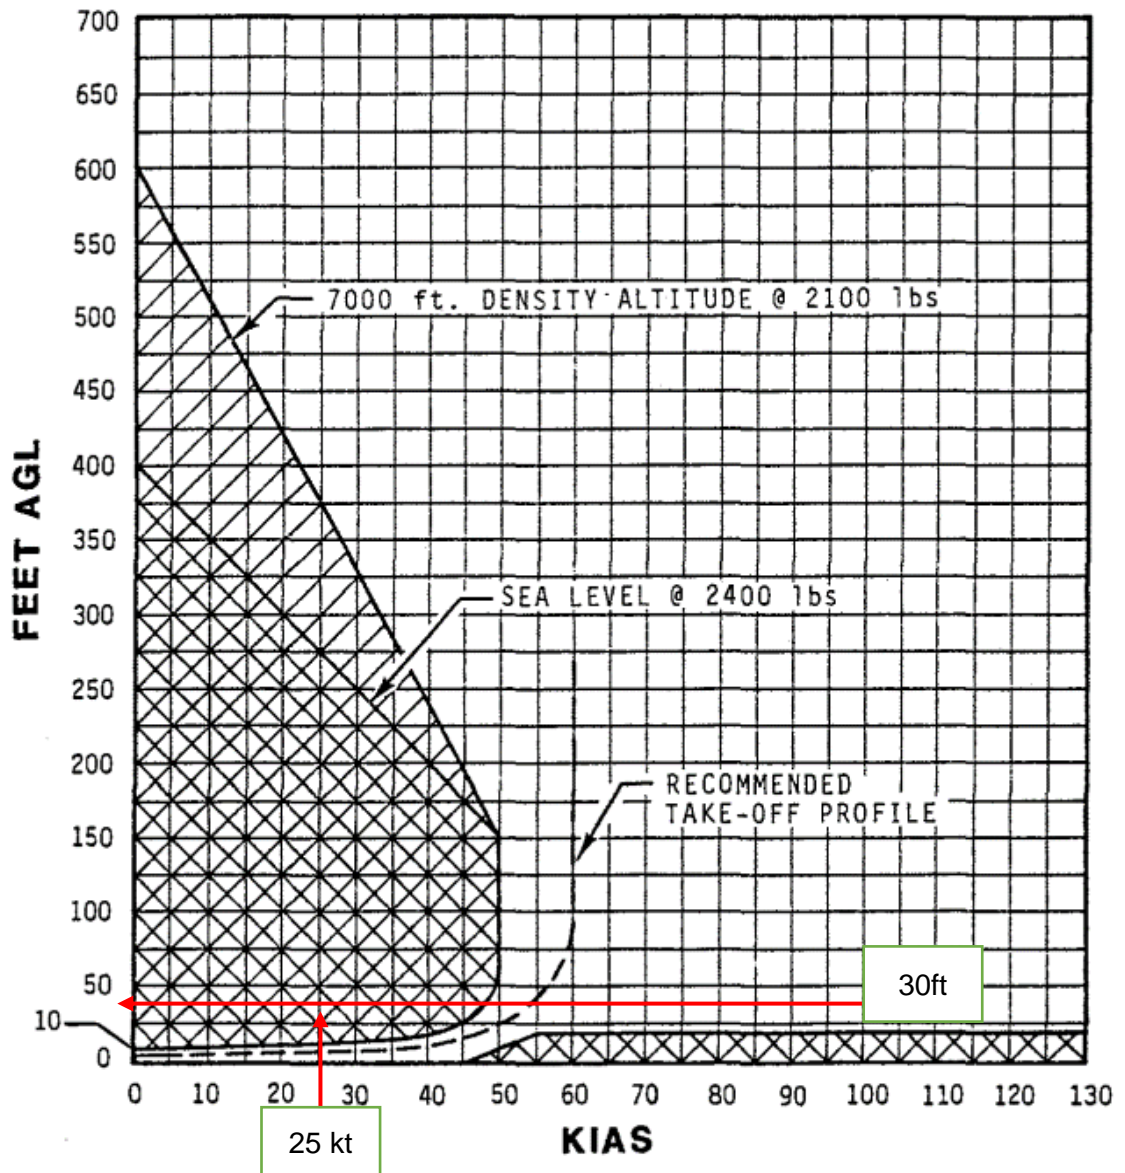
Height-Velocity Diagram for Robinson R44, Raven II

AVOID OPERATION IN SHADED AREAS

12. On the height velocity diagram, it is evident that one needs to increase the air speed or forward speed to 50 knots before attempting a climb out.

The main rotor RPM decayed as the helicopter climbed out before it reached an air speed of 50 knots as outlined in the height velocity diagram; as a result, there was loss of lift and the subsequent crash-landing on the street.

Low-level operation within the danger area of the height velocity diagram.
