LIMITED OCCURRENCE INVESTIGATION REPORT – FINAL

Reference Number	CA18/2/3/10371					
Classification	Accident	Date	5 October 2023	Time	1008Z	
Type of Operation	Private (Part 94)					
Location						
Place of Departure	Potchefstroom Aerodrome (FAPS), North West Province		Place of Intended Landing	Potchefstroom Aerodrome (FAPS), North West Province		
Place of Occurrence	Open field, southwest of FAPS, North West Province					
GPS Co-ordinates	Latitude	26°41'27.90" S	Longitude	027°02'47.63" E	Elevation	4 562 ft
Aircraft Information						
Registration	ZS-GWN					
Make; Model; S/N	Grob Burkhardt Flugzeugbau; Astir CS 77 (Serial Number: 1746)					
Damage to Aircraft	Substantial		Total Airframe Hours	1 633.9		
Pilot-in-command						
Licence Type	Glider Pilot Licence		Gender	Male		Age 50
Licence Valid	Yes	Total Hours	128.6		Total Hours on Type	128.6
Total Hours 90 Days	11.6		Total Flying on Type Past 90 Days		11.6	
People On-board	1 + 0	Injuries	0	Fatalities	0	Other (on ground) 0

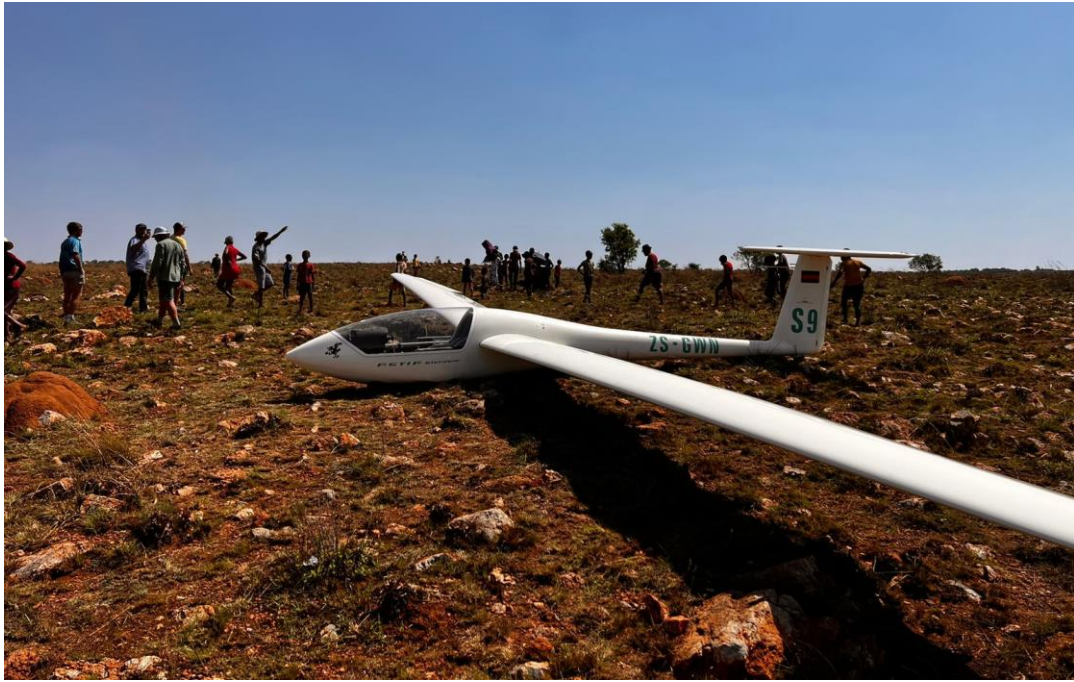
Figure 3: The glider as it came to rest. (Source: Pilot)

The pilot performed an out landing on a rocky terrain which resulted in substantial damage to the glider after failure to obtain sufficient lift to proceed to FAPS to land.

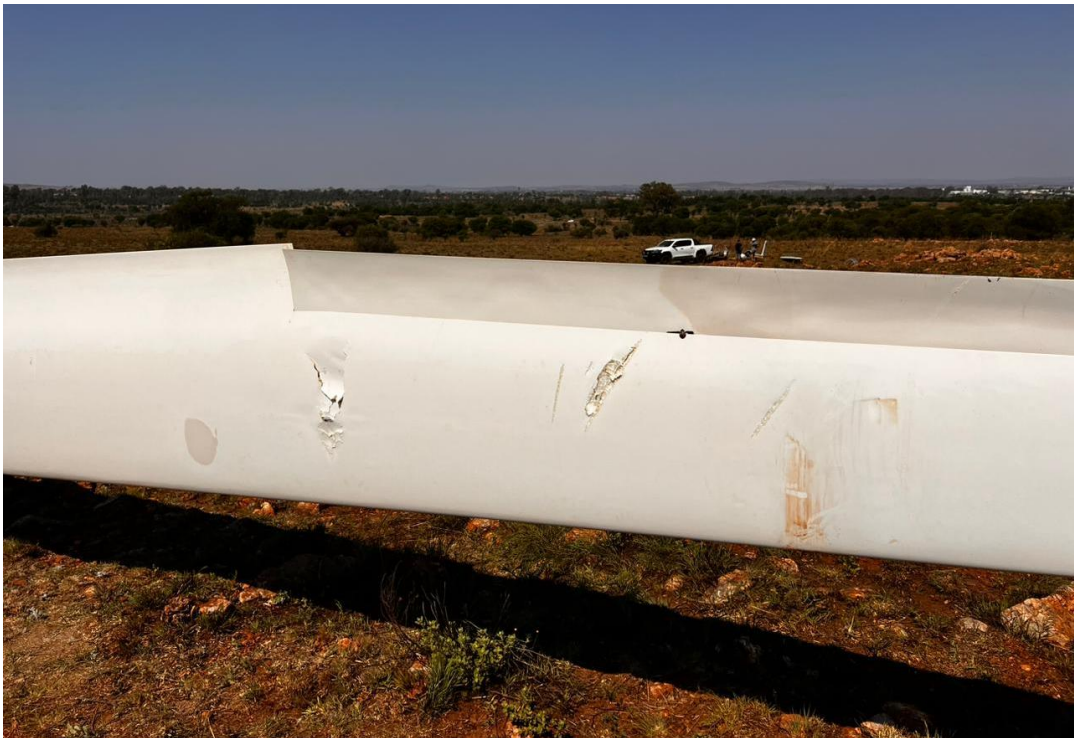
Figure 4: Damage to the right wing. (Source: Pilot)

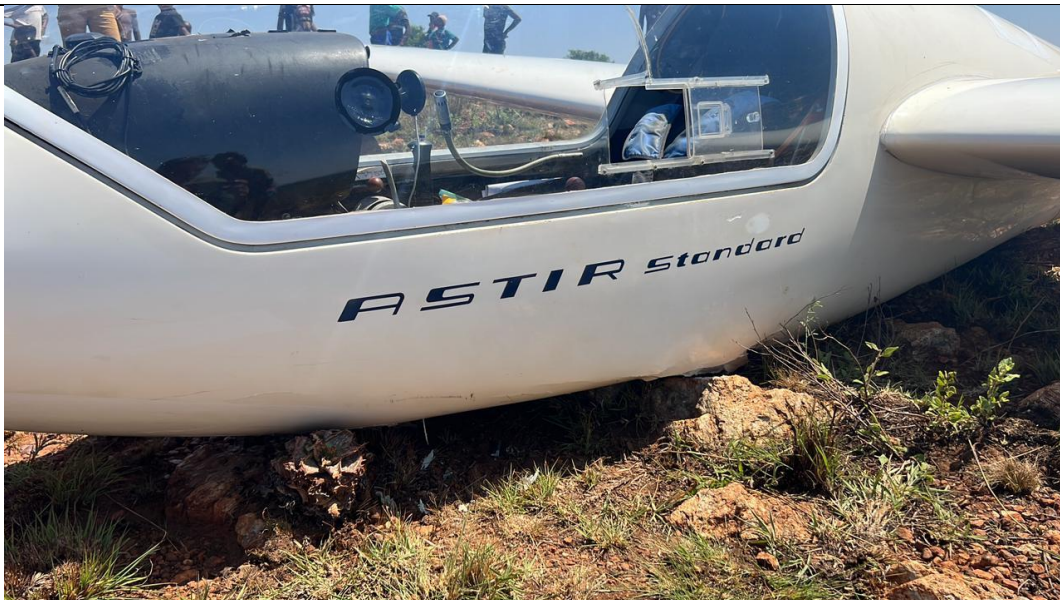
Figure 5: A closer view of the lower fuselage showing damage caused by the rocks. (Source: Pilot)
