AIRCRAFT ACCIDENT REPORT AND EXECUTIVE SUMMARY

Reference:		CA18/2/3/10372	
Aircraft Registration	ZU-ITA	Date of Accident	5 October 2023		Time of Accident	1500Z	
Type of Aircraft	Titan Tornado S		Type of Operation		Private (Part 94)		
Pilot-in-command Licence Type	National Pilot Licence (NPL)		Age	63	Licence Valid	Yes	
Pilot-in-command Flying Experience	Total Flying Hours		1 882.5		Hours on Type	48.7	
Last Point of Departure	Ceres Airfield (FACE), Western Cape Province						
Next Point of Intended Landing	New Tempe Aerodrome (FATP), Bloemfontein, Free State Province						
Damage to Aircraft	Destroyed						
Location of the accident site with reference to easily defined geographical points (GPS readings if possible)							
Bushy terrain near a farm located west of Ceres Airfield at Global Positioning System (GPS) co-ordinates determined to be 33°19'14" South 19°25'4" East, at an elevation of 1 480 feet (ft)							
Meteorological Information	Wind direction: 180°; Wind speed: 08kts; Temperature: 21°C; Dew Point: 16°C; Cloud Cover: Scattered (SCT); Cloud Base: 4 000; Visibility: CAVOK; QNH: 1015hPa

Reference Number : CA18/2/3/10372
Occurrence Category : Category 1
Type of Operation : P

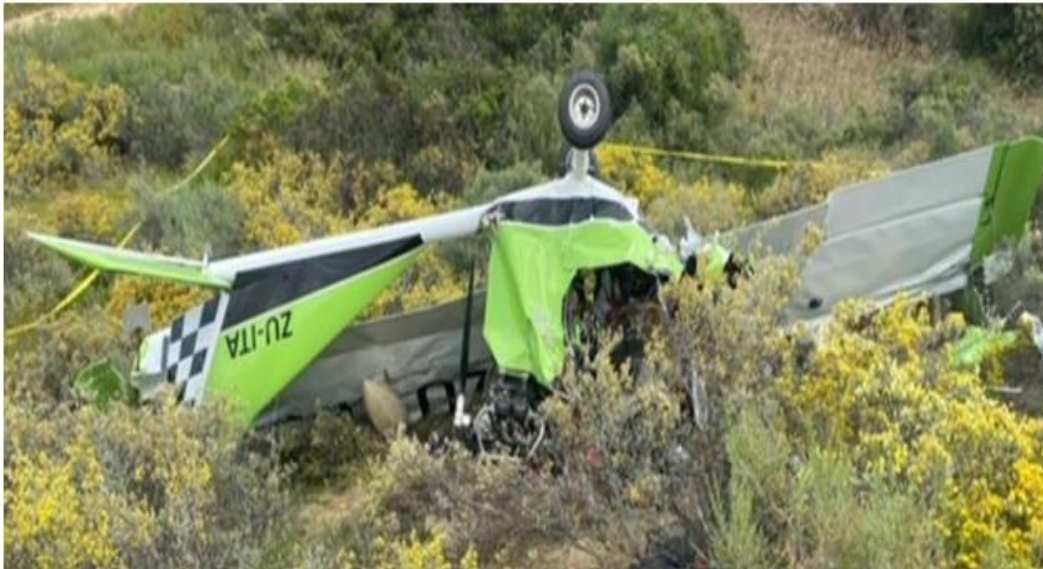
1.3.1. The aircraft was destroyed by impact forces.

Figure 2: The aircraft at the accident site.

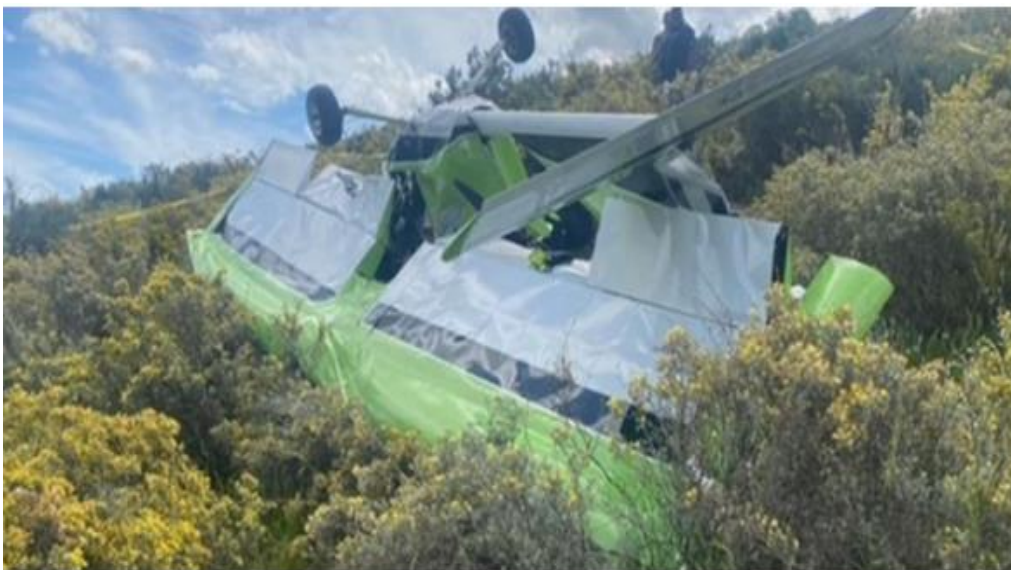
1.12.1. The aircraft impacted the ground in a nose-down attitude and came to rest in an inverted attitude at 203° magnetic heading. The continuity of the flight controls was checked, and no anomalies were found. The wings were found separated from their mounting points, the flaps were selected to 15°, the main landing gears and wheel assemblies were intact, and the tyres were sufficiently inflated.

Figure 4: The aircraft in an inverted attitude.

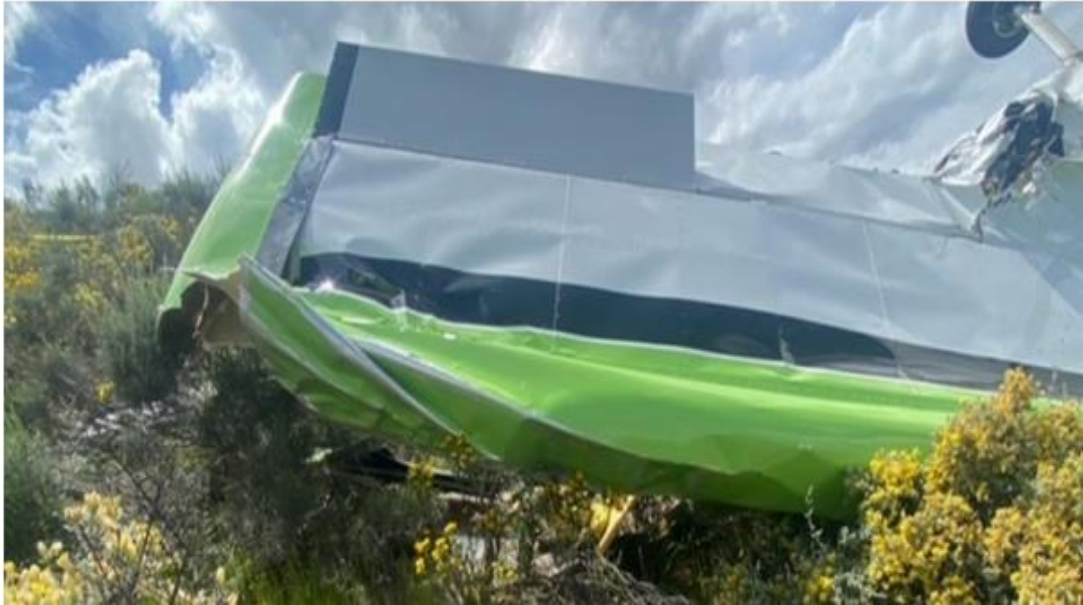
Figure 5: The damaged right-wing tip.

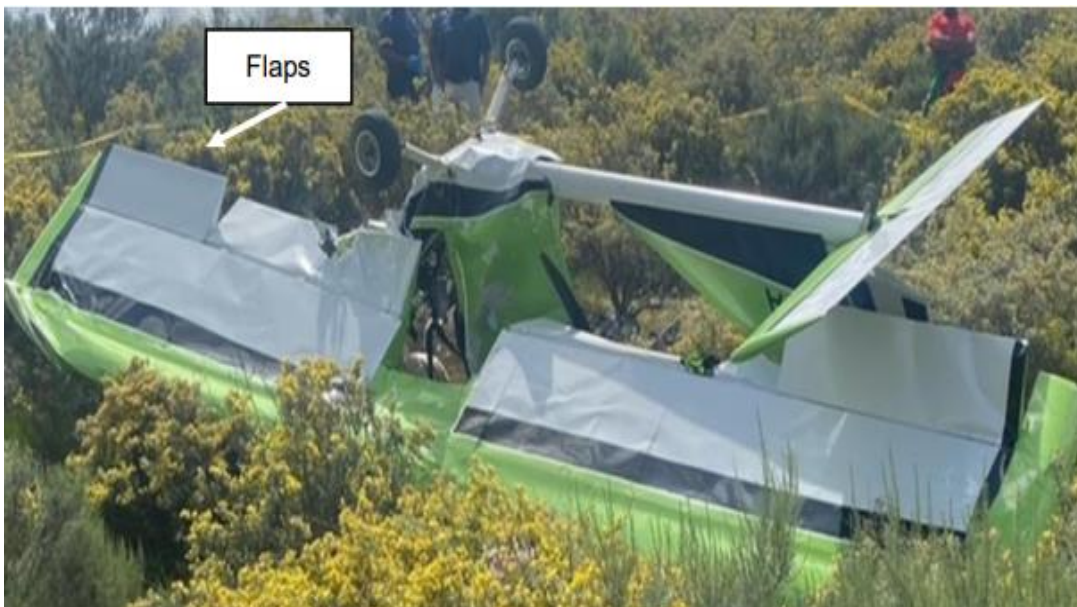
Figure 6: The damaged wings.

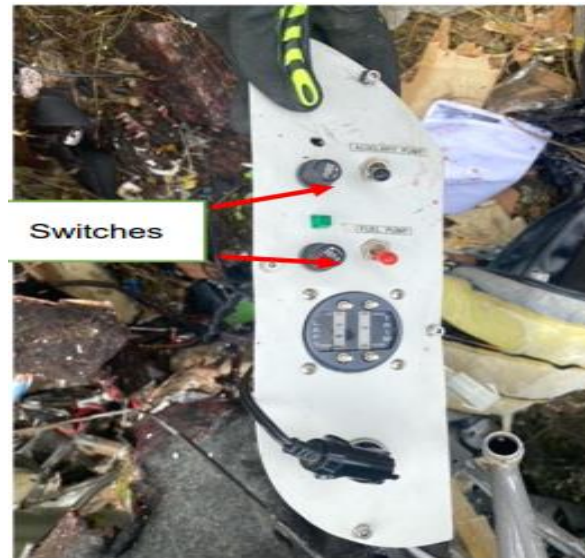
1.12.2. Both fuel tanks contained sufficient fuel. The instruments were substantially damaged; they had separated from the instrument panel during the accident. The auxiliary and fuel pump switches were found in the “OFF” position.

Figure 7: Auxiliary and fuel pump switches in OFF positions (red arrows).

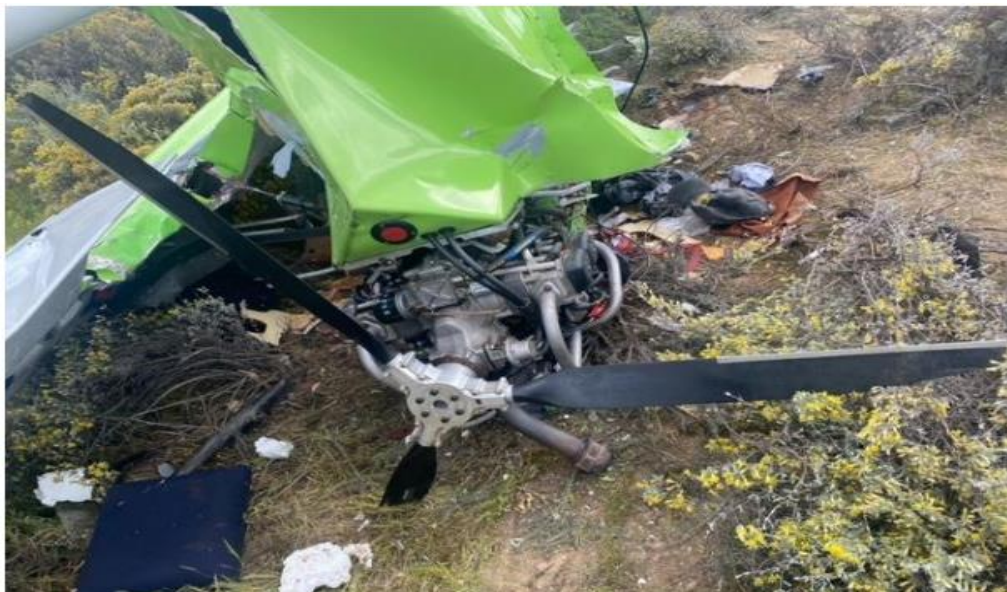
1.12.3. The on-site examination of the propeller indicated that the engine was not delivering power at the time of impact. Most of the engine components were still attached to the crankcase, except for the carburettor that had dislodged after impact. The fuel filter contained adequate amount of fuel which was free of contaminants.

Figure 8: The damaged engine and propeller.

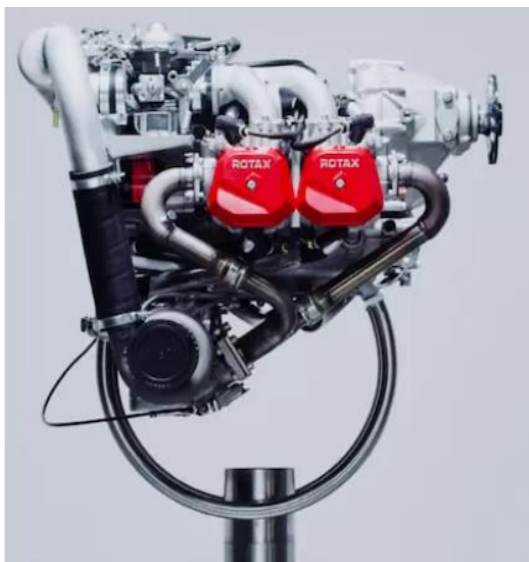
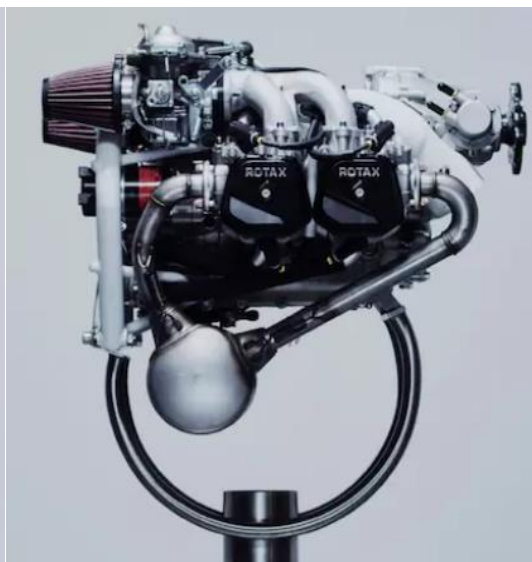
- I. The engine was modified from its original configuration of 914UL turbo-charged (115 horsepower) to 912UL (80 horsepower). Rotax does not approve such modifications. The provisions of Part 44.01.10 of the CAR 2011 were contravened.
- II. The engines are identical, the only difference is the performance. The 914UL is 115 horsepower (hp) while the 912UL is 80 horsepower.

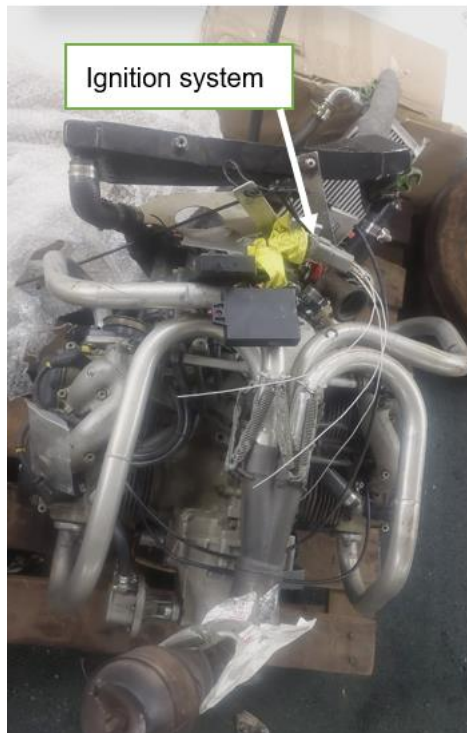
- IV. A test of the ignition system was not possible due to the unapproved modifications.
- V. The carburetors were dismantled and examined, revealing no signs of component failure.

Figure 11: An unauthorised modification found on the ignition system.

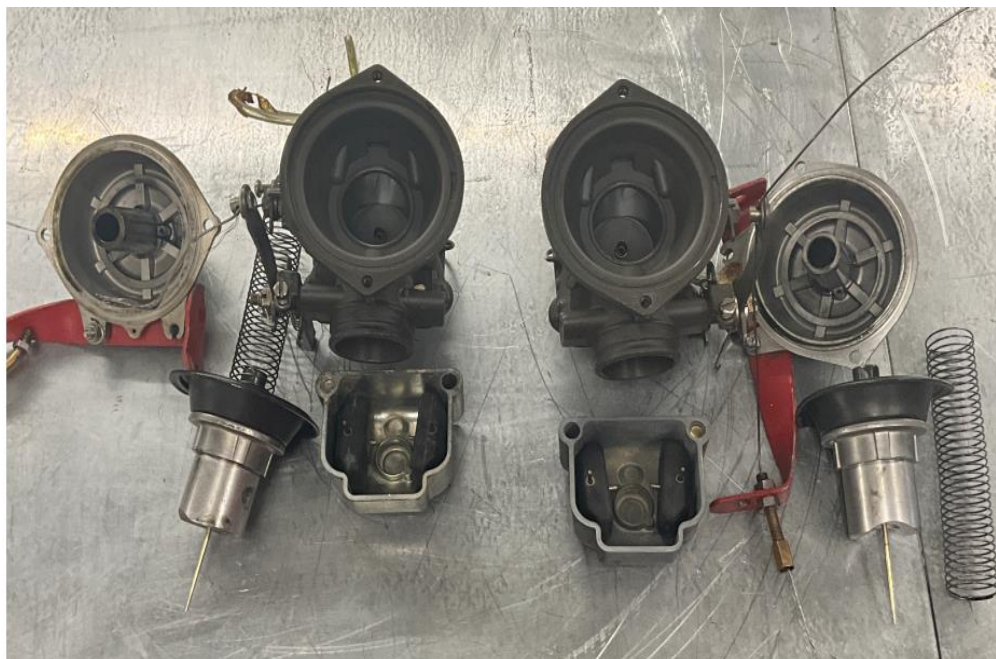
Figure 12: Dismantled carburetors.

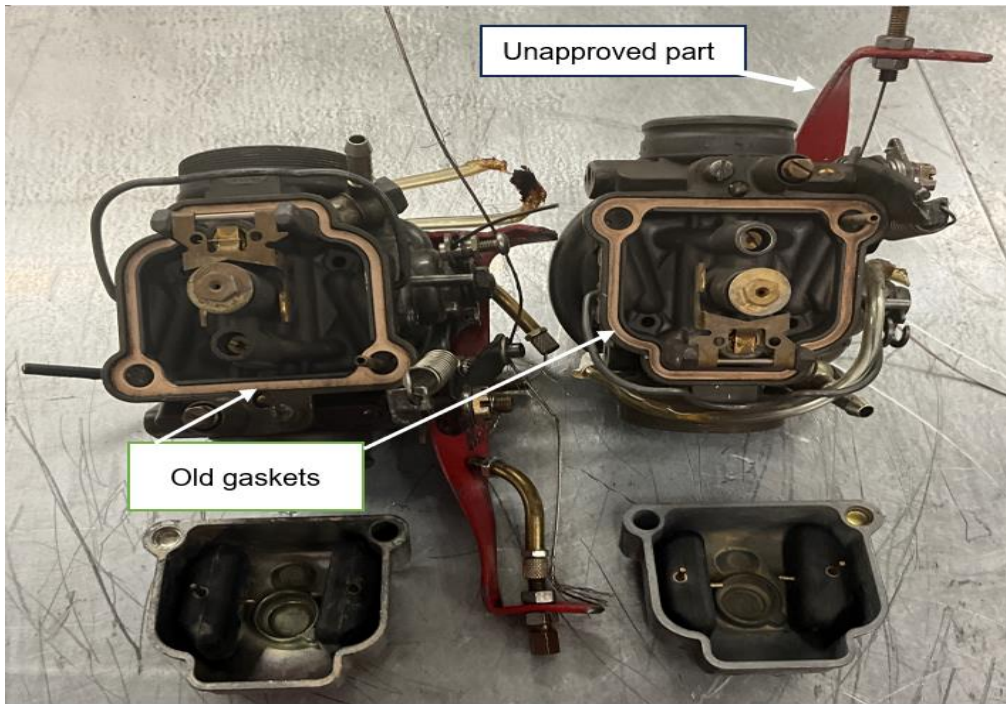
- VI. The float chambers had the old version of the floating gasket, which is no longer in use, this indicated that the specified 200-hour inspections of the carburetors were not done. The parts in red, are not from the manufacturer, and the attached cables are incorrectly installed. In case they fail they would cut off the engine instead of letting the engine run.

Figure 13: Old gaskets on the carburetors.
