**LIMITED OCCURRENCE INVESTIGATION REPORT – FINAL**

<b>Reference Number</b>	CA18/2/3/10373						
<b>Classification</b>	Accident	<b>Date</b>	6 October 2023		<b>Time</b>	1530Z	
<b>Type of Operation</b>	Private (Part 91)						
<b>Location</b>							
Place of Departure	New Tempe Aerodrome (FATP), Free State Province		Place of Intended Landing	Treverton College Airstrip, KwaZulu-Natal Province			
Place of Occurrence	Treverton College Airstrip in Mooi River, KwaZulu-Natal Province						
GPS Co-ordinates	Latitude	29°11'34.95" S	Longitude	030°00'36.83" E	Elevation	4 615 ft	
<b>Aircraft Information</b>							
Registration	ZS-CFN						
Make; Model; S/N	Cirrus Aircraft; SR22 (Serial Number: 0645)						
Damage to Aircraft	Substantial			Total Aircraft Hours	3 341.9		
<b>Pilot-in-command</b>							
Licence Type	Private Pilot Licence (PPL)		Gender	Male		Age	33
Licence Valid	Yes	Total Hours	973.8		Total Hours on Type	901.7	
Total Hours Past 30 Days	60.3		Total Flying Hours on Type Past 90 Days	62

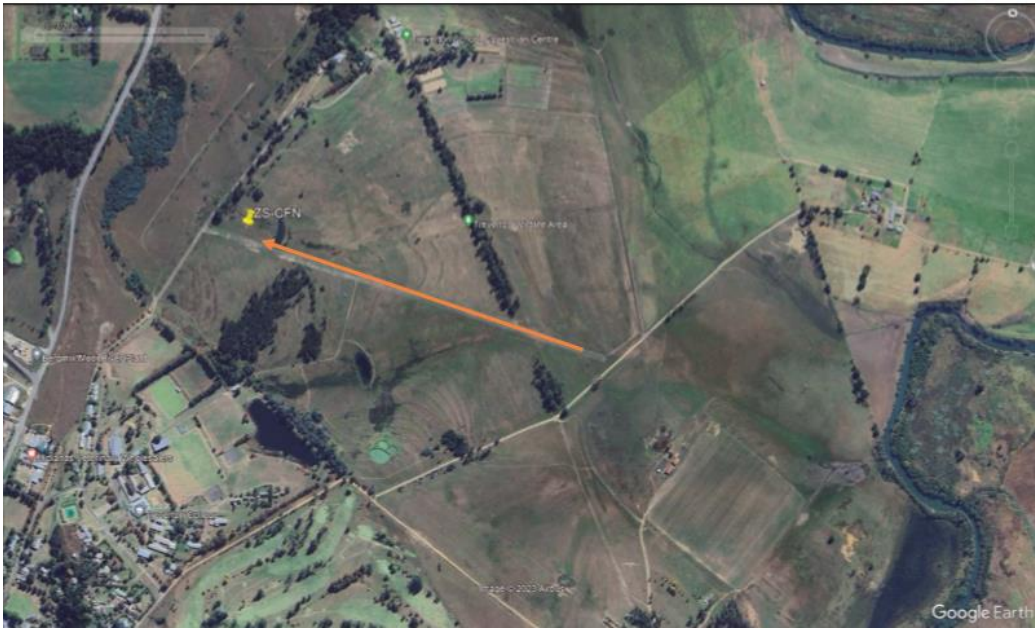
**Figure 1:** Aerial view of the accident site. The orange arrow indicates direction of landing. (Source: Google Earth)

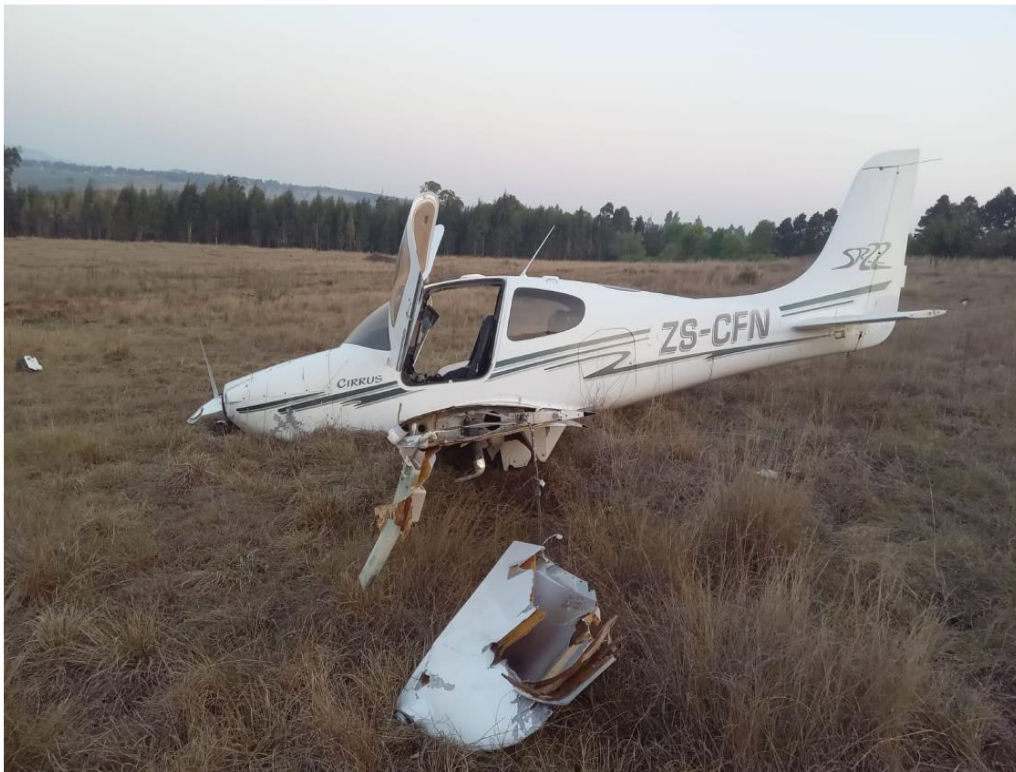
**Figure 2:** The aircraft as it came to rest after the accident. (Source: Pilot)

The aircraft was in a landing configuration with full flaps and, as a result, it did not gain sufficient speed for the pilot to initiate a successful go-around. The aircraft stalled and crashed on the right side of the runway.
