LIMITED OCCURRENCE INVESTIGATION REPORT – FINAL

Reference Number	CA18/2/3/10374						
Classification	Accident	Date	10 October 2023	Time	1240Z		
Type of Operation	Private (Part 94)						
Location							
Place of Departure	Karoo Gateway Airport (FABW), Western Cape Province		Place of Intended Landing	Upington International Airport (FAUP), Northern Cape Province			
Place of Occurrence	R381 road between Loxton and Beaufort West, Western Cape Province						
GPS Co-ordinates	Latitude	32° 00' 20.85" S	Longitude	022° 25' 47.83" E	Elevation	4 874 feet	
Aircraft Information							
Registration	ZU-ITU						
Make; Model; S/N	Kitplanes for Africa; Safari (Serial Number: 054-05-20 SAF3)						
Damage to Aircraft	Substantial		Total Aircraft Hours	75.8			
Pilot-in-command							
Licence Type	Private Pilot Licence (PPL) Aeroplane		Gender	Male	Age	65	
Licence Valid	Yes	Total Hours	1 330	Total Hours on Type	100.2		
Total Hours 30 Days	5.2		Total Flying on Type Past 90 Days	12.2

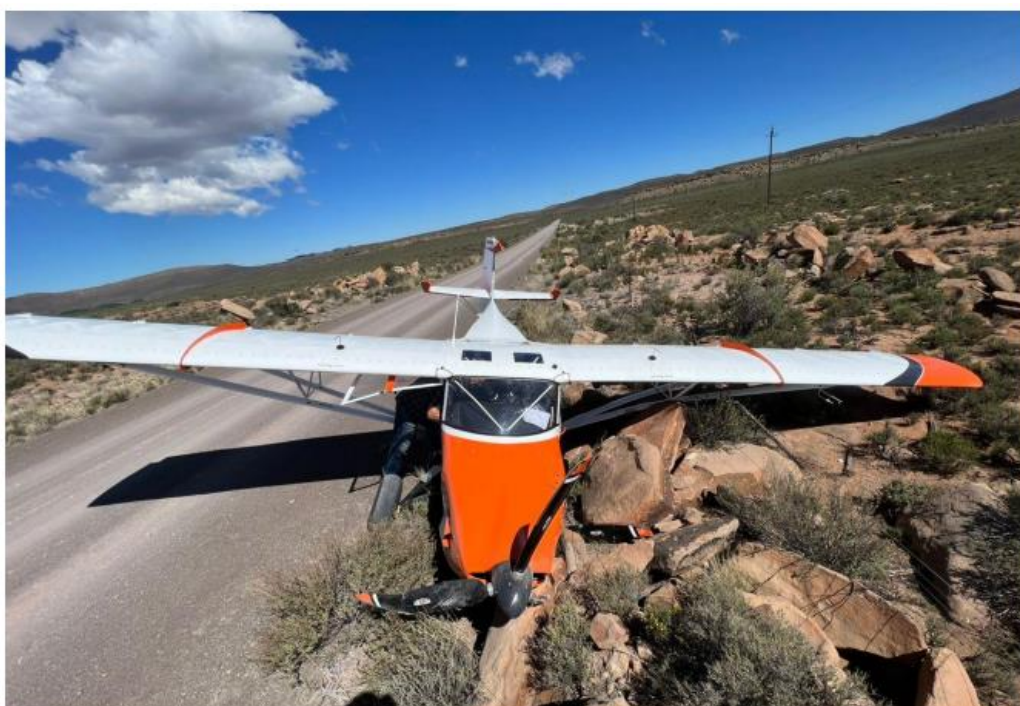
Western Cape province. After touch down on the road, the aircraft drifted slightly to the right due to the camber (bend) of the road. The pilot then steered the aircraft to bring it to the centre of the road, however, the aircraft impacted some rocks which brought it to a stop. Both occupants exited the aircraft unassisted and uninjured.

Figure 2: The ZU-ITU as it came to rest next to the road. (Source: ARCC)

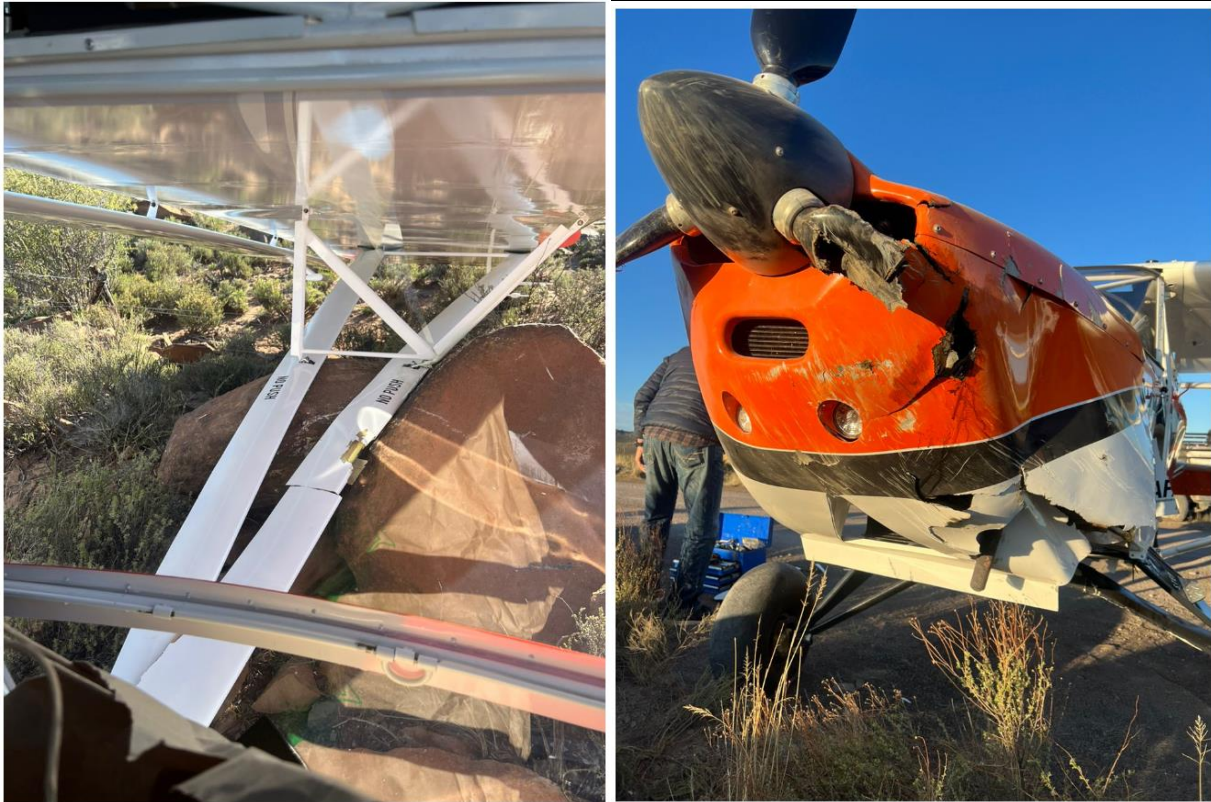
The aircraft sustained damage to the propeller, airframe and the undercarriage. The accident occurred 21 nautical miles (nm) north-west of FABW.

Figures 3 and 4: Damage to the left-wing support structure (left) and the engine cowling and propeller blades (in a coarse pitch position) (right). (Source: ARCC)

The pilot left the position of the blades in a coarse pitch and did not adjust the pitch manually or set the controller to manual but rather left it in auto and attempted to re-set by switching the controller to the “OFF” and “ON” positions whilst the controller was in auto. This aggravated the situation as the propeller runs through a sequence of pitching coarser and then finer until it settles at the desired position for the rpm and throttle setting. It ended up pitching very coarse and, thereby, overloading the engine, resulting in the engine losing power. The pilot should have switched the controller to manual mode and continued to use the propeller as a standard variable pitch propeller.

5. The pilot did not adjust the pitch manually or set the controller to manual, but rather left it in auto mode and attempted to re-set the electronic propeller pitch controller. This aggravated the situation as the propeller rotates (runs) through a sequence of pitching coarser and then finer, until it settles at the desired position for the rpm and throttle setting. The propellers ended up pitching very coarse and, thereby, overloading the engine. Hence, the subsequent loss of power.

Engine power loss in-flight due to the propeller blades which were in coarse pitch; this resulted in engine overload and an unsuccessful forced landing.
