AIRCRAFT ACCIDENT REPORT AND EXECUTIVE SUMMARY

Reference:	CA18/2/3/10375		
Aircraft Registration	ZS-JTW	Date of Accident	11 October 2023		Time of Accident	0430Z	
Type of Aircraft	Piper Pawnee PA-25-260		Type of Operation		Training (Part 141)		
Pilot-in-command Licence Type	Commercial Pilot Licence (CPL)		Age	22	Licence Valid	Yes	
Pilot-in-command Flying Experience	Total Flying Hours		286.6	Hours on Type	20.1		
Last Point of Departure	Kroonstad Airfield (FAKS), Free State Province						
Next Point of Intended Landing	Kroonstad Airfield (FAKS), Free State Province						
Damage to Aircraft	Destroyed						
Location of the accident site with reference to easily defined geographical points (GPS readings if possible)							
On an open field at GPS co-ordinates 27° 40' 15.66" South 027°19' 30" East, elevation 4 582 feet							
Meteorological Information	Surface wind: 020°/ 5 kt; temperature: 19°C; dew point: 12°C; CAVOK						
Number of People On-board	1 + 0	Number of People Injured	0	Number of People Killed	1	Other (On Ground)	0

Synopsis

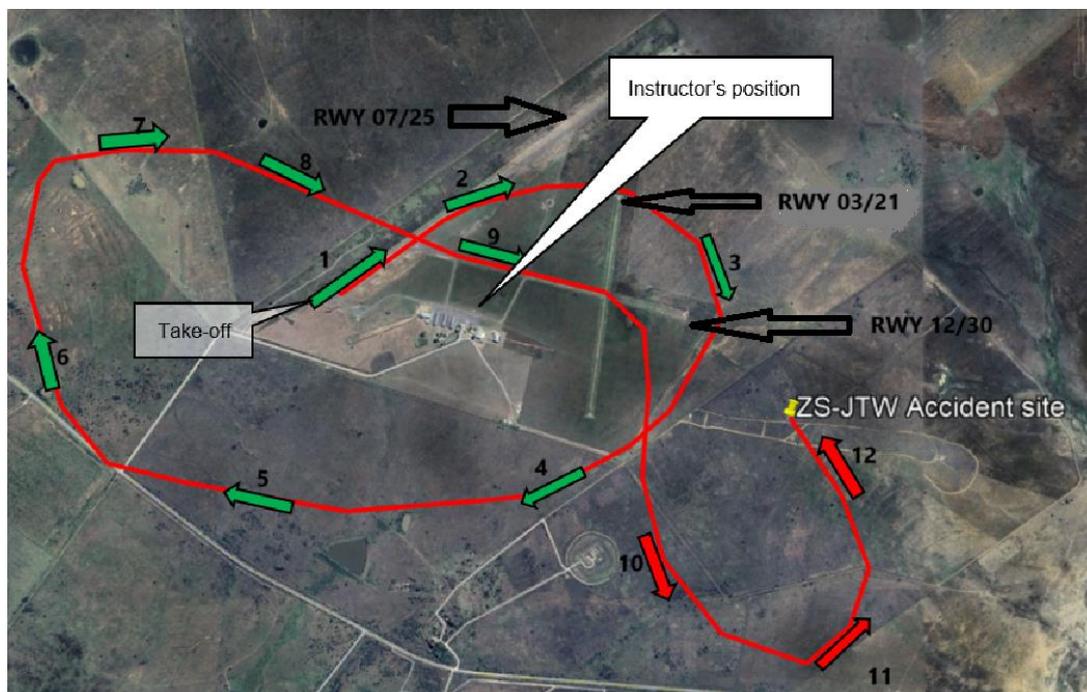
Figure 1: Aerial view of the accident site. The labelled arrows show the direction of flight.

- 2.2.5 On the day of the accident, the pilot took off from RWY07 and followed the sequence reflected in Figure 1. She climbed to 300ft AGL. At arrow number 8, the pilot descended to 6ft AGL to commence a spray run and was communicating with the instructor. During this sequence, the aircraft was at 2500 rpm as per the training. Towards the end of the runway, the aircraft should climb and complete a teardrop turn to the left at 300ft AGL and, thereafter, proceed to commence descent once in line with RWY30.

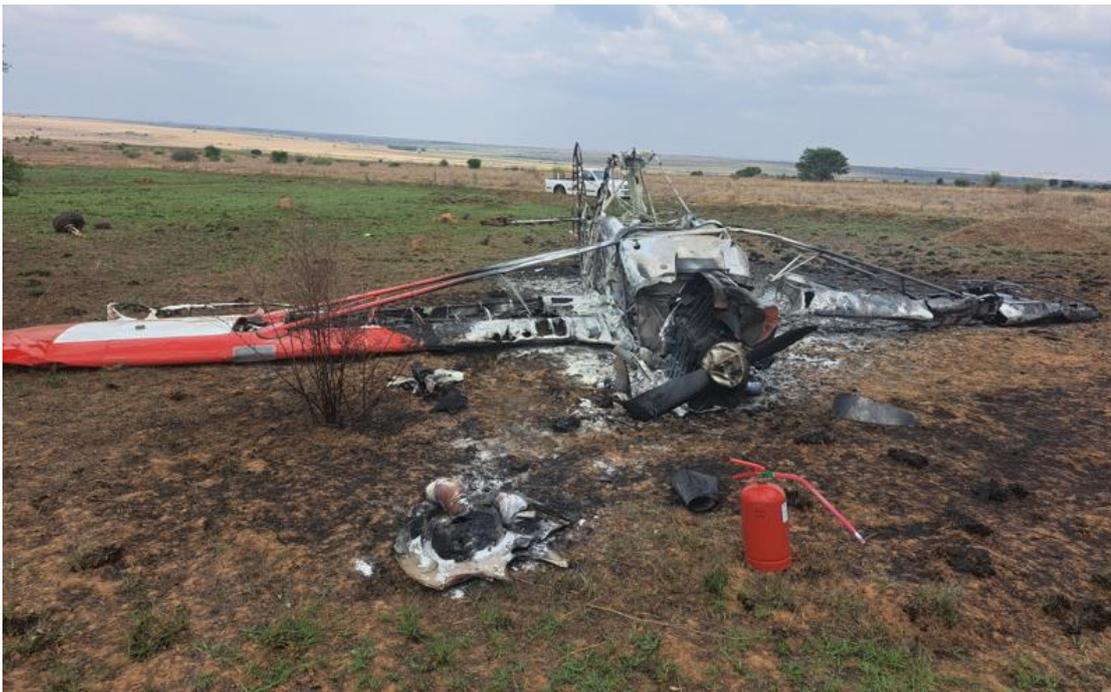
1.3.1 The aircraft was destroyed by impact forces and the post-impact fire.

Figure 2: The wreckage in an upright position after the accident.

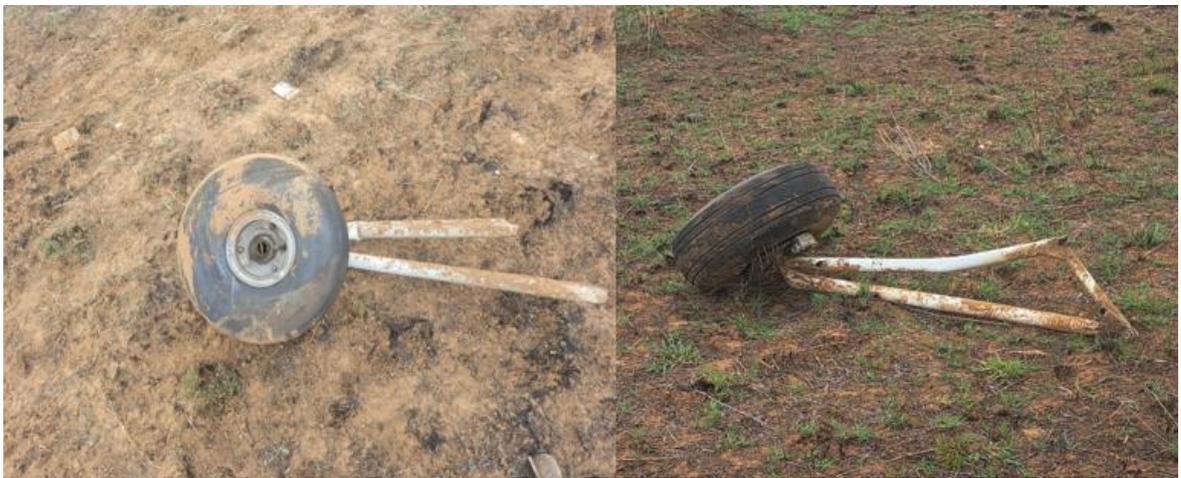
- 1.12.2 When the aircraft impacted the ground, the main landing gear and the crop-spraying system broke off. One of the propeller blades was found curled backwards but still attached to the engine. The second propeller blade's tip had also curled backwards but was severed from the engine; it was found near the wreckage. The engine, including the two magnetos, was substantially damaged towards the rear section as a result of the fire. The auxiliary tanks on both wing tips were not damaged; they were found empty. The cables of the control columns were relatively intact. A continuity test was conducted on-site, and all the control cables moved freely.

Figures 4 and 5: The left and right landing gears at the accident site.

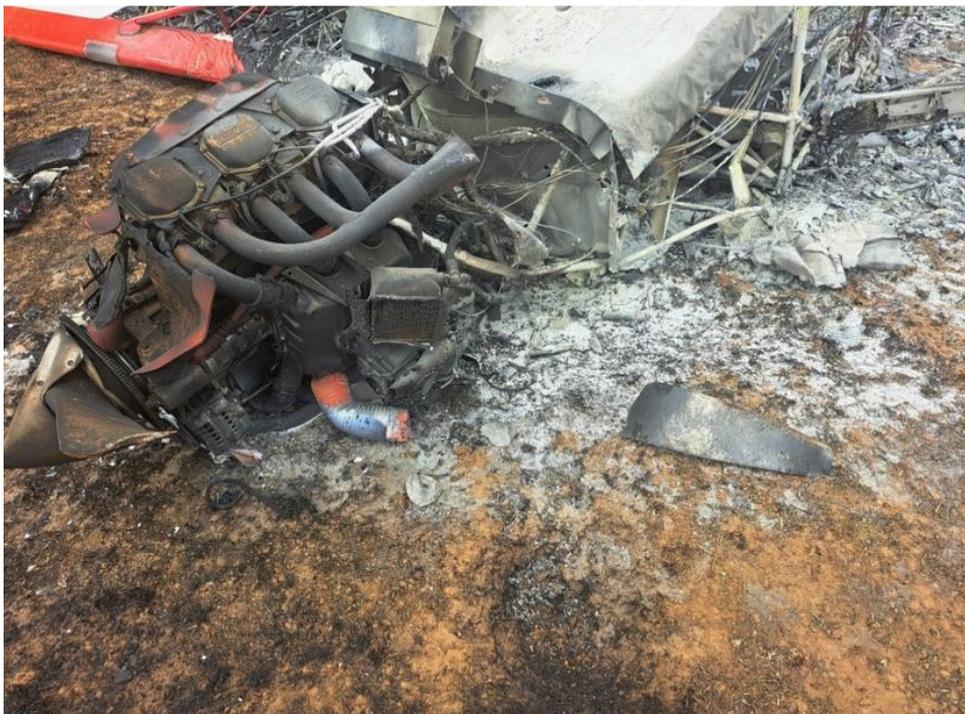
Figure 6: The propeller blade tip was located on the left side of the engine.

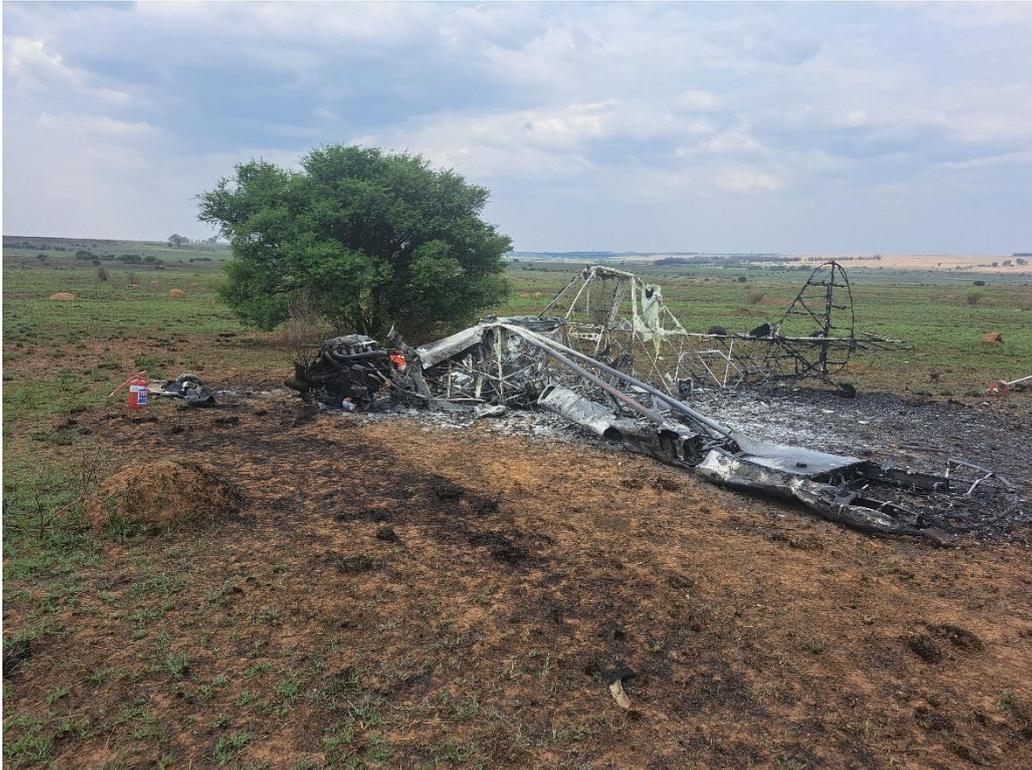
Figure 7: The aircraft as it came to rest in an upright position.

- 2.2.6 According to the instructor, the pilot was slow in making the 45-degree turn, and the aircraft disappeared from his line of sight. The instructor did not see the aircraft in a wings level position. He then heard a loud bang which was followed by smoke, 10 seconds later. It is likely that during the left turn, the pilot did not apply co-ordinated controls which likely resulted in the aircraft skidding. *In a skid turn, the outer wing generates more lift than the inner wing. If the pilot tries to use aileron input to raise the inner wing, the elevator deflection would increase the angle-of-attack on the inner wing and cause it to stall. During the stall, recovery would have required that the pilot pushes the elevator forward which would result in loss of height. At a low altitude, the pilot would not have been able to recover, and impact would be inevitable.* The aircraft impacted the ground with the undercarriage first and came to rest in a level

position, which suggests that it is possible the pilot recovered to a wings level position prior to impact.

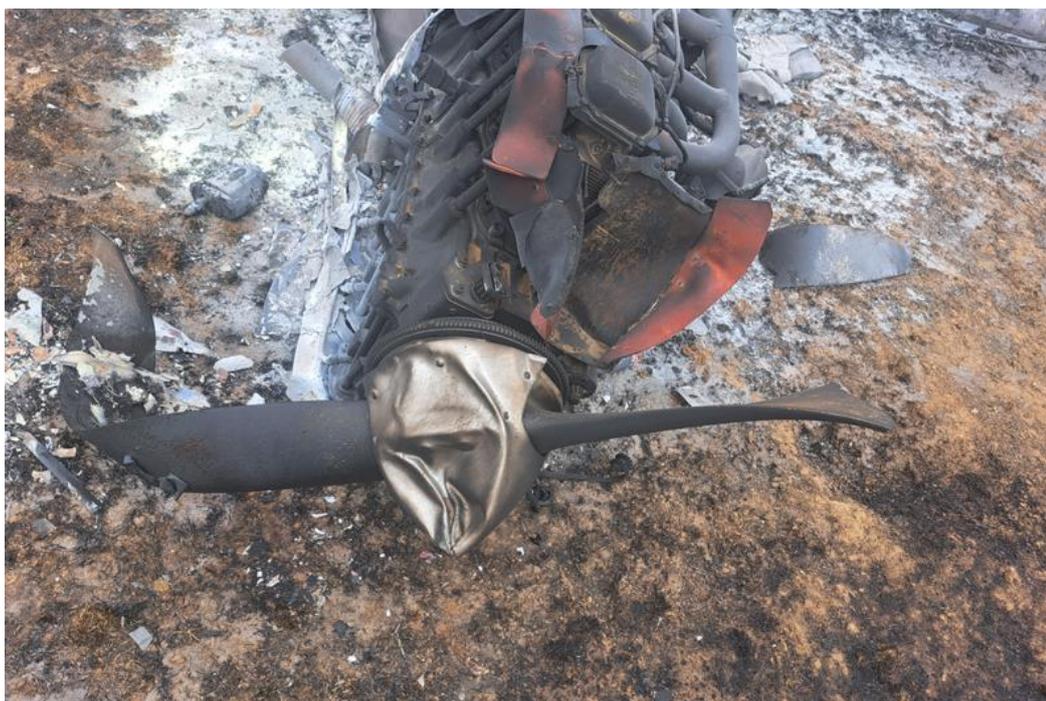
not at full power. The starter motor moved freely when examined, and all the spark plugs were in good condition. The damage sustained by the propeller blades (Figure 8) indicated that the propeller was producing power at the time of impact.

Figure 8: The bent propellers. The engine was producing power at the time of impact.

- 2.2.3 The starter motor moved freely when examined, and all the spark plugs were in good condition. The damage sustained by the propeller blades indicated that the engine was producing power during the impact sequence. One of the propeller blades was found curled backwards and still attached to the engine. The second propeller blade's tip was severed and was found near the wreckage. The engine sustained major damage towards the rear section, including the two magnetos, because of the fire.

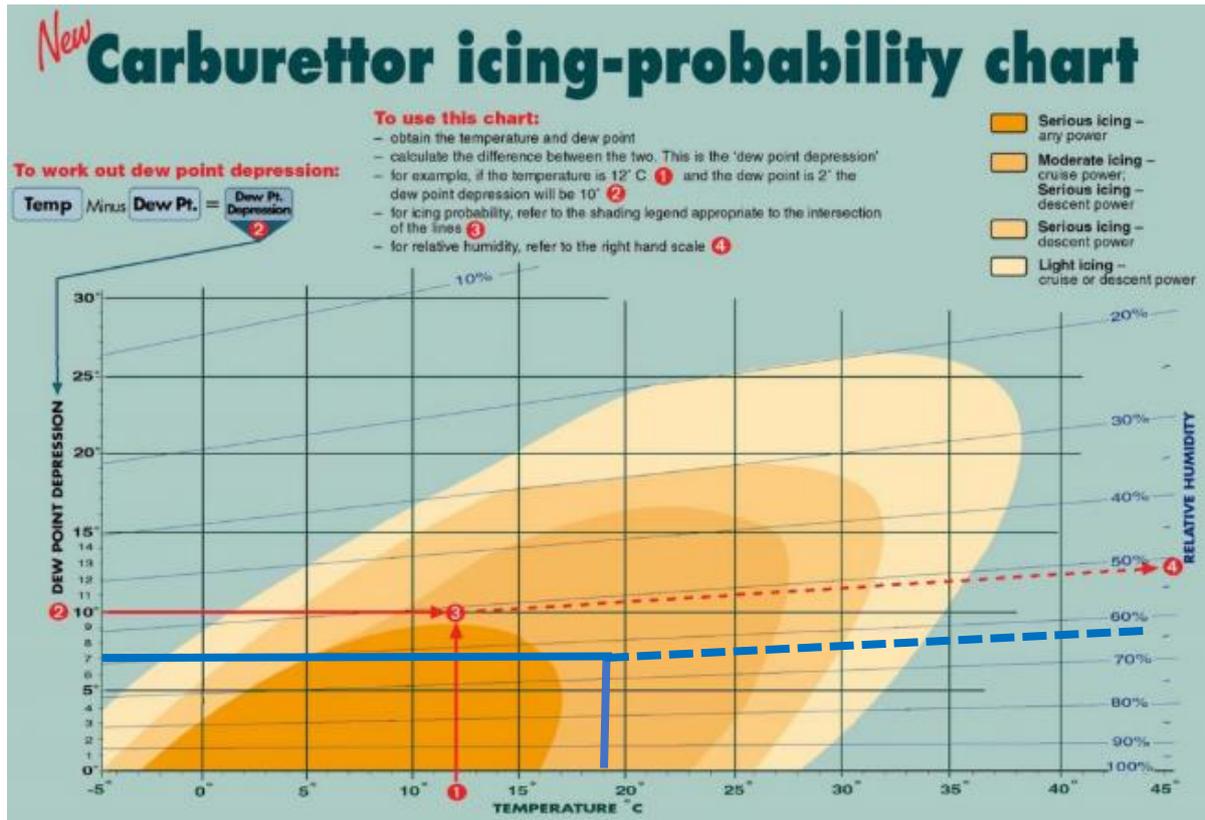
Figure 11: Carburettor icing chart.

1.19.3 The above carburettor icing chart indicates the dew point depreciation of 7°C. A temperature of 19°C gives a relative humidity of 62% and a moderate icing probability at descent power setting. As per the training syllabus, spray runs are conducted at 2500 rpm.

2.2.7 Carburettor icing was a low possibility as the exercise is conducted at high-power setting.
