AIRCRAFT ACCIDENT REPORT AND EXECUTIVE SUMMARY

Reference:		CA18/2/3/10376	
Aircraft Registration	ZS-UJM	Date of Accident	14 October 2023		Time of Accident	0653Z	
Type of Aircraft	Jodel F12A			Type of Operation	Private (Part 94)		
Pilot-in-command Licence Type	Private Pilot Licence		Age	68	Licence Valid	Yes	
Pilot-in-command Flying Experience	Total Flying Hours		2 149.0		Hours on Type	unknown	
Last Point of Departure	Springs Aerodrome (FASI), Gauteng Province						
Next Point of Intended Landing	Springs Aerodrome (FASI), Gauteng Province						
Damage to Aircraft	Destroyed						
Location of the accident site with reference to easily defined geographical points (GPS readings if possible)							
Springs Aerodrome (GPS position: 26°15'02.50" South 028°24'02.95" East) at an elevation of 5 340 feet (ft)							
Meteorological Information	Surface wind: 150°/6kt, temperature: 15°C, dew point: 4°C, CAVOK						
Number of People On-board	1 + 1	Number of People Injured	0	Number of People Killed	2	Other (On Ground)	0

Probable Cause							
The aircraft experienced an in-flight structural failure when the main wing spar failed during flight, which resulted in a loss of control and the subsequent

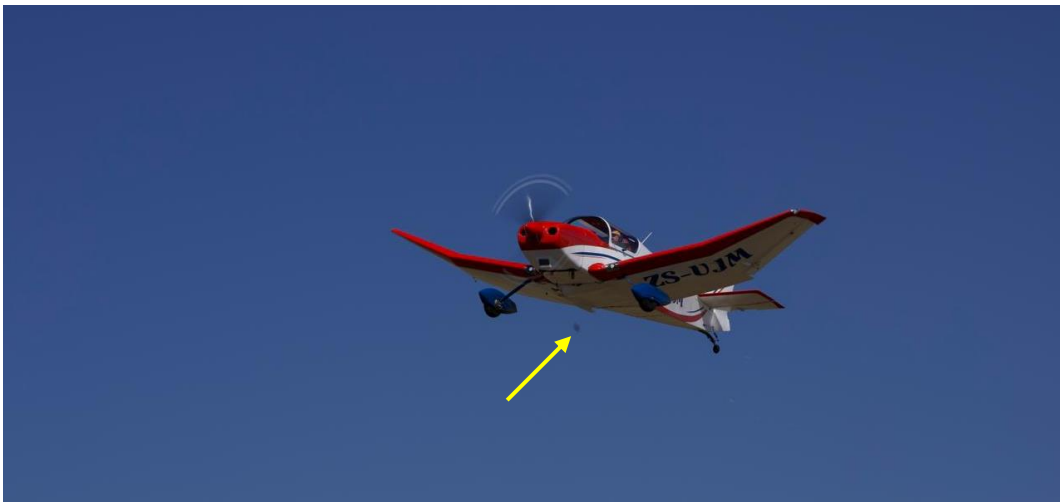
Figure 1: First piece of debris seen falling (arrow) from the aircraft. (Source: Mr. S. Fletcher)

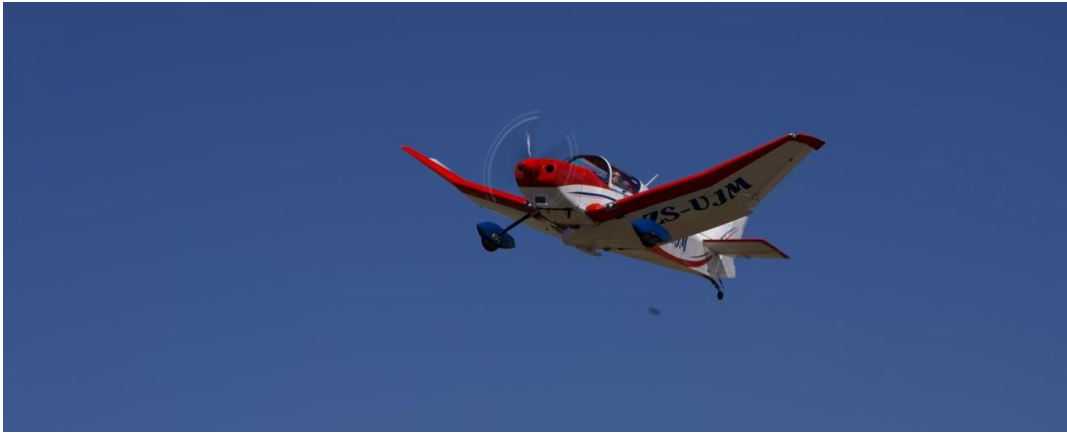
Figure 2: The wings start to cone upwards. (Source: Mr. S. Fletcher)

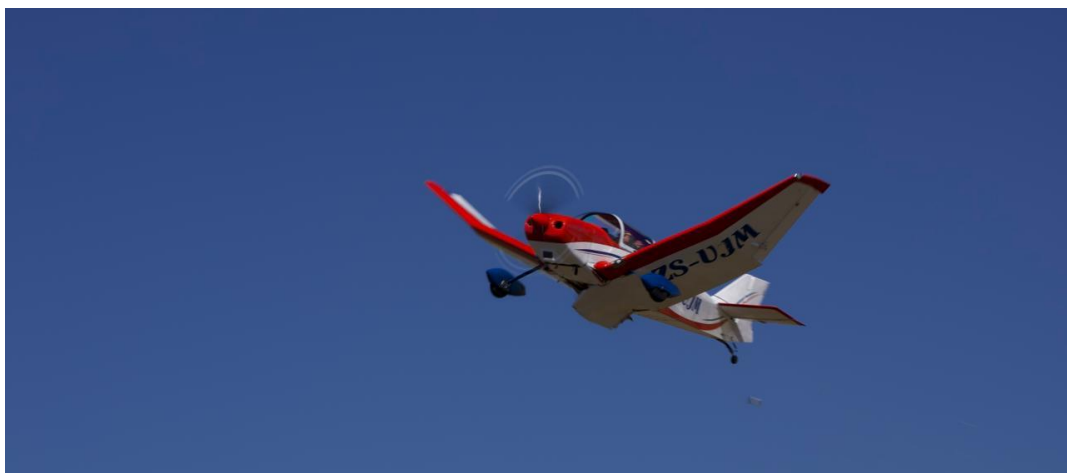
Figure 3: The wings continue to cone upwards. (Source: Mr. S. Fletcher)

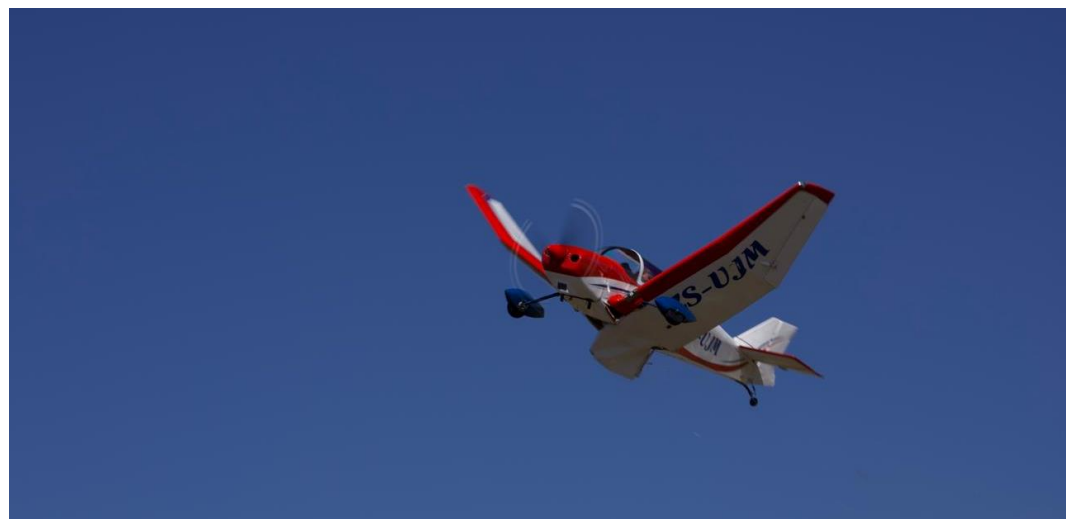
Figure 4: The wings continue to cone upwards. (Source: Mr. S. Fletcher)

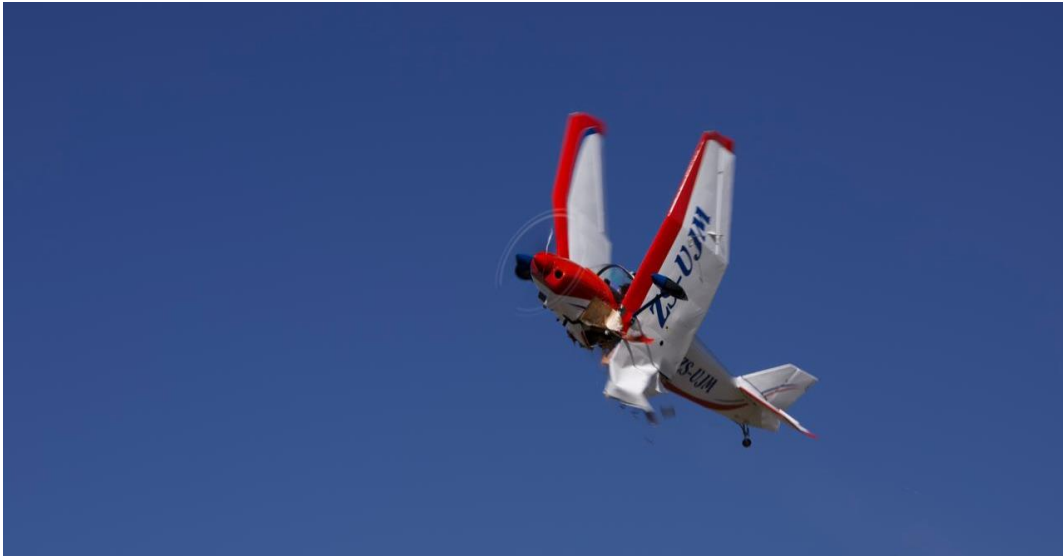
Figure 5: The wings in a near-vertical position. (Source: Mr. S. Fletcher)

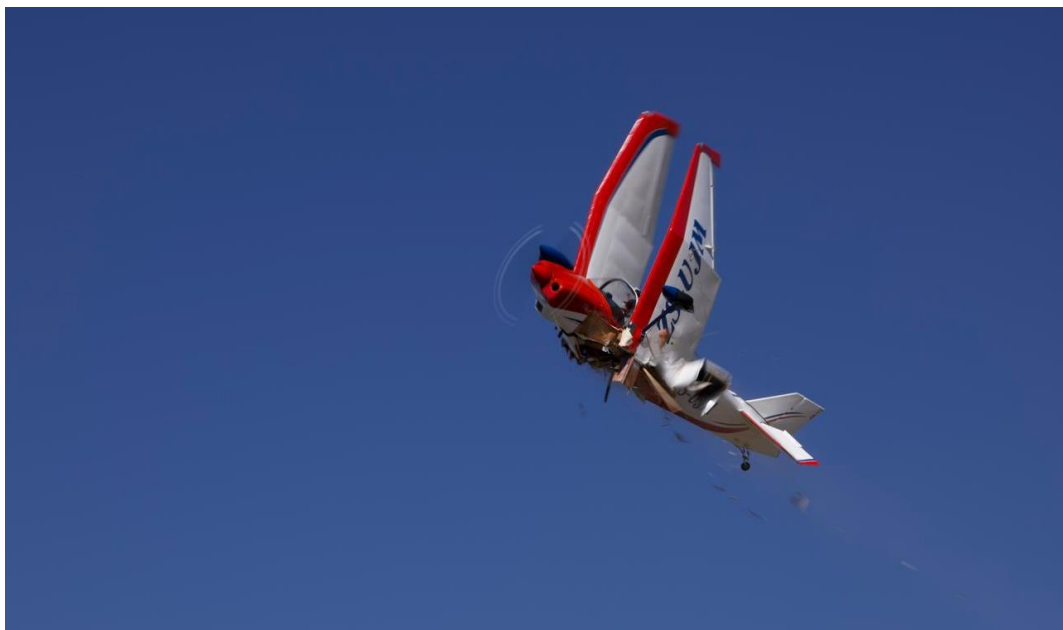
Figure 6: Both wings in a vertical position. (Source: Mr. S. Fletcher)

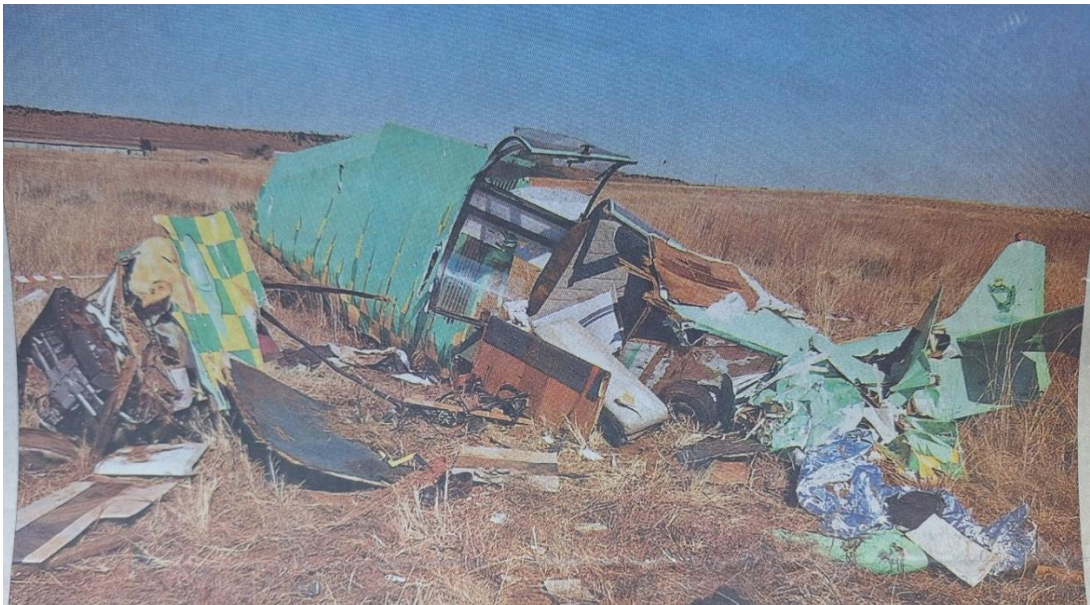
Figure 9: The wreckage of ZS-UJM following the accident on 4 July 2004. (Source: Newspaper clip)

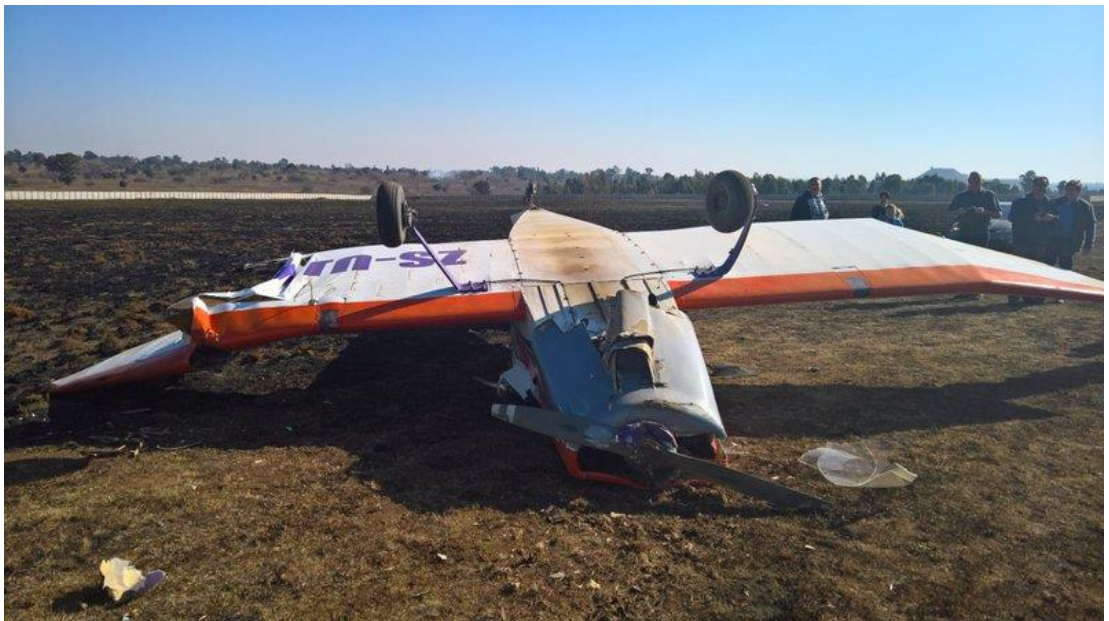
Figure 10: The wreckage of ZS-UJM following the accident on 29 July 2017.

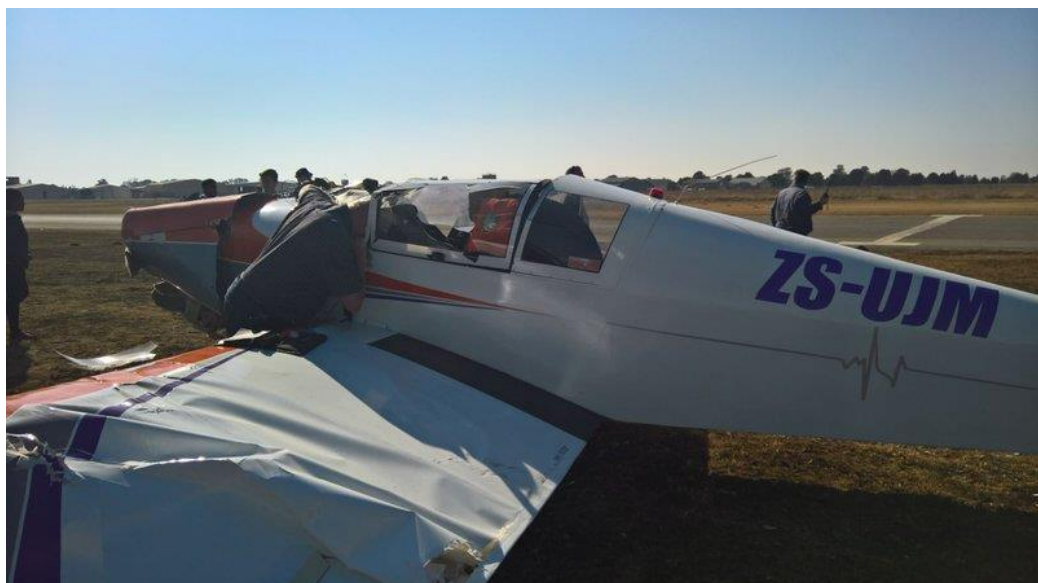
Figure 11: ZS-UJM after it was turned upright.

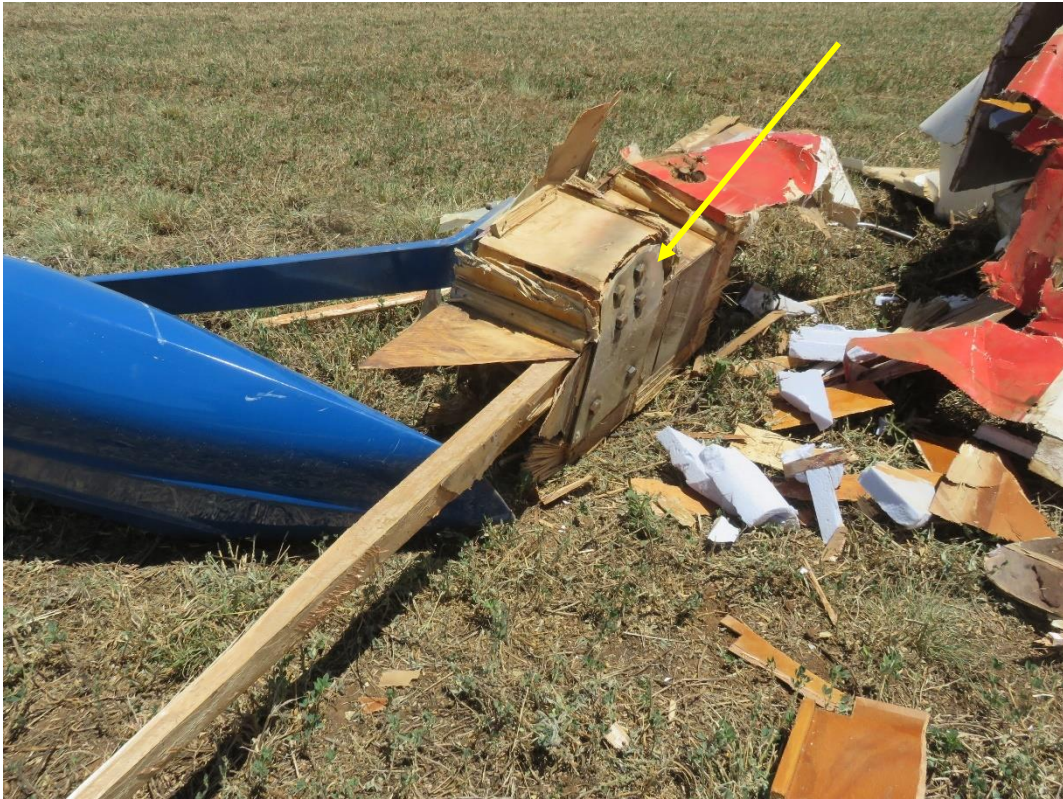
- f. In Figures 13 and 14, the bending of the left upper landing gear support plate can be seen where it attaches to the main wing spar which is indicative of poor workmanship and stems from the overtightening of the four bolts that secure the leaf-spring strut to the wing support bracket. Further, the four supporting bolt heads were welded (substandard workmanship) to the upper support plate (see Figure 15). Part 66.04.16(5) states: *“The holder of an authorised person certificate who wishes to carry out welding on a non-type certificated aircraft shall be the holder of a welding certificate for the type of welding to be carried out. The certificate does not necessarily have to be for aircraft welding.”*

Figure 13: The upper attachment support plate of the left main landing gear was bent.

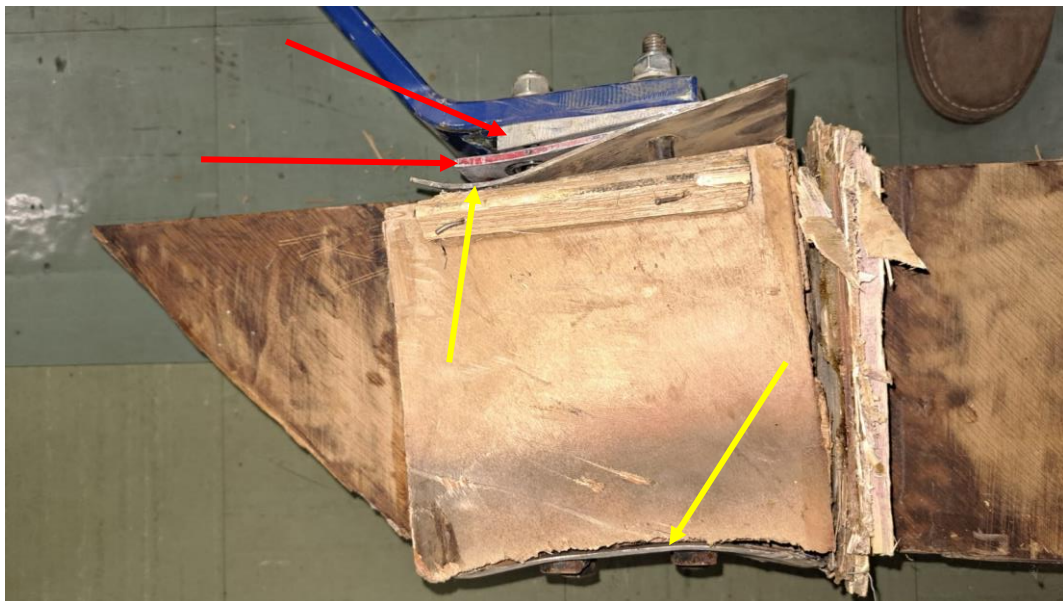
Figure 14: Two homemade spacers, indicated by red arrows were found on the left main gear. The yellow arrows indicate substantial bending of the upper and lower steel support plates.

Regarding the leaf spring gear installation, it was found that two homemade spacers were installed between the leaf spring support bracket and the lower wing structure on the left main gear. These two spacers were installed after the two leaf springs were removed from the aircraft and were taken to a sheet metal shop to be bent. The primary reason for the bending and the two spacers on the left side was that the aircraft owner/pilot was not happy with the aircraft on the ground as it presented a left-wing low attitude. There were, however, no documented flight folio or logbook entries in this regard. It was, however, confirmed with the owner of the sheet metal shop that the owner/pilot had brought two leaf springs in person and explained to him what his problem was and what he required. The two leaf spring gear struts were then re-installed to the aircraft on 25 September 2023 by two people who were not acquainted with aviation maintenance. It would appear that following the installation, the aircraft owner/pilot was still not happy with the aircraft's attitude, hence, the two spacers were inserted to get a wings-level aircraft. The primary reason as to why the aircraft suddenly presented the left-wing low attitude on level ground was not pursued further, yet the owner opted for the easy solution of solving the problem by inserting the two spacers. The accident flight was the first flight after the work was conducted. It could be asked if the main spar did not present any indication of a potential initial failure before the accident flight already, hence, the reason why the aircraft suddenly presented this left-wing low phenomenon.

- 3.2.11 Two homemade (substandard) spacers were found inserted between the lower wing body (main spar) and the leaf spring strut on the left main gear.

3.4.2 The fitment of the main landing gear leaf springs after the last annual inspection to the main spar displays evidence of poor workmanship. Spacers were inserted and substantial bending of the support plates was observed that was supported by the main wing spar. This work was conducted by two non-aviation qualified maintenance personnel under the supervision of the aircraft owner.

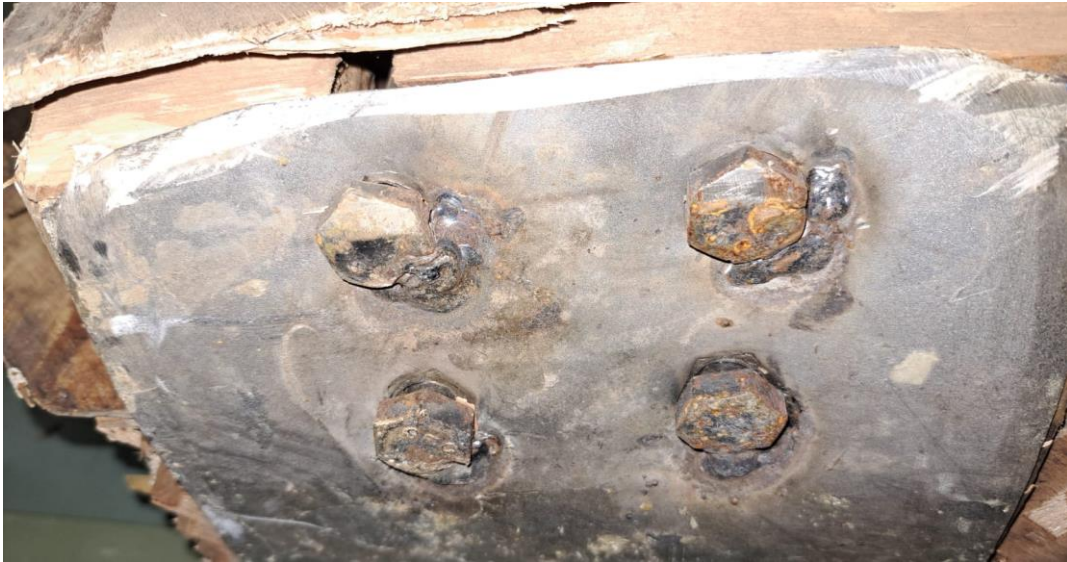
Figure 15: The four-bolt heads welded to the upper support plate (left gear).

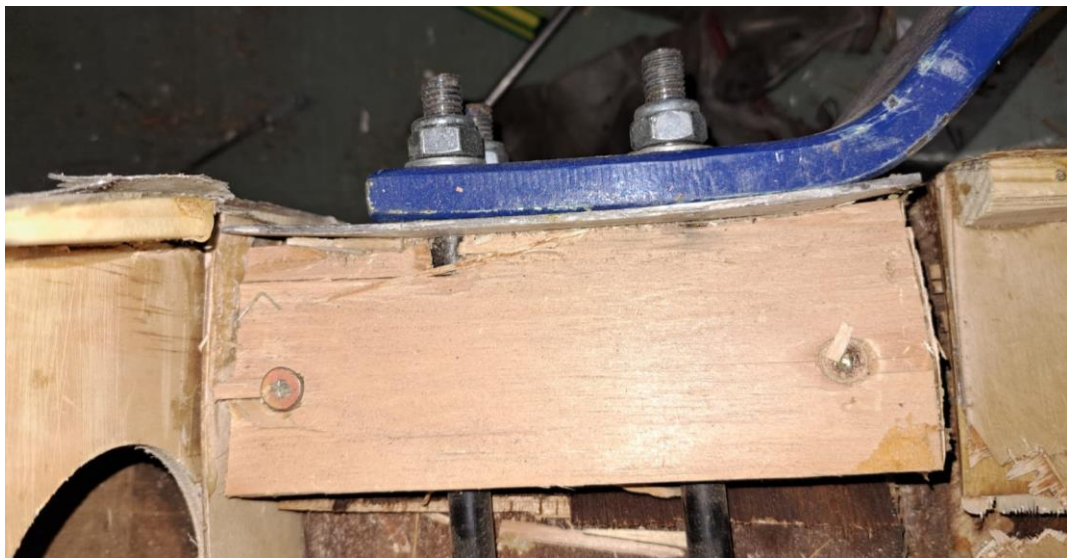
Figure 16: The leaf spring strut secured to the lower main spar (right gear).

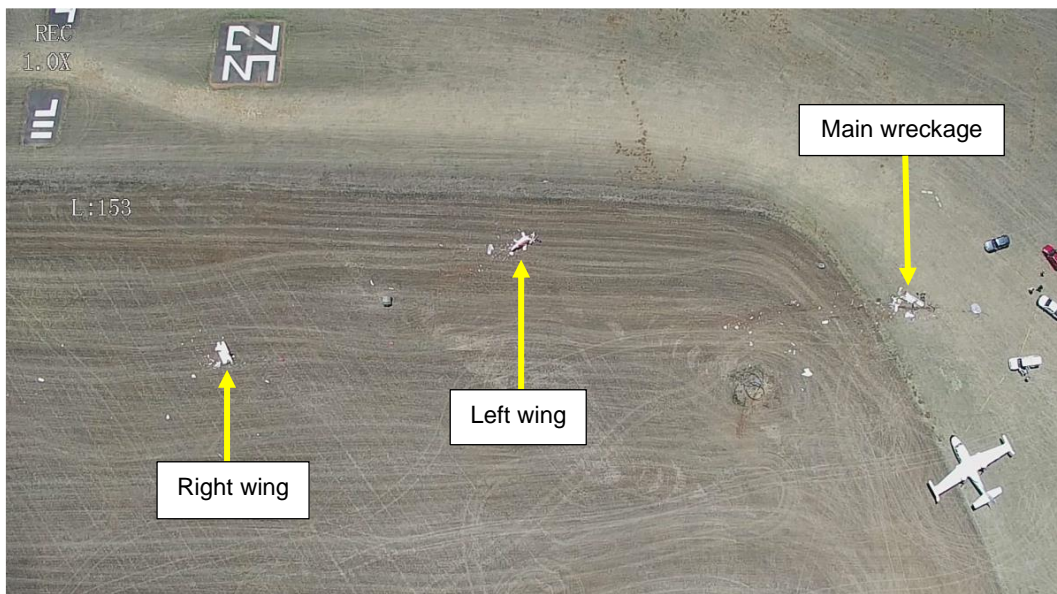
1.12.1 Following the in-flight structural failure, the wreckage was spread in a straight line on the grass area to the right of Runway 15 at FASI. The right-wing was the first structure in the sequence of break up, it was followed by the left wing and the main fuselage, empennage structure, and the engine. The wreckage spread over a distance of 98m.

Figure 17: Drone camera footage depicting the wreckage distribution. (Source: Drone Ops)

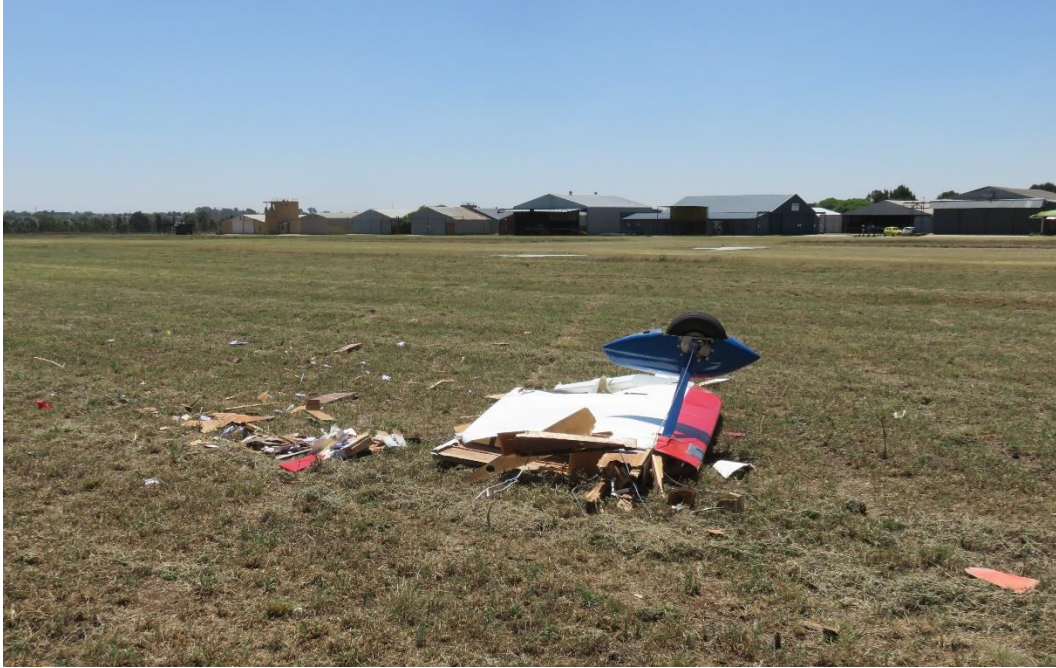
Figure 18: The right wing.

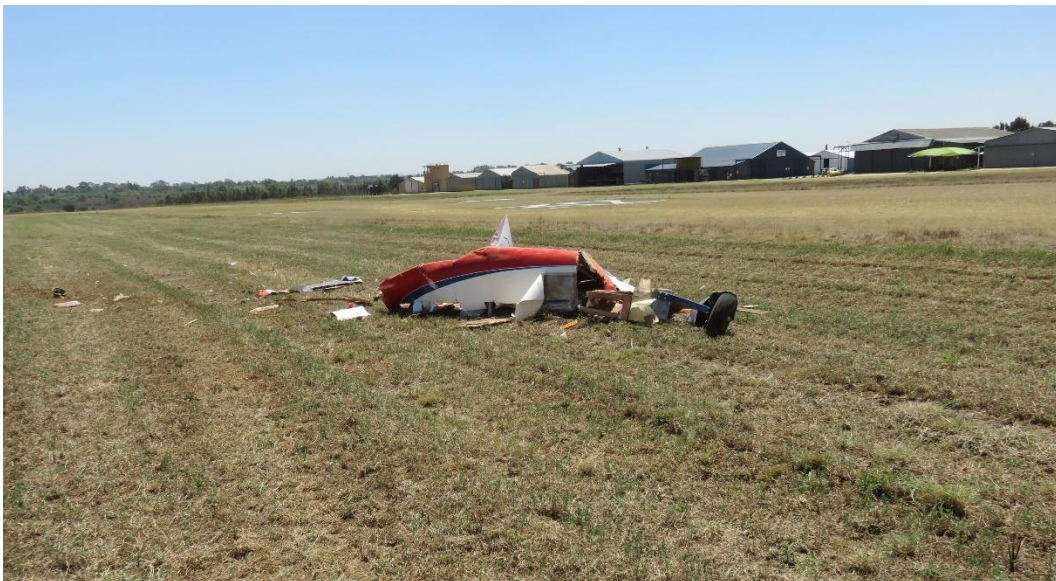
Figure 19: The left wing.

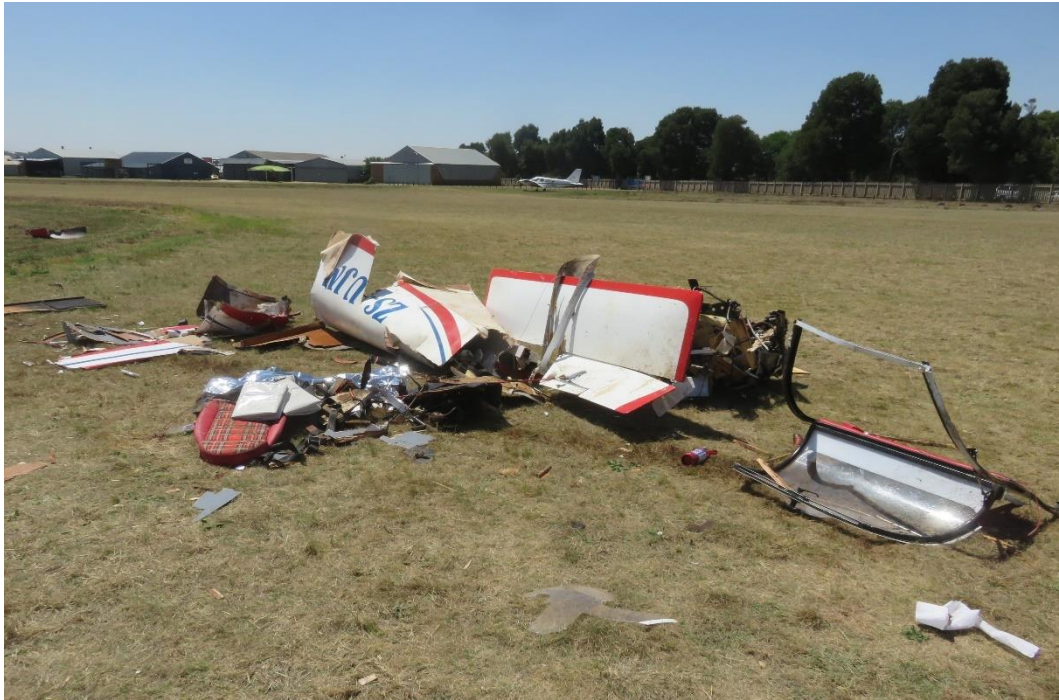
Figure 20: The main wreckage.

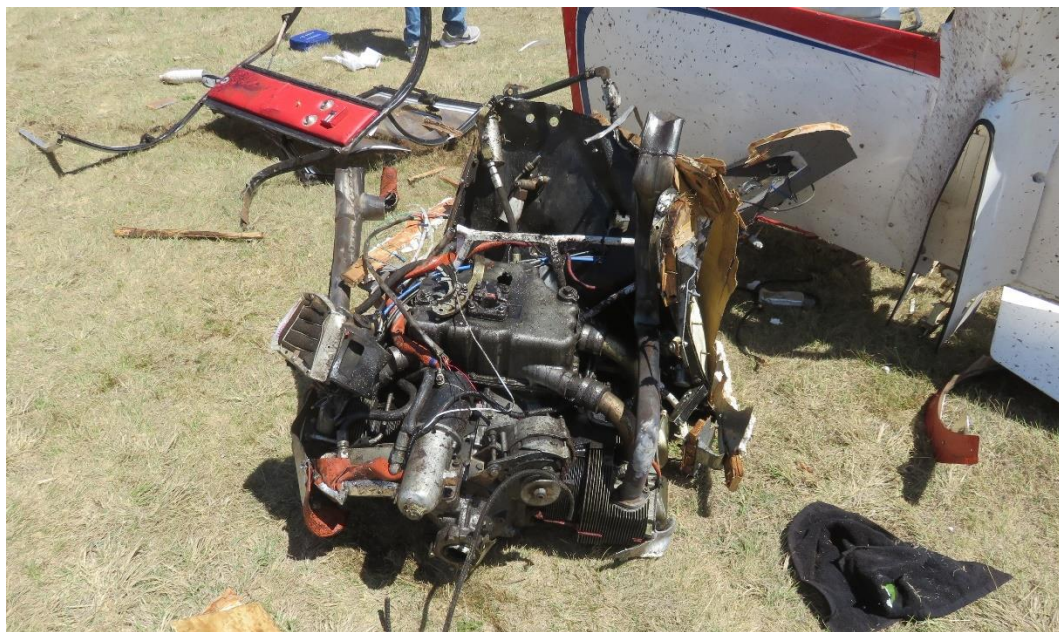
Figure 21: The engine in an inverted attitude with the propeller severed from the crankshaft.

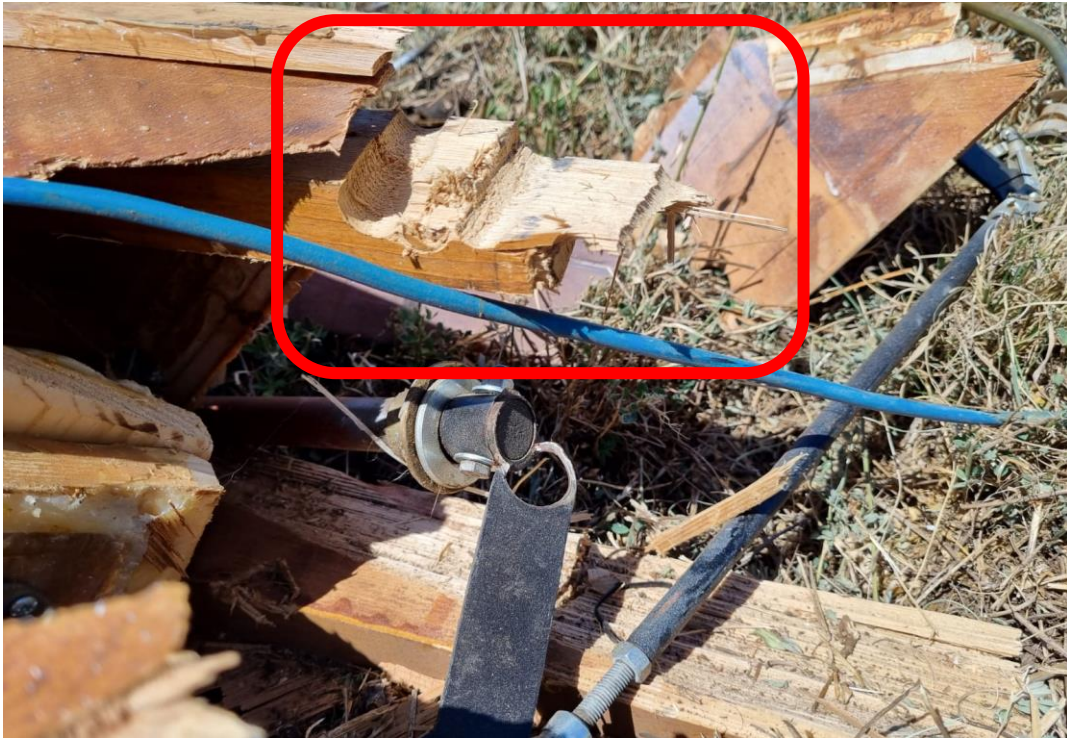
1.16.2 The report concludes that the holes drilled through the main spar beams centre section severely compromised the structural integrity of the main wing spar and, in combination with the increased moment-arm force induced by the main landing gear leaf-spring modification, are considered the primary factors to this failure.

Figure 22: Several holes that were drilled next to each other through the main spar beam.

3.4.1 The main wing spar structural integrity was severely compromised when the builder/repairer drilled several holes through the centre section of the wing spar beams.

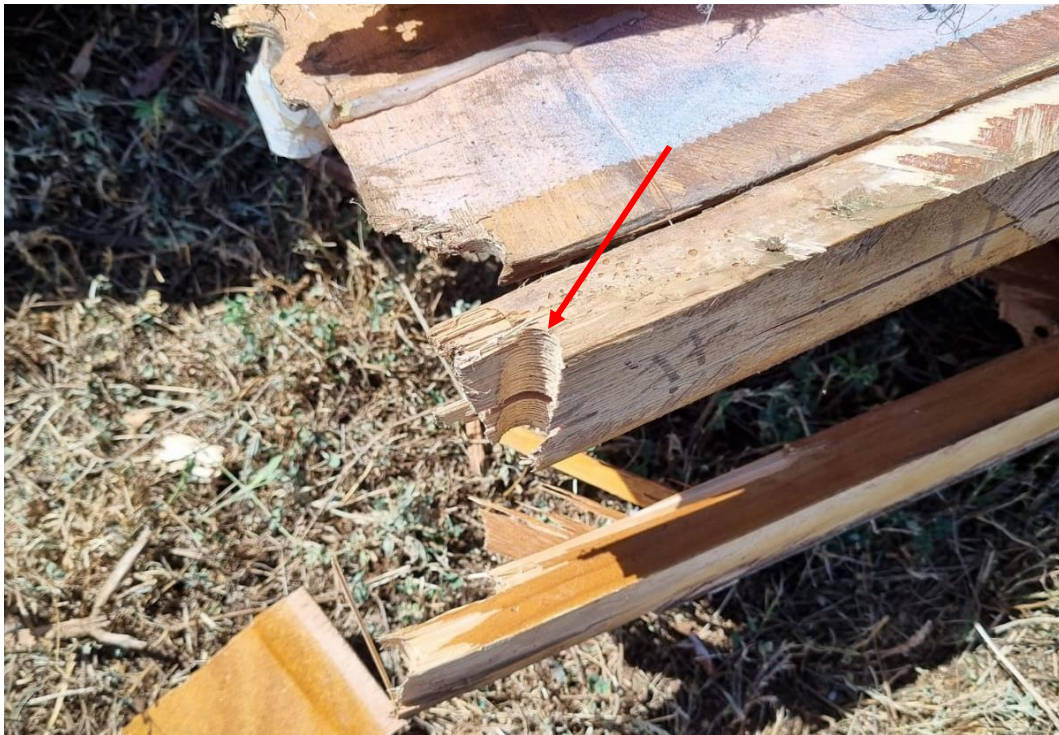
Figure 23: A hole drilled through the main spar beam.

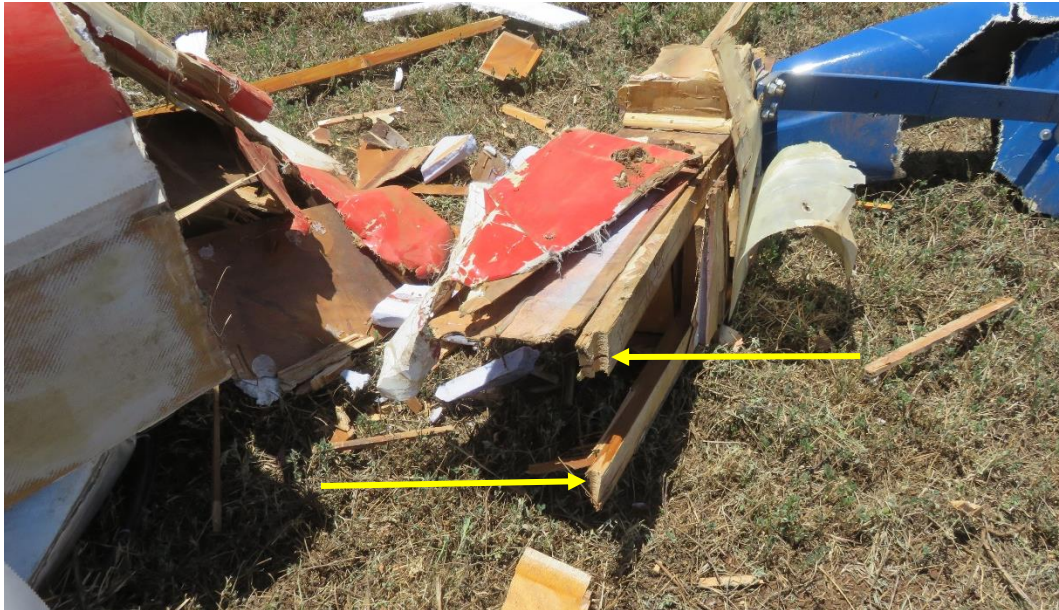
Figure 24: Fractured lower main spar beams with holes drilled through them.

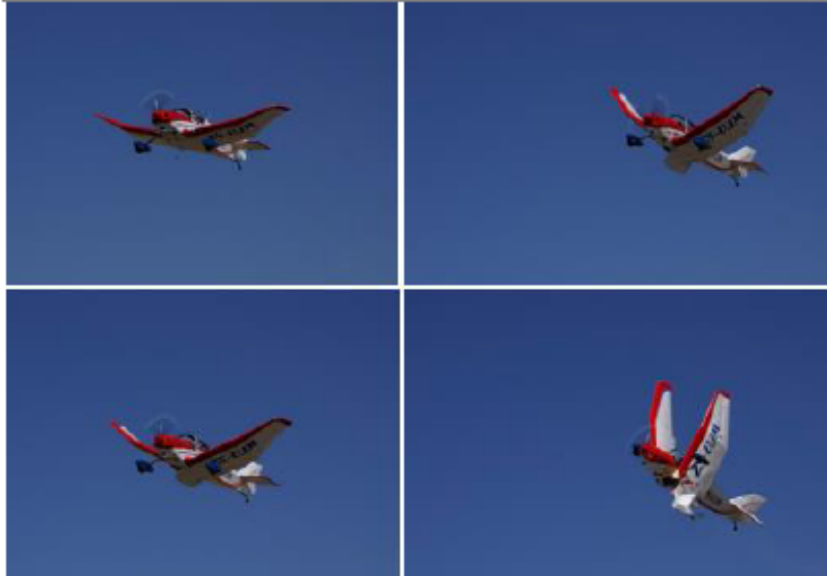
Photo 3: Accident Photos²

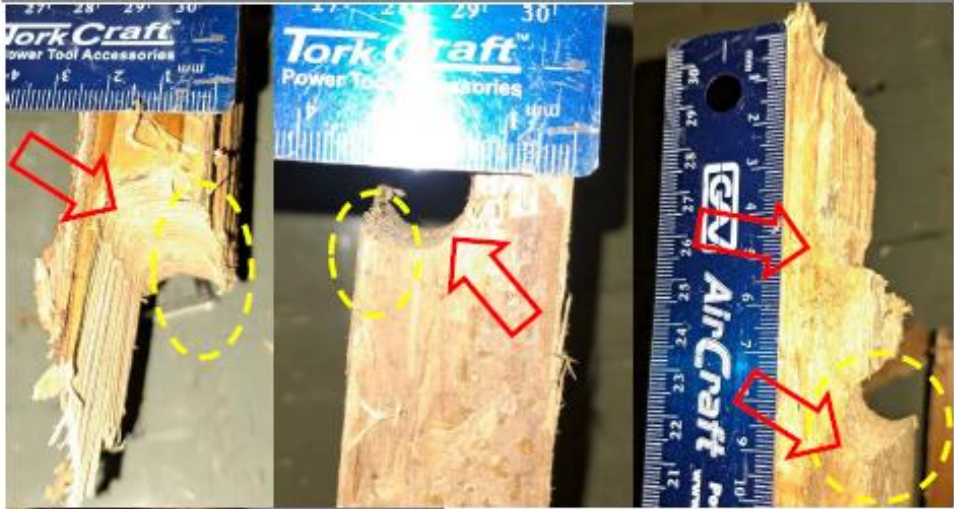
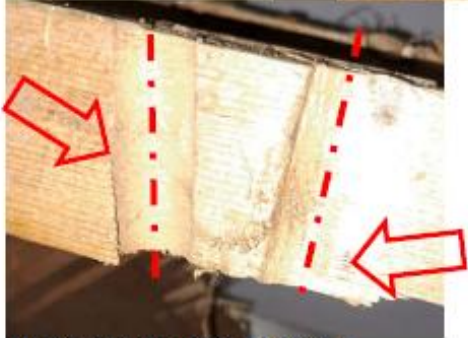
Photo 7: Drilled holes (digital)
