LIMITED OCCURRENCE INVESTIGATION REPORT – FINAL

Reference Number	CA18/2/3/10377						
Classification	Accident	Date	20 October 2023		Time	0835Z	
Type of Operation	Training Flight (Part 141)						
Location							
Place of Departure	Wonderboom Aerodrome (FAWB), Gauteng Province		Place of Intended Landing	Wonderboom Aerodrome (FAWB), Gauteng Province			
Place of Occurrence	Runway 29 at Wonderboom Aerodrome (FAWB)						
GPS Co-ordinates	Latitude	33°11'20" S	Longitude	022°01'06.74" E	Elevation	1801 feet	
Aircraft Information							
Registration	ZS-PMK						
Make; Model; S/N	Cessna 172 M (Serial number: 172-63294)						
Damage to Aircraft	Substantial		Total Aircraft Hours	8391.7 (Tachometer)			
Pilot-in-command							
Licence Type	Student Pilot Licence (SPL)		Gender	Female		Age	22
Licence Valid	Yes	Total Hours	69.7		Total Hours on Type	69.7	
Total Hours past 30 Days	1.2		Total Flying Hours on Type Past 90 Days	1.2			
People On-board	1 + 0	Injuries	1	Fatalities	0	Other (on ground)	0

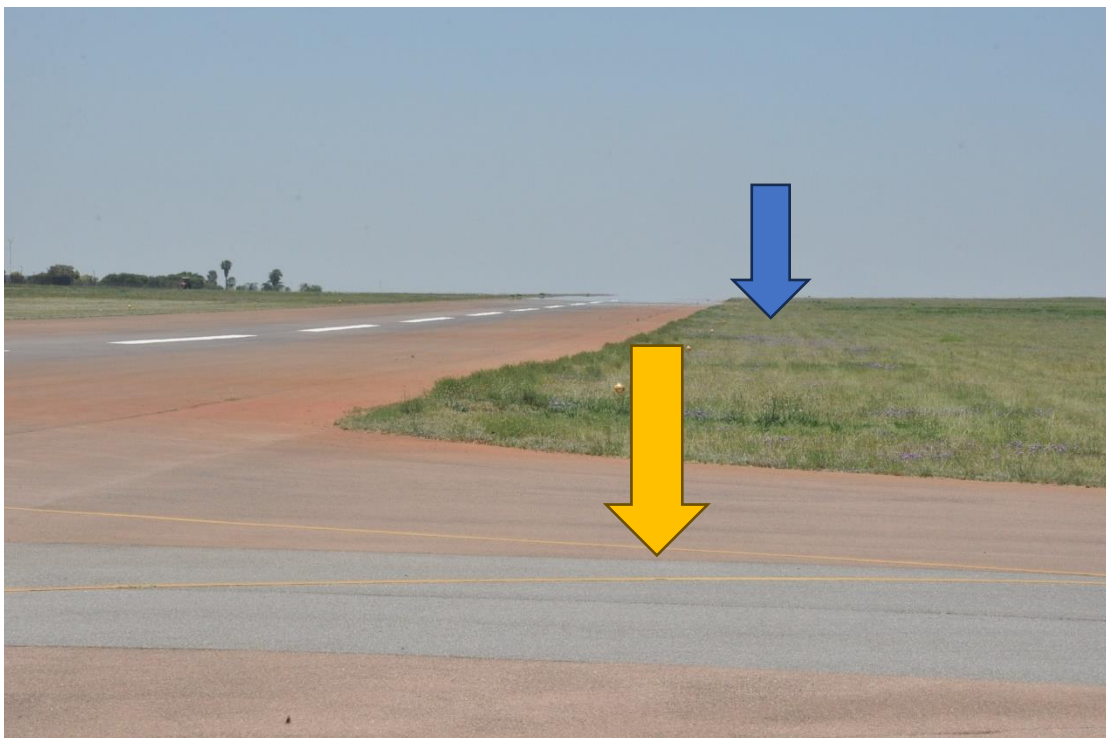
The chief pilot caught up with the SP and flew alongside her aircraft on the left side; he instructed her using the radio to follow him back to FAWB. During landing on Runway 29 after touchdown, the SP did not apply enough rudder to maintain directional control and the power was not fully closed; as a result, the aircraft drifted to the left and onto the grass area during the landing roll. The aircraft kept rolling on the grass and the SP retracted the flaps with the mindset of conducting a go-around. The aircraft crossed over taxiway Charlie, bounced and flipped; it finally rested in an inverted position.

Figure 1: The blue arrow indicates where the aircraft rolled on the grass; the yellow arrow shows taxiway Charlie.

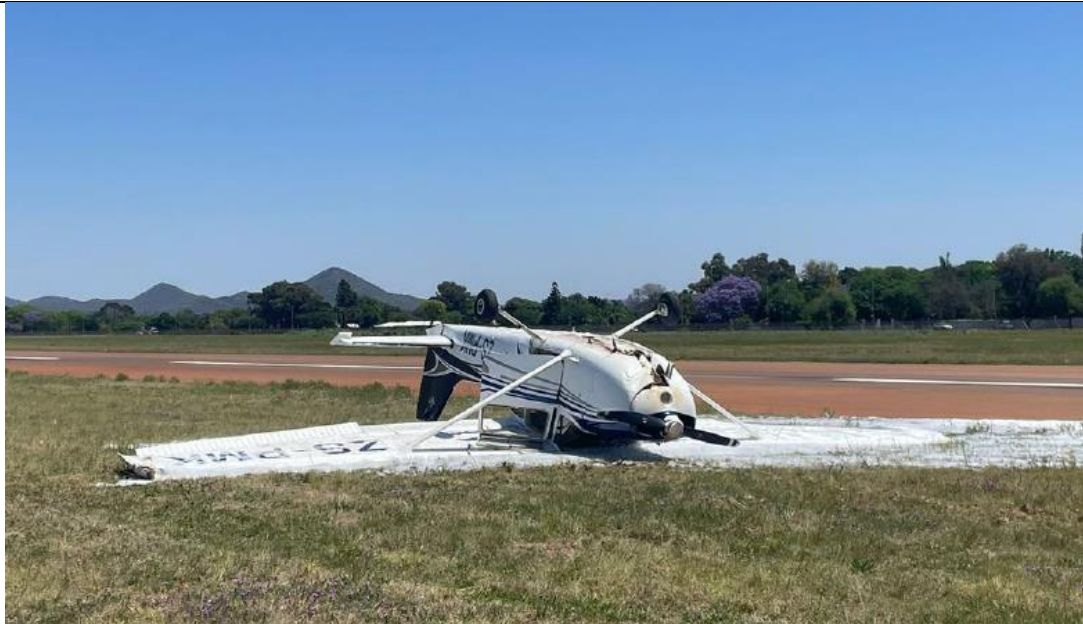
The aircraft was substantially damaged, and the pilot sustained minor cuts to her forehead.

Figure 2: The final resting position of the aircraft. (Source: Airport Rescue and Fire-fighting Service)

The aircraft landed in a high speed which led to a bounce, and the SP lost directional control which culminated in the aircraft nosing over.
