AIRCRAFT ACCIDENT REPORT AND EXECUTIVE SUMMARY

Reference:		CA18/2/3/10378	
Aircraft Registration	ZS-JKE	Date of Accident	21 October 2023		Time of Accident	0722Z	
Type of Aircraft	Beechcraft Sundowner C23		Type of Operation		Private (Part 91)		
Pilot-in-command Licence Type	Private Pilot Licence (PPL)		Age	21	Licence Valid	Yes	
Pilot-in-command Flying Experience	Total Flying Hours		±111.7		Hours on Type	±19.3	
Last Point of Departure	Bram Fischer International Airport (FABL), Free State Province						
Next Point of Intended Landing	Wonderboom Airport (FAWB), Gauteng Province						
Damage to Aircraft	Destroyed						
Location of the accident site with reference to easily defined geographical points (GPS readings if possible)							
One kilometre east of Bram Fischer International Airport (FABL) RWY 20 at Global Positioning System (GPS) co-ordinates determined to be 29°04'47.98" South 026°18'46.83" East, at an elevation of 4 409 feet (ft).

Reference Number	: CA18/2/3/10378
Occurrence Category	: Accident Category 1
Type of Operation	: Private (Part 91)
Name of Operator	: 4 AVIATORS
Aircraft Registration	: ZS-JKE
Aircraft Make and Model	: Beechcraft Sundowner C23
Nationality	: South Af

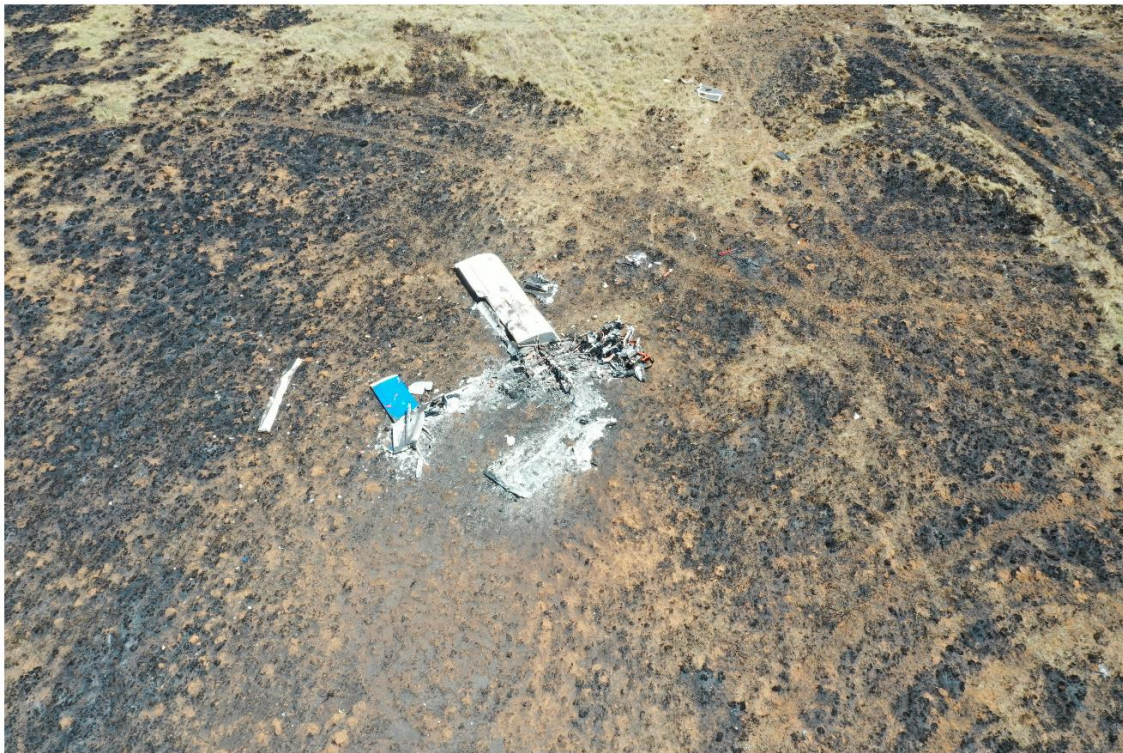
1.3.1. The aircraft was destroyed by post-impact fuel fed-fire that erupted.

Figure 2: Aerial view of the wreckage at the accident site. (Source: Operator)

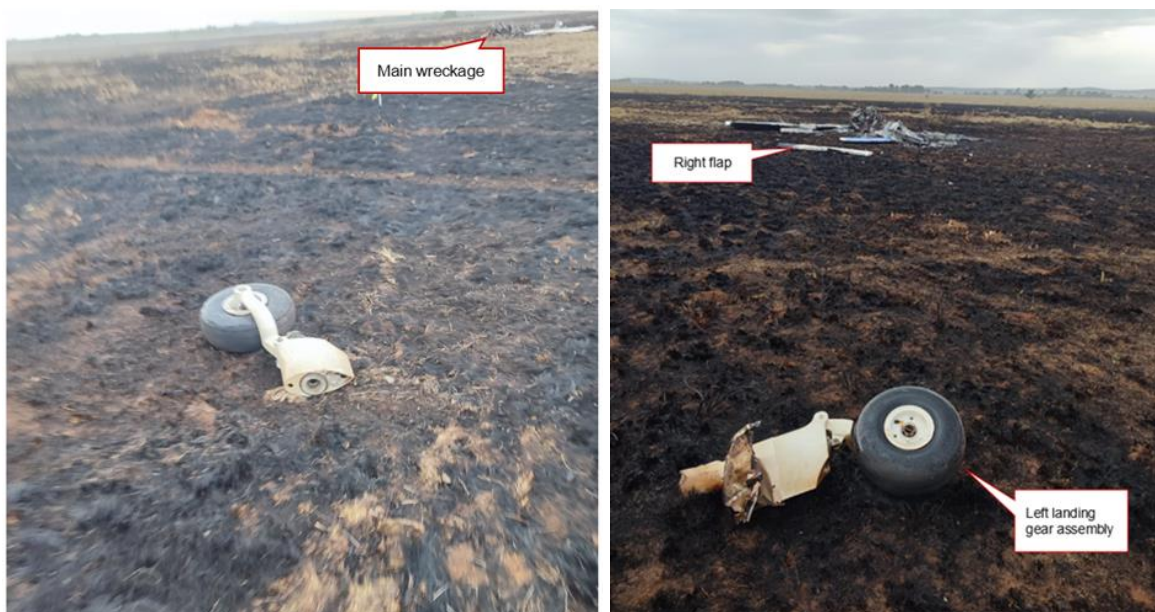
1.12.1. Witness marks at the accident site showed that the aircraft impacted the ground hard with the right wing first, this resulted in the right main landing gear strut separating from the under fuselage. The aircraft came to rest in an upright position facing the direction from which it had taken off. The left main landing gear and the right flap also broke off during the 180° turn. The bladder fuel tanks ruptured after impact and the aircraft burst into flames. The control surfaces were all accounted for at the accident site.

Figures 4 and 5: The right main landing gear assembly (left); and the left main landing gear assembly (right).

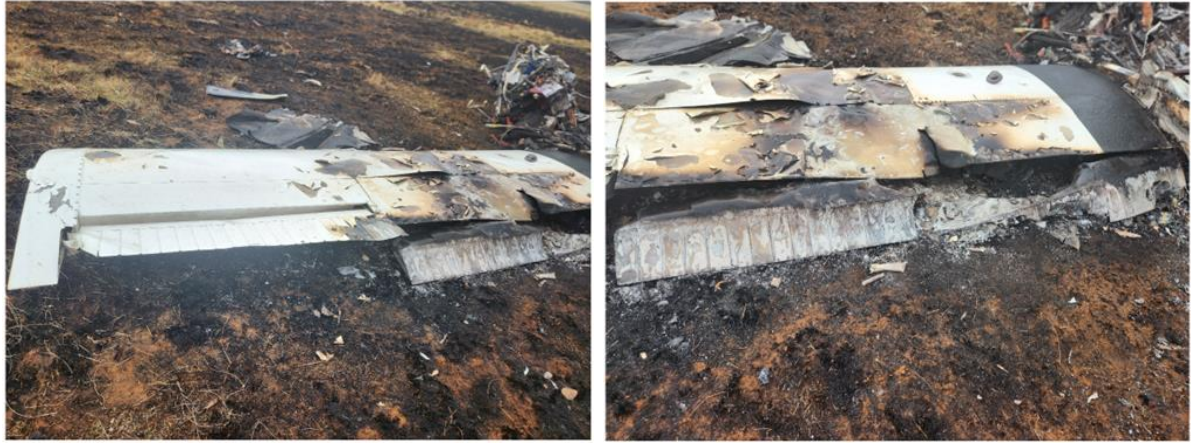
1.12.2. The left aileron, flap and part of the left wing were damaged by post-impact fire; they were still attached to the aircraft.

Figures 6 and 7: The damaged left aileron and flap (left). Closer-up picture of the left wing (right).

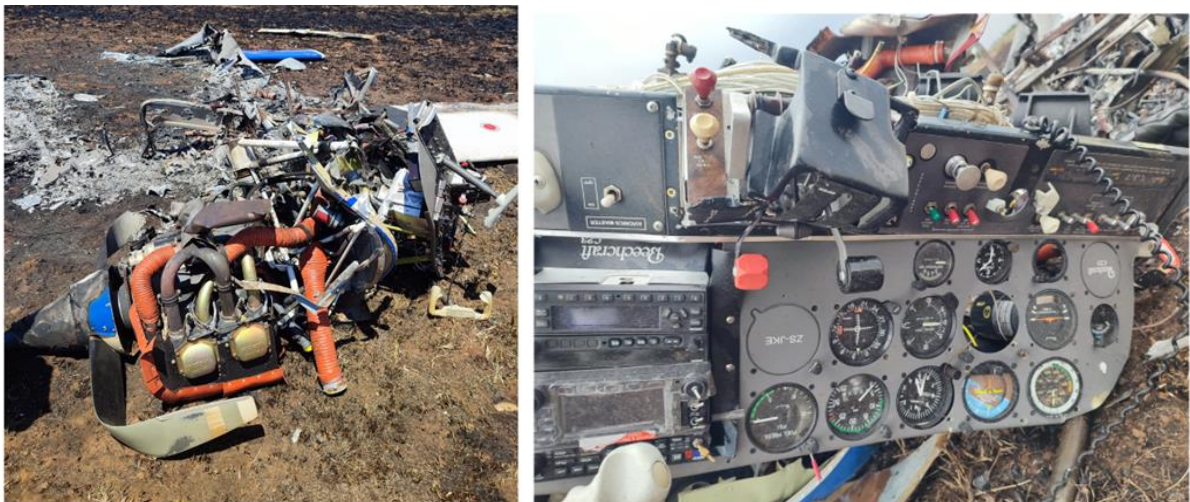
1.12.3. The engine and the propeller blades sustained substantial damage. The instrument panel, both control columns and the wiring behind the instrument panel were also damaged during the accident sequence.

Figures 8 and 9: The damaged engine and propeller (left), and instrument panel (right).

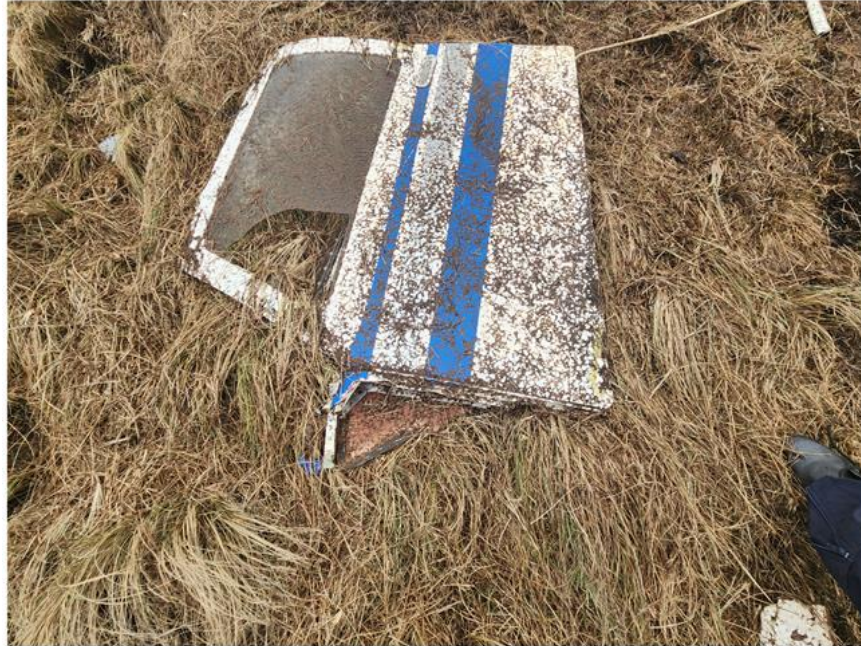
1.12.4. The left door had detached from its mounting point during the accident sequence. The overall examination of the wreckage showed that the aircraft was intact before the flight.

Figure 10: The left door that separated from the fuselage.

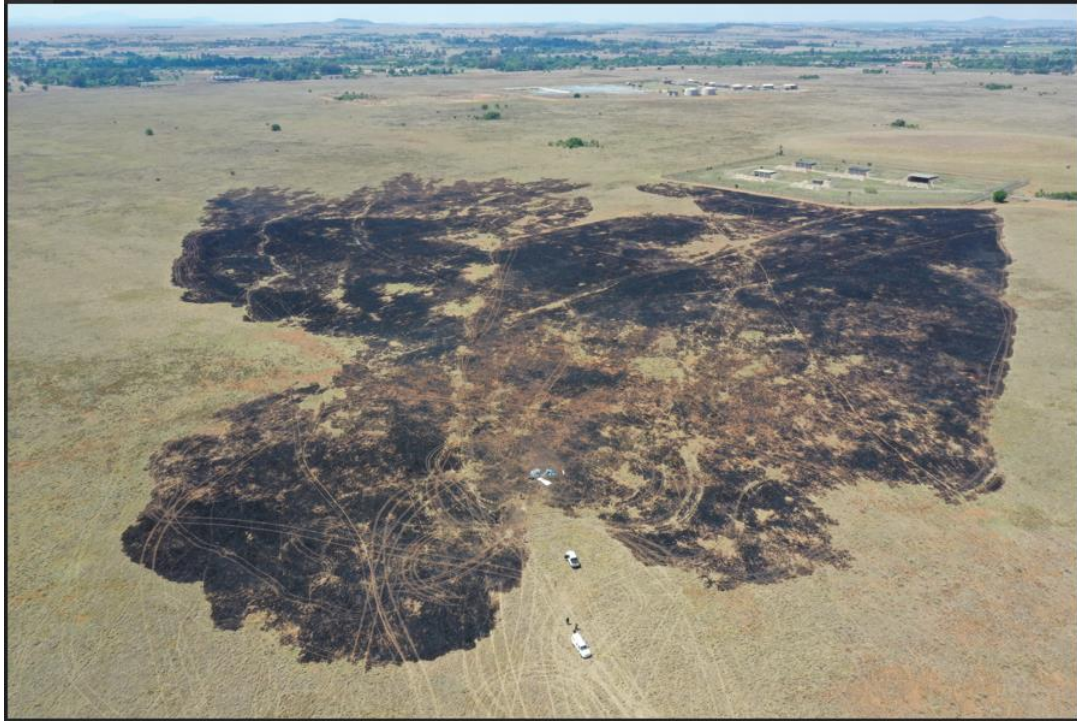
1.14.1. A post-impact fire ensued and destroyed the aircraft. According to the Airports Company South Africa (ACSA) report, the ARFF arrived at the scene at approximately 0731Z (9 minutes later) and started extinguishing the fire that had erupted; they also attempted to rescue the deceased (PF). The report from ACSA also stated that a total of five vehicles from the neighbourhood watch had arrived at the scene at approximately 0744Z (22 minutes later) to assist in containing the fire.

Figure 11: The accident site that was ravaged by the fire. (Source: Operator)

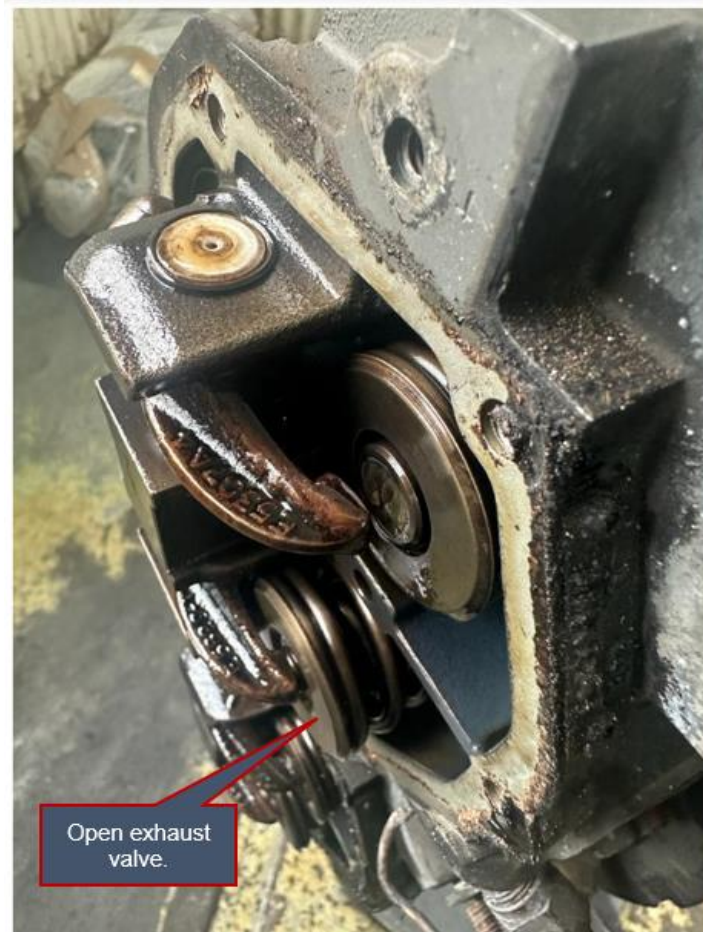
1.16.1. The engine was removed from the airframe and sent to the SACAA-approved engine overhaul facility for inspection. After the valve covers were removed, it was discovered that the exhaust valve on the number four (4) cylinder was stuck in an open position; this resulted in a loss of compression on cylinder number 4 (see Appendix C).

Figure 12: Cylinder No 4 exhaust valve in open position.

Examination of the engine post-accident revealed that the exhaust valve on the number four (4) cylinder was stuck in an open position. This resulted in a loss of compression on cylinder number 4. The investigation also revealed that SB 388C, dated 22 November 2004, issued by Lycoming was not complied with during the MPI that was conducted on 25 November 2021 at 2 895.70. The SB was last complied with on 18 June 2018 at 2 243.4 engine total time. The engine had operated 652.3 hours since the last SB was conducted. The SB on the engine was exceeded by 252.3 hours in operation at the time of this inspection.

- 3.3.1. The engine lost power during the climb as a result of a loss of compression on cylinder number 4 (four) which was caused by the exhaust valve that was stuck in open position. A forced landing was initiated, which was unsuccessful.

4.2.1. The AMO responsible for the maintenance had released the aircraft with an unhonoured Service Bulletin (SB) 388C. Moreover, the SACAA renewed the Certificate of Airworthiness (C of A) as prescribed by the CAR and the South Africa Civil Aviation Technical Standards (SA-CATS) 21.08.12A. It is recommended to the Director of Civil Aviation to review its internal processes of verifying and validating aircraft's airworthiness prior to the issuance of renewed C of As.
