LIMITED OCCURRENCE INVESTIGATION REPORT – FINAL

Reference Number	CA18/2/3/10379						
Classification	Accident	Date	14 October 2023	Time	1445Z		
Type of Operation	Private (Part 91)						
Location							
Place of Departure	Dwarsfontein Farm near Lephhalale, Limpopo Province		Place of Intended Landing	Dwarsfontein Farm near Lephhalale, Limpopo Province			
Place of Occurrence	Dwarsfontein Farm, Limpopo Province						
GPS Co-ordinates	Latitude	23°47'52.51" S	Longitude	027°51'37.89" E	Elevation	3 486 ft	
Aircraft Information							
Registration	ZT-RLP						
Make; Model; S/N	Robinson Helicopter; R44 Raven II (Serial Number: 13921)						
Damage to Aircraft	Substantial		Total Airframe Hours	383.1			
Pilot-in-command							
Licence Type	Private Pilot Licence		Gender	Male		Age	64
Licence Valid	No	Total Hours	1 253.8		Total Hours on Type	Unknown	
Total Hours 90 Days	50.8		Total Flying Hours on Type Past 90 Days		50.8		
People On-board	1 + 2	Injuries	0	Fatalities	0	Other (on ground)	0

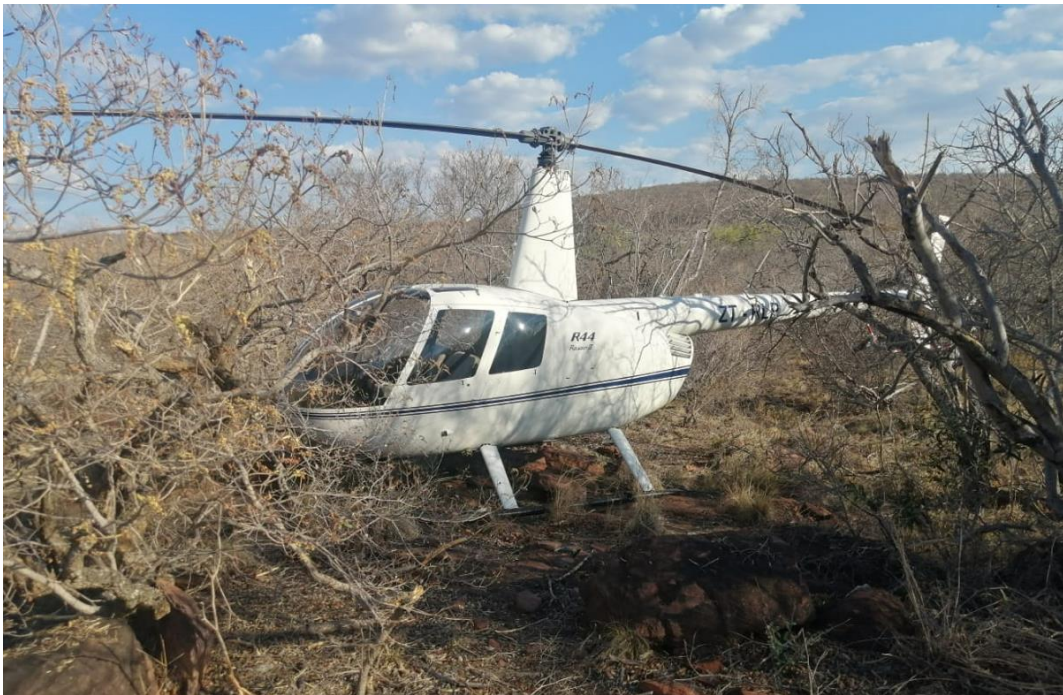
Figure 1: The helicopter as it came to rest in a dense bush and rocky terrain. (Source: Pilot)

Whilst manoeuvring the helicopter during a game culling operation, the pilot allowed the main rotor RPM to decay. He entered autorotation flight at 200ft AGL, which resulted in a hard landing in hostile terrain.

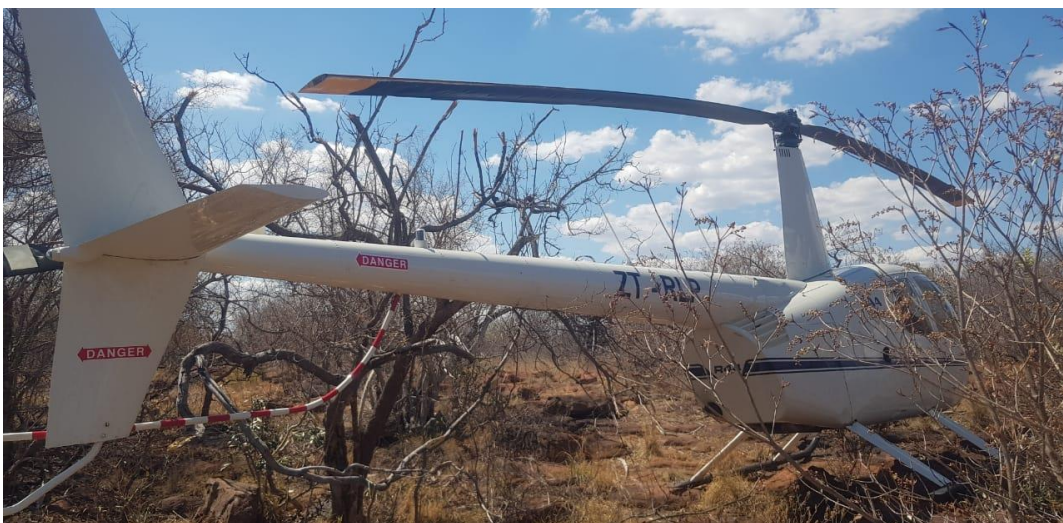
Figure 2: A view of the right side of the helicopter. (Source: Pilot)

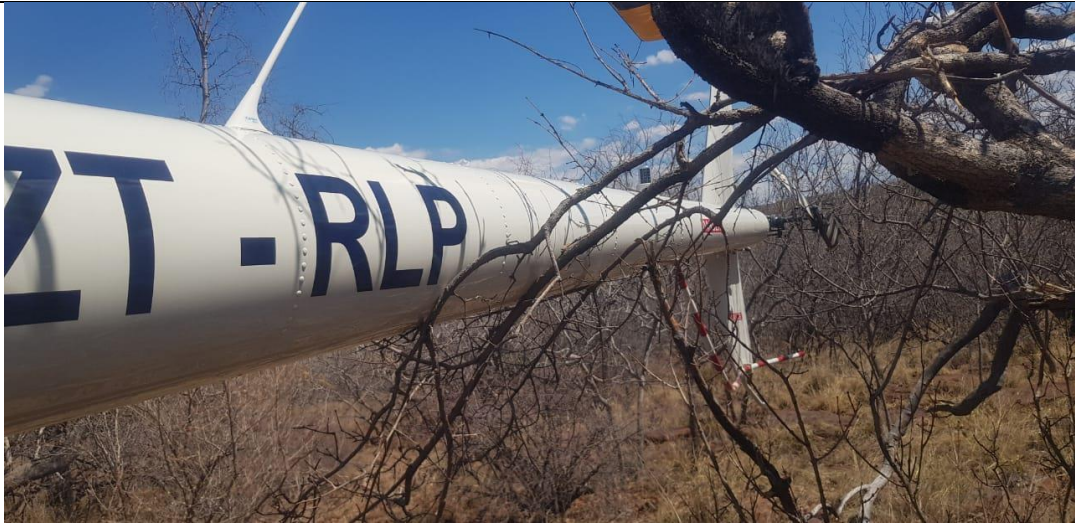
Figure 3: A view of the tail boom and tail rotor assembly. (Source: Pilot)

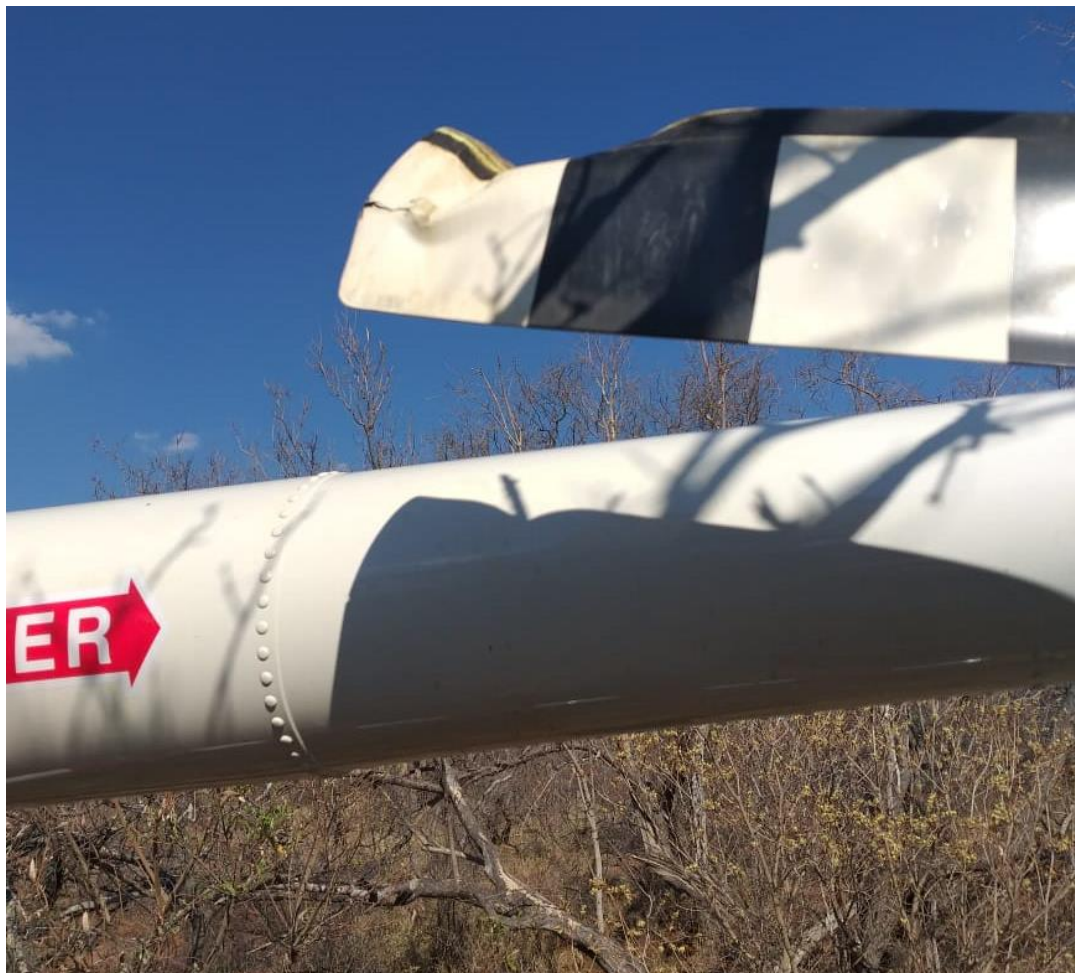
Figure 4: Damage to one of the tail rotor blades. (Source: Pilot)

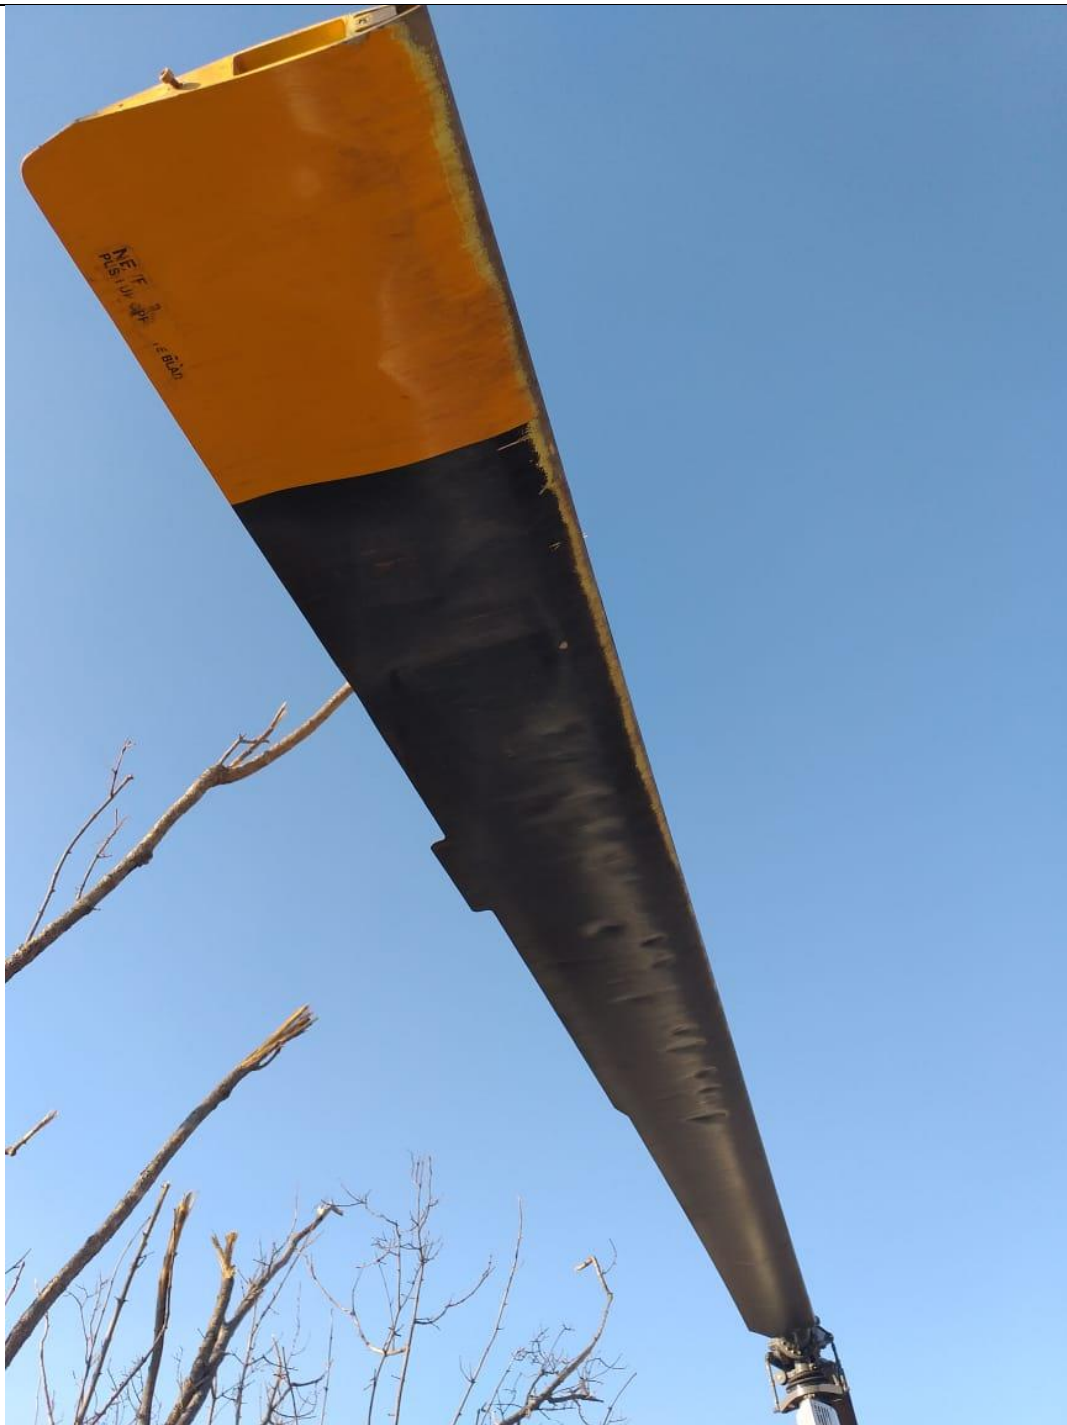
Figure 5: Damage to one of the main rotor blades. (Source: Pilot)

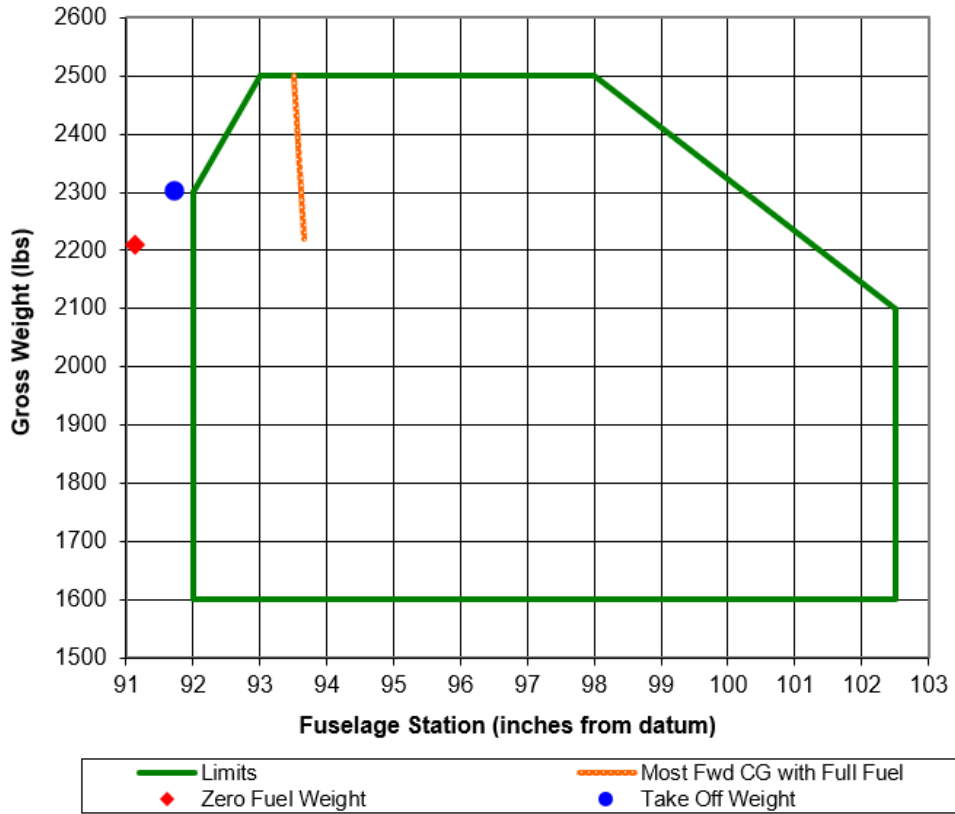
R44 Raven II Longitudinal Center of Gravity Limits

According to the weight and balance calculation, the forward centre of gravity (CG) was calculated at 91.7 inches, which was outside of the forward CG limit when looking at the graph (see longitudinal centre of gravity limits graph), which indicated the forward limit as 92 inches from the datum. The lateral CG was also out of limits, which indicated 1.07 inches from the datum.

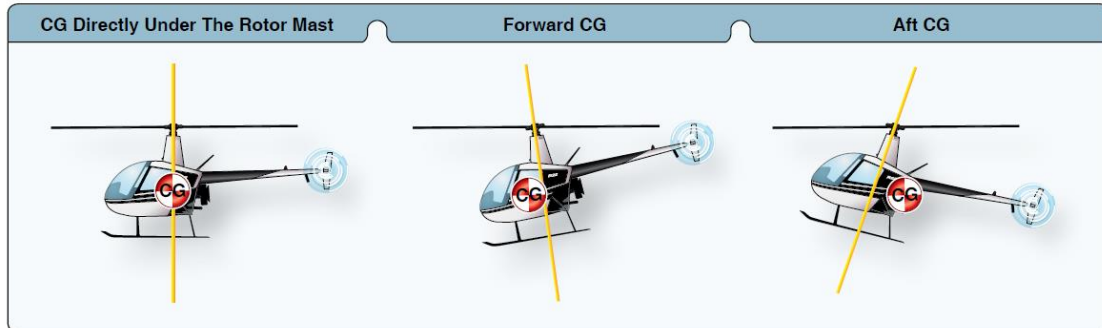
The pilot should ensure that the helicopter is properly balanced and within its centre of gravity limitations, so that minimal cyclic input is required during hovering flight, except for any wind corrections. Since the fuselage acts as a pendulum suspended from the rotor, changing the CG changes the angle at which the aircraft hangs from the rotor mast, the helicopter hangs horizontally; if the CG is too far forward of the mast, the helicopter hangs with its nose tilted down; if the CG is too far aft of the mast, the nose tilts up (see Figure 6).

Figure 6: The location of the CG position strongly influences how the helicopter handles.
