AIRCRAFT ACCIDENT REPORT AND EXECUTIVE SUMMARY

Reference:	CA18/2/3/10380		
Aircraft Registration	ZT-RBU	Date of Accident	26 October 2023		Time of Accident	0700Z	
Type of Aircraft	Robinson R44, Raven II		Type of Operation	Private (Part 91)			
Pilot-in-command Licence Type	Commercial Pilot Licence (CPL)		Age	40	Licence Valid	Yes	
Pilot-in-command Flying Experience	Total Flying Hours		9 848.2	Hours on Type	6 315		
Last Point of Departure	Private Farm in Vaalwater, Limpopo Province						
Next Point of Intended Landing	Marataba Mountain Lodge in Thabazimbi, Limpopo Province						
Damage to Aircraft	Substantial						
Location of the accident site with reference to easily defined geographical points (GPS readings if possible)							
Bushy terrain, approximately 170 metres west of Marataba Mountain Lodge in Thabazimbi, Limpopo Province, at GPS position determined to be 24°20'44.1" South 027°29'41.5" East, at an elevation of 3 349 feet							
Meteorological Information	Wind direction: Calm; Wind speed: Calm; Air Temperature: 19°C; Dew Point: 09°C

Synopsis

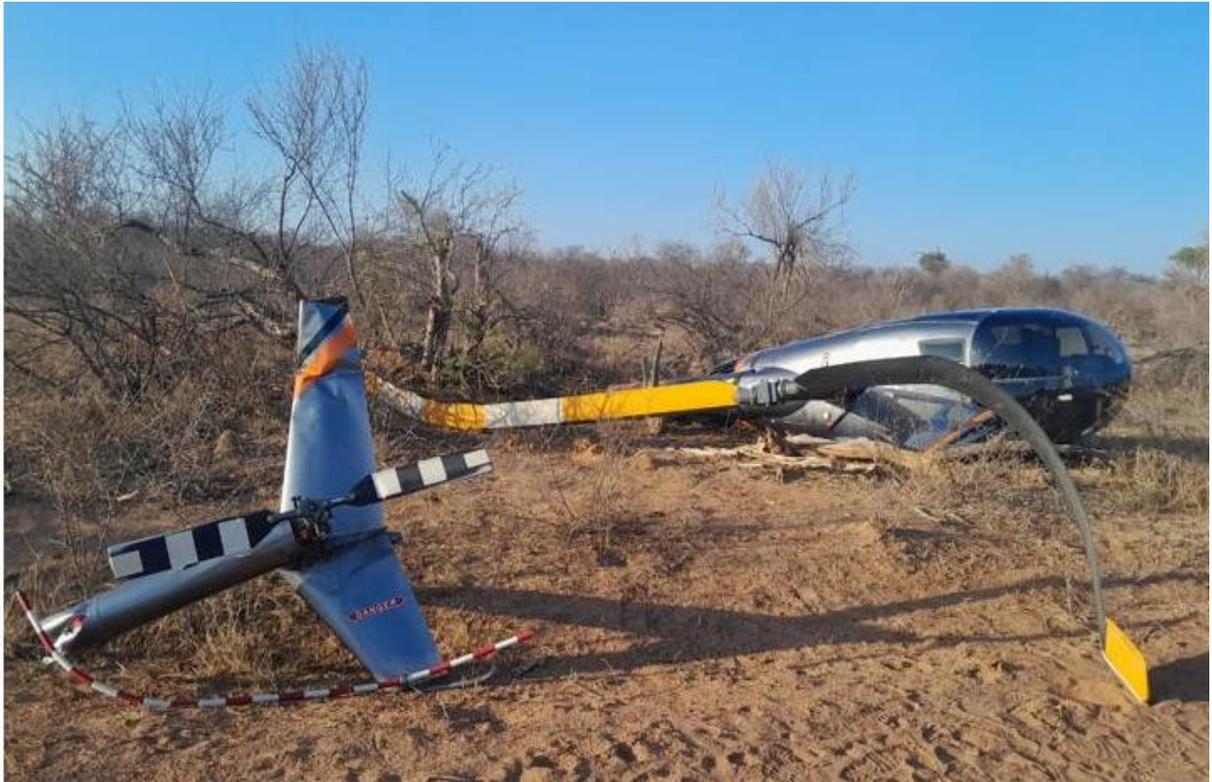
- 1.3.1. The helicopter sustained substantial damage. The landing gear skids were broken and detached from the fuselage; the main rotor blades and the main rotor pitch change links were damaged on impact; the tail boom was severed, and the tail rotor was dislodged.

Figure 1: The helicopter at the accident site. (Source: Pilot)

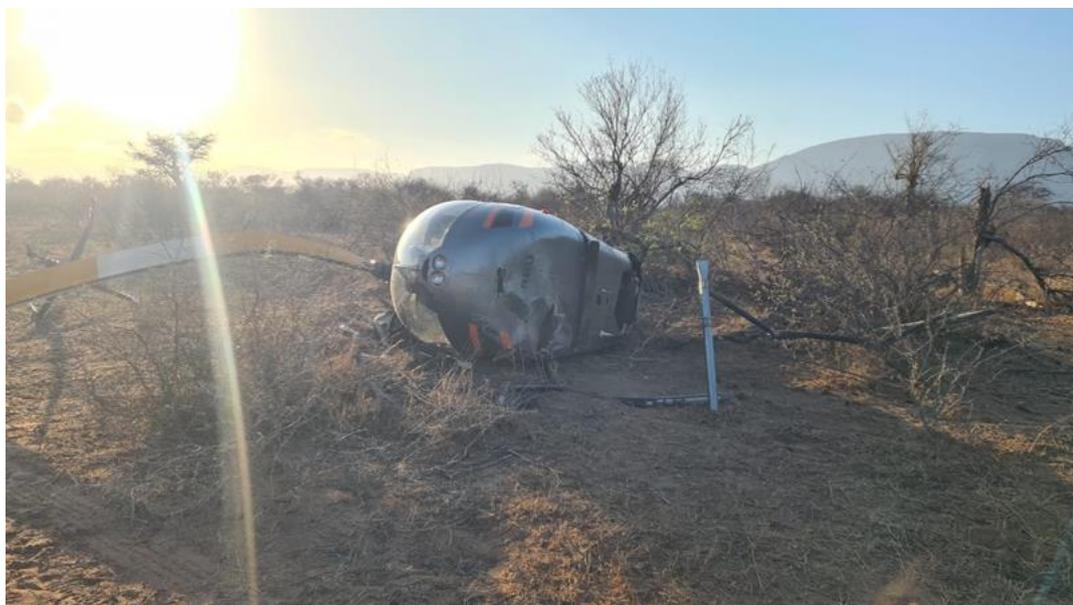
1.12.1. The accident occurred on a bushy terrain, approximately 170 metres (m) west of Marataba Mountain Lodge. The helicopter was found lying on its right side. The aft section of the tail boom was severed, indicating an impact that was consistent with contact with the main rotor. The helicopter's landing skids were detached, this damage aligned with the hard landing sequence. Both main rotor blades exhibited significant bending, which was consistent with low rotor RPM as they impacted the ground.

Figure 3: The helicopter at the accident site with broken landing gear skids. (Source: Pilot)

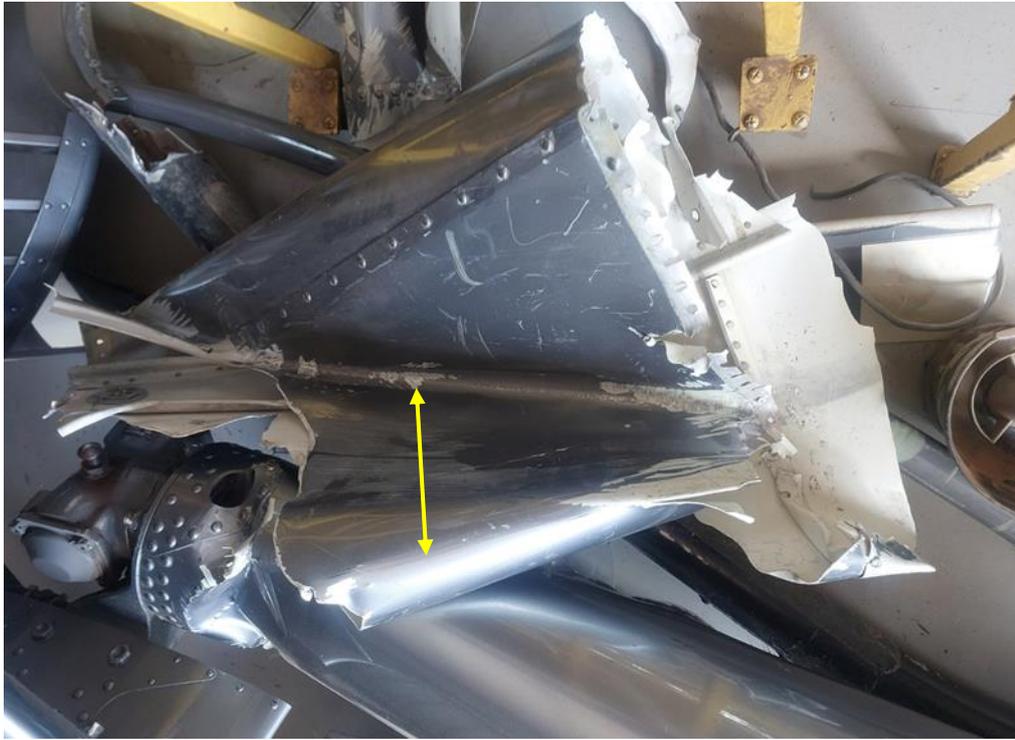
Figure 4: Imprint of the main rotor blade strike on the tail boom section.

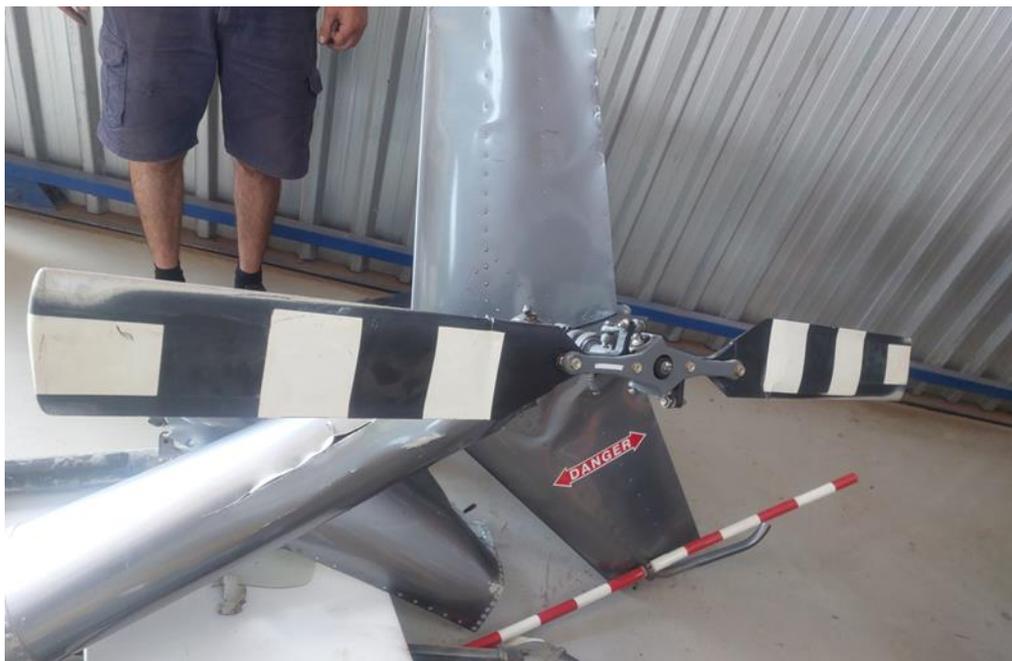
Figure 5: The detached tail rotor.

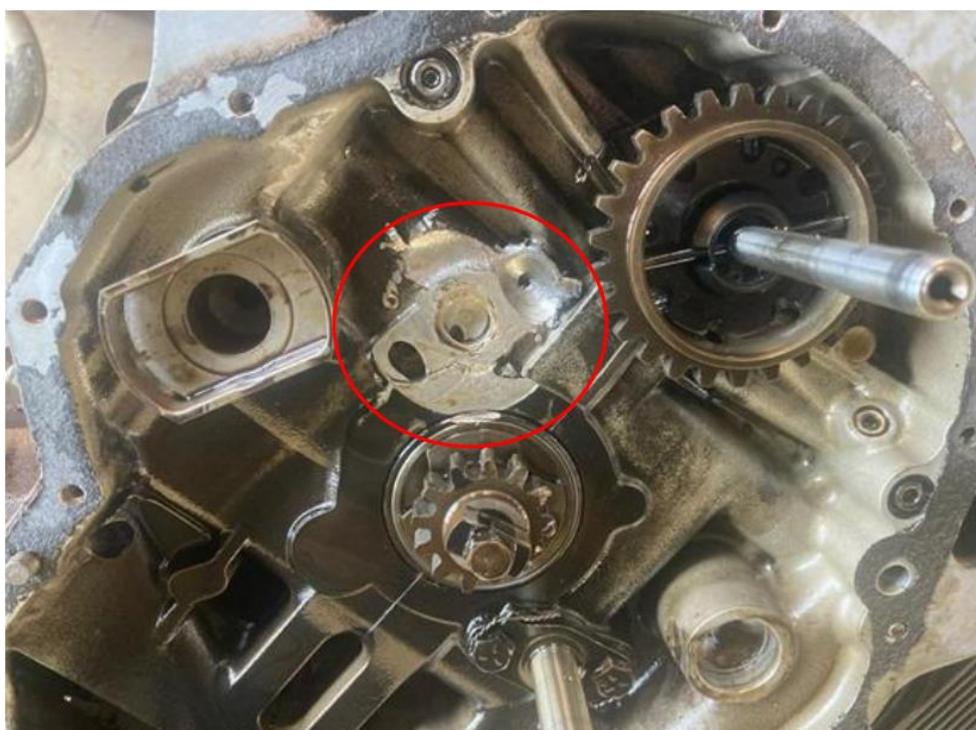
1.16.1 The engine was recovered to the SACAA-approved engine overhaul facility at Springs Aerodrome (FASI) and was subjected to a teardown inspection. The aircraft maintenance organisation (AMO) discovered that the idler gear shaft flange fractured on the flange bolt hole. The idler gear drives the camshaft gear and magneto, it is considered an on-condition item. The failed idler gear and fasteners (bolts and nuts) were sent to the engine manufacturer (Lycoming) in the United States of America (USA) for assessment. The idler gear shaft flange material and hardness conformed to Lycoming standards.

Figure 6: The failed idler gear location circled in red.

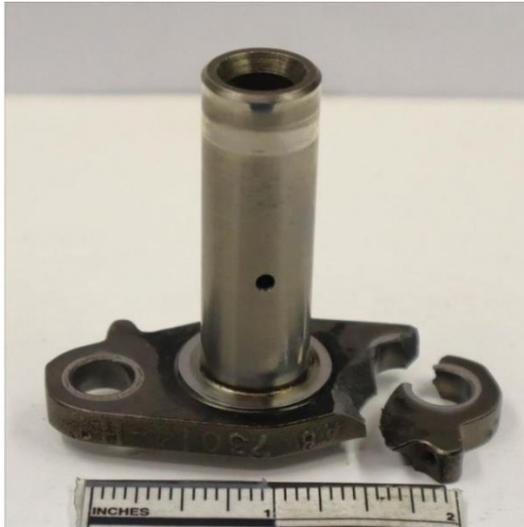
Figure 7: The idler gear shaft fractured on the flange bolt hole.

2.2.2.5 The engine was recovered to the SACAA-approved engine facility at Springs Aerodrome (FASI) and was subjected to a teardown inspection. The AMO found that the idler gear shaft flange bolt hole had fractured.

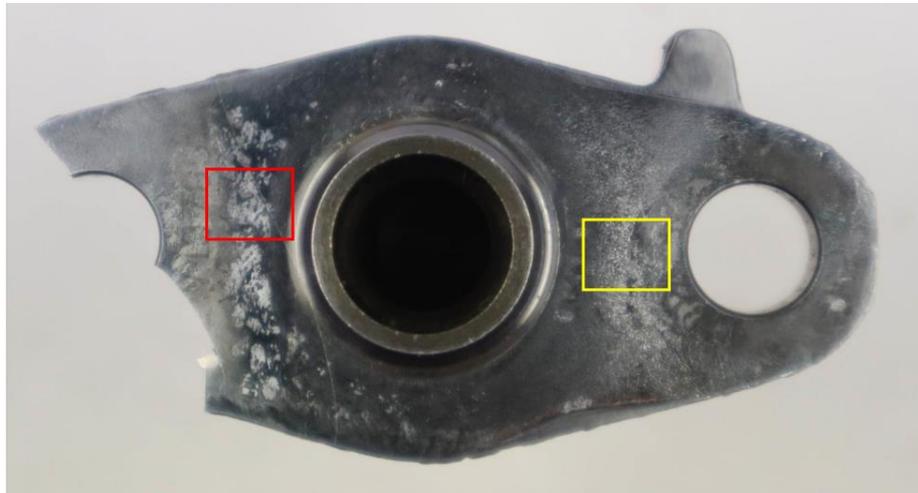
Figure 8: The red and yellow squares show wear on the idler gear shaft flange.

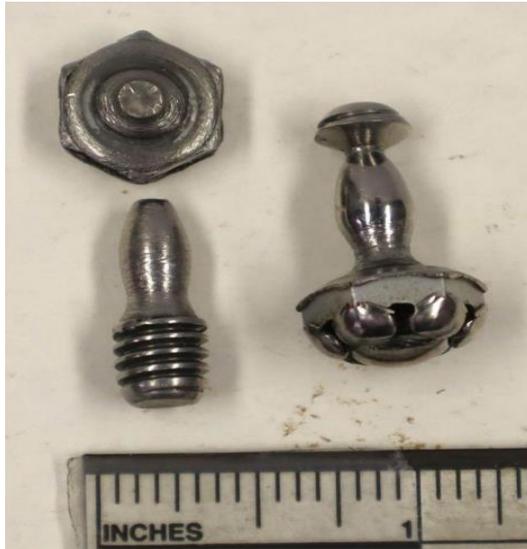
1.16.2 The fasteners that secured the shaft flange were not marked or identified before they were sent to the engine manufacturer; they were both assumed to be 01A23354 studs with STD-2168 castellated nuts and LW-31H0.88 bolts. The location of the fasteners in relation to the broken flange was unknown. One of the two bolts was fractured. Studs on both bolts were severely altered by wear. The non-fractured fastener had a castellated nut still attached to it.

Figure 9: The fasteners that secured the flange; one fastener is fractured and other one is intact. Both were severely altered by wear.

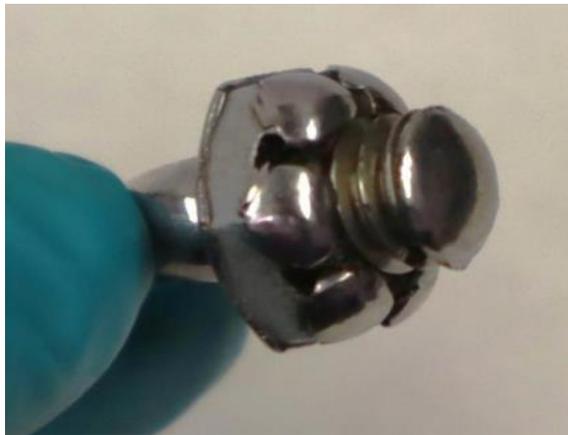
Figure 10: A castellated nut was still attached to the non-fractured fastener.

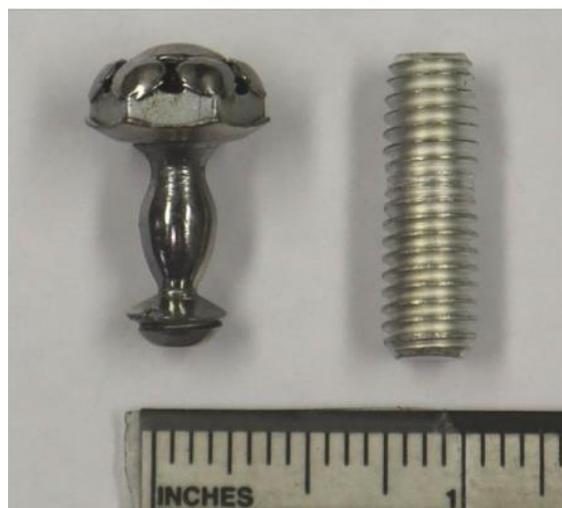
Figure 11: A used stud (left) and a new O1A23354 stud (right).

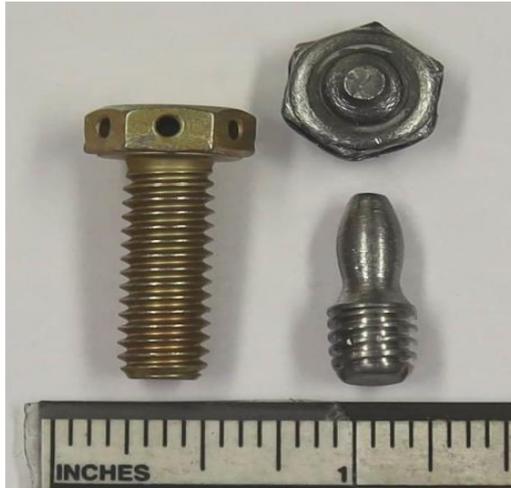
The flange bolt that secured the idler gear failed due to fatigue; the origin of the fatigue was unknown.

1.16.3 The failed flange bolt was subjected to a microscopic analysis and the root cause of its failure was determined to be fatigue; the origin of the fatigue was unknown. It was also not determined which failed first between the idler gear shaft flange and the bolt that secured it.

Figure 12: The fractured bolt compared to a new LW-31H0.88 bolt.

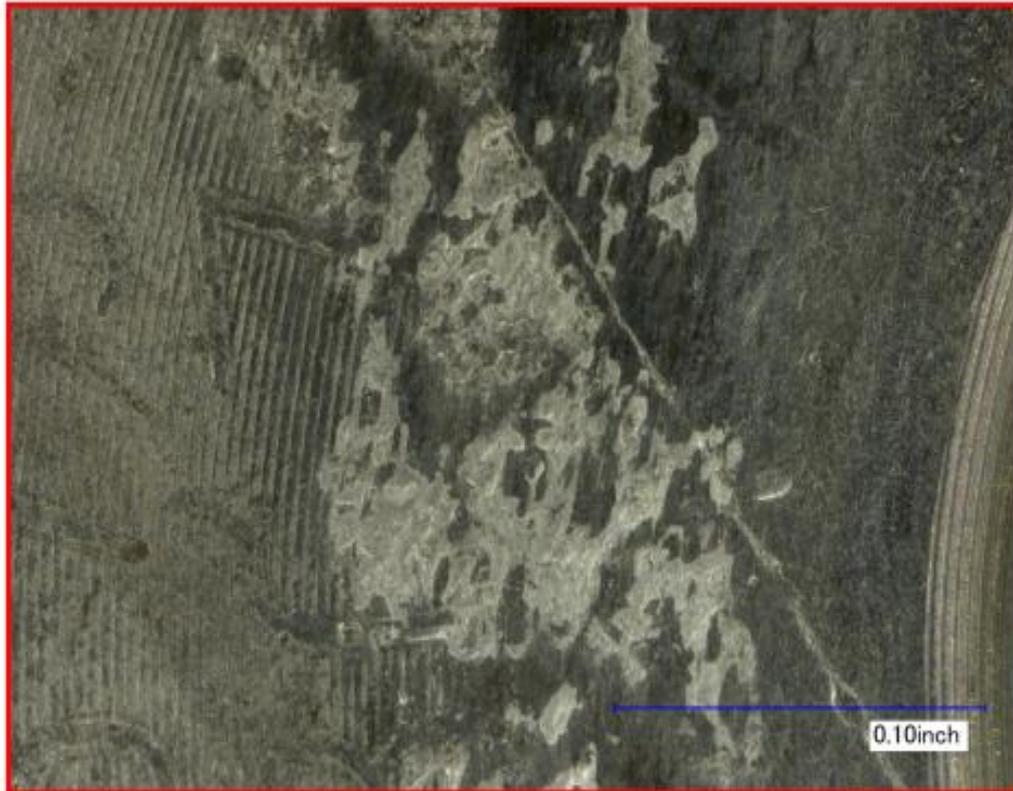
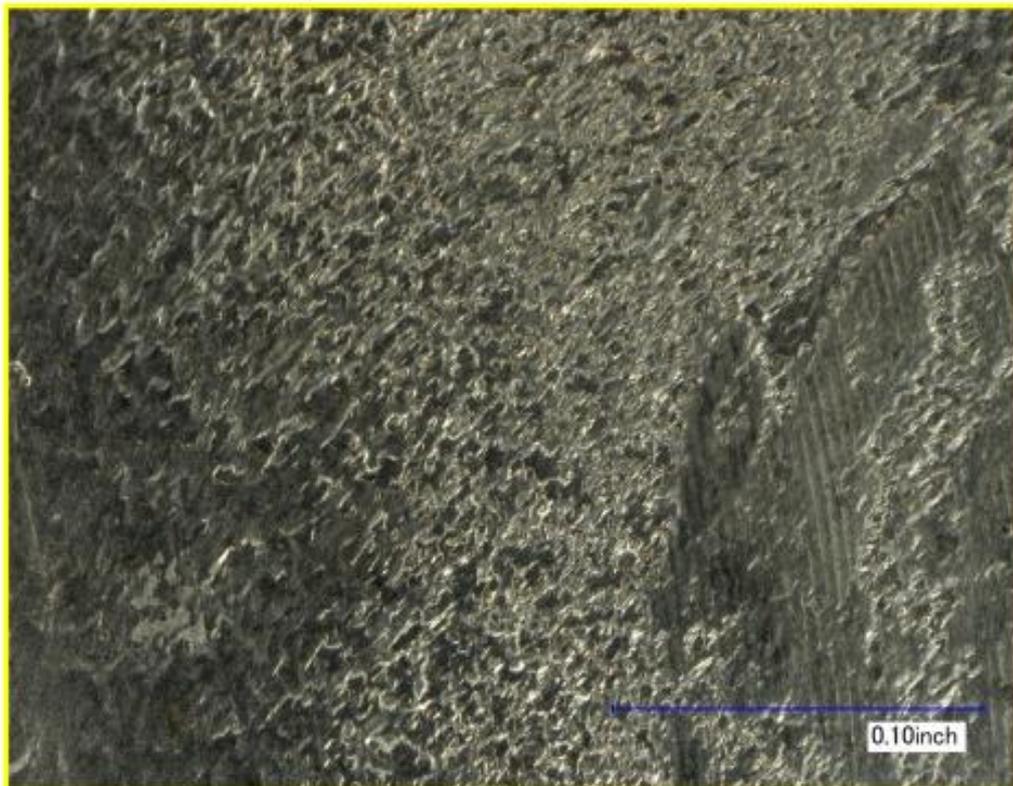
Figure 4. The flange contains contact wear marks. The line in the red box image is likely a scratch. The restrictions stated on the first page of this document are applicable to all pages of this document.

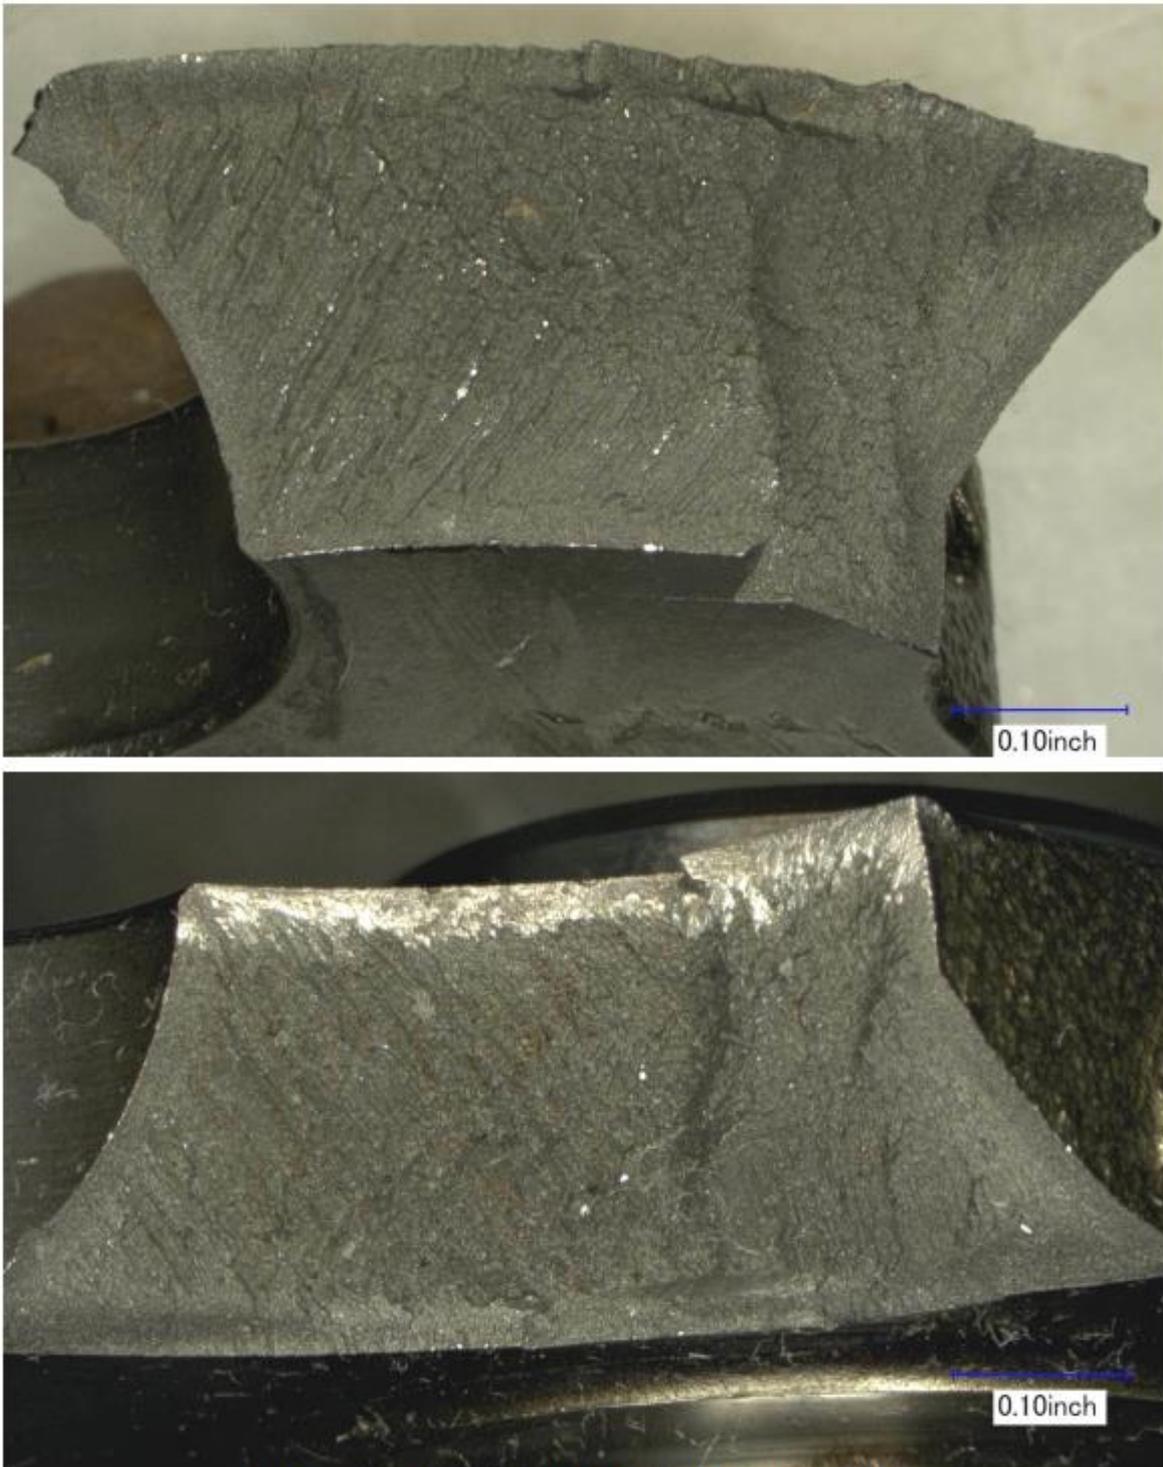
Figure 5. Right side of idler gear bolt hole fracture surfaces.

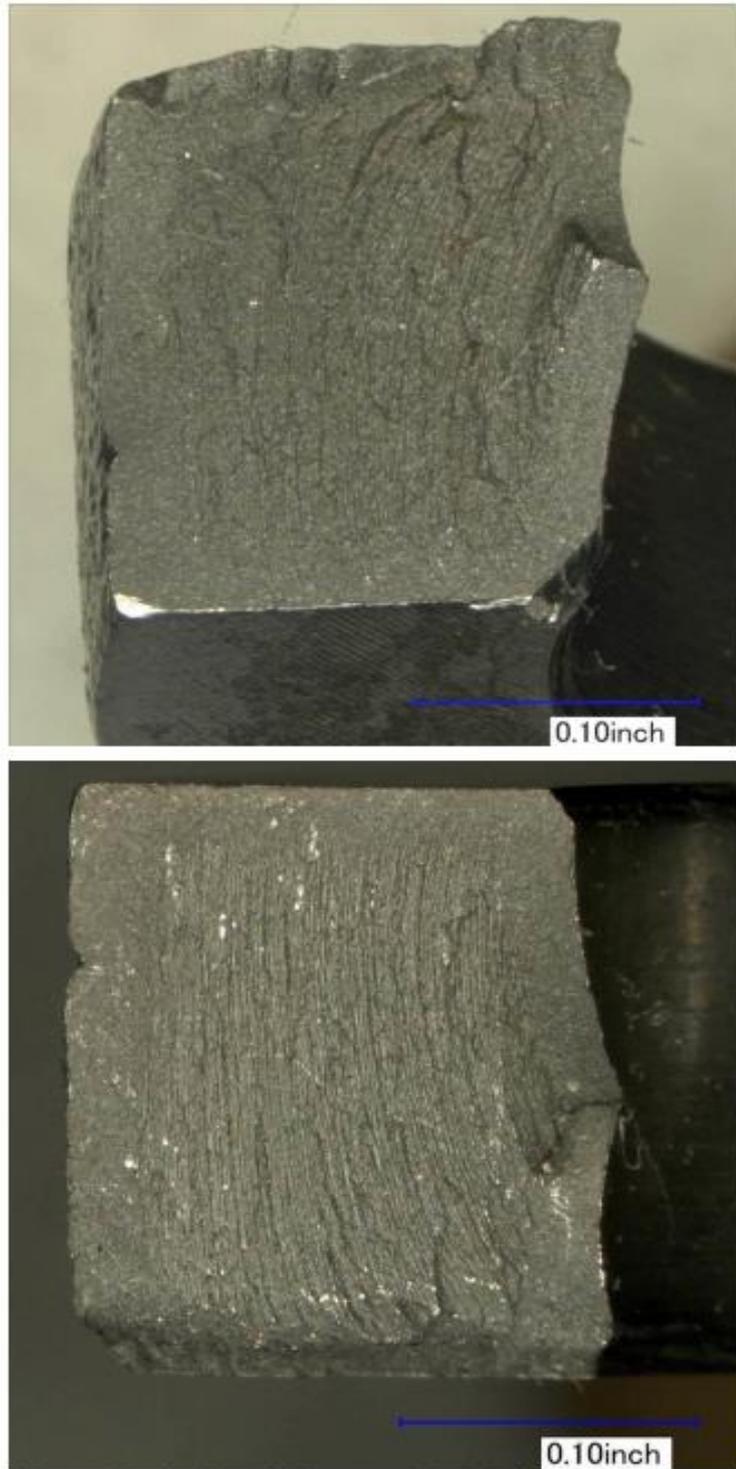
Figure 6. Left side of idler gear bolt hole fracture surfaces.

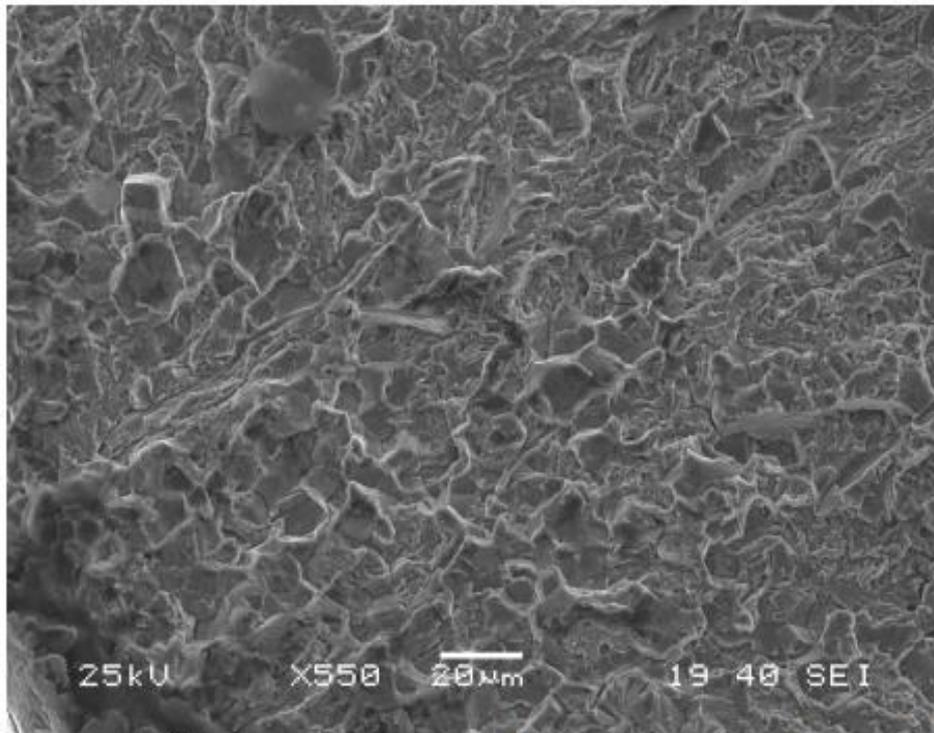
Figure 7. Idler gear shaft fracture surface case under SEM contains regions of intergranular fracture.

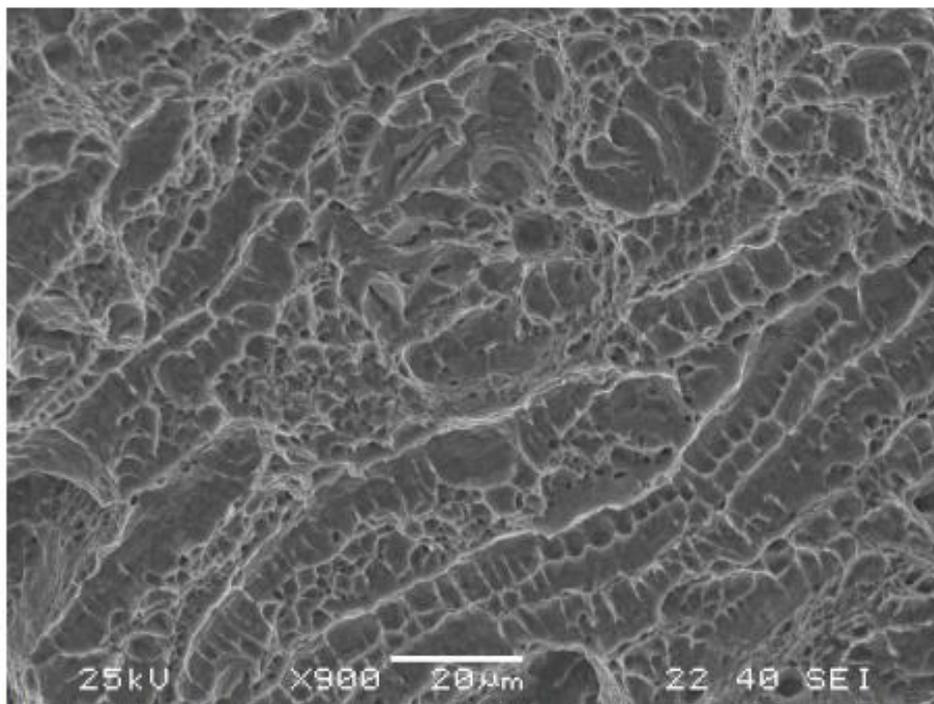
Figure 8. Idler gear shaft fracture surface woody texture region under SEM contains evidence of ductile overload.

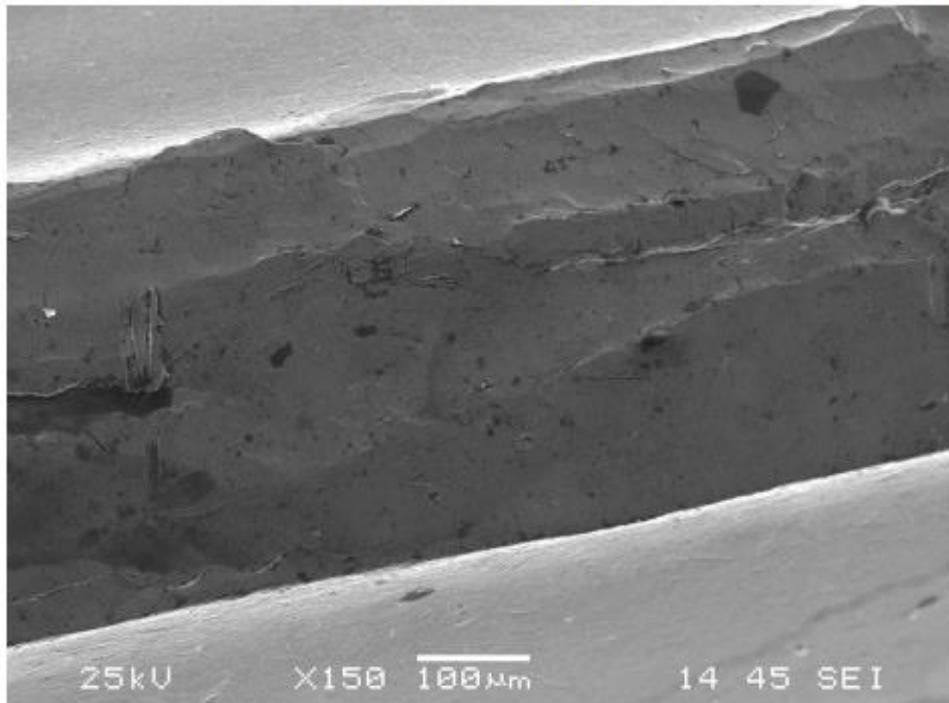
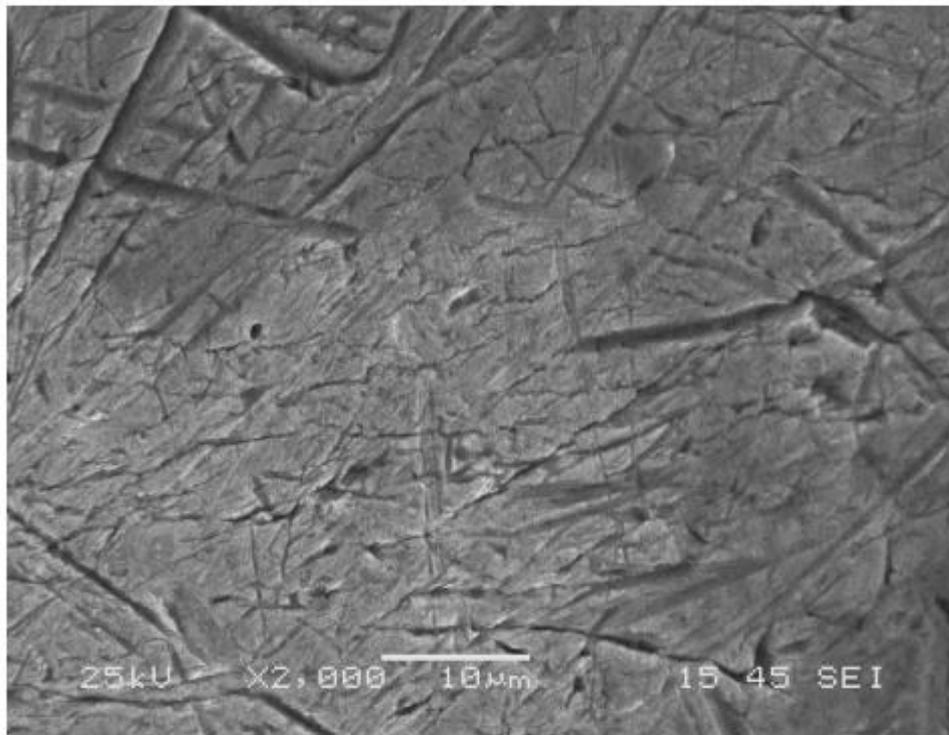
Figure 20. Fractured bolt thread under SEM.

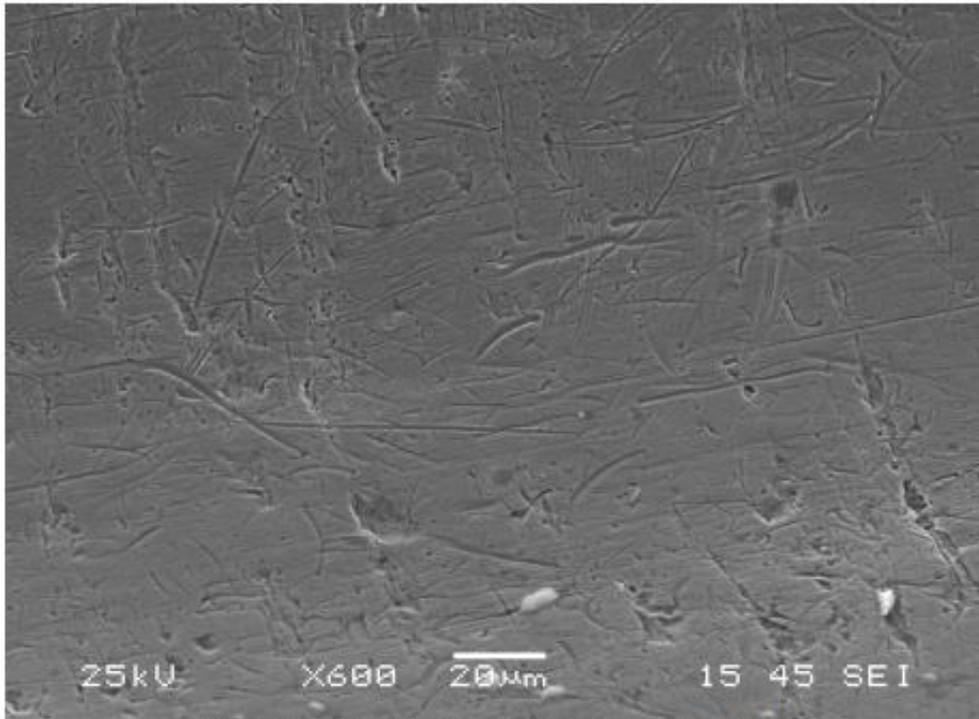
Figure 21. Fractured bolt thread root under SEM.

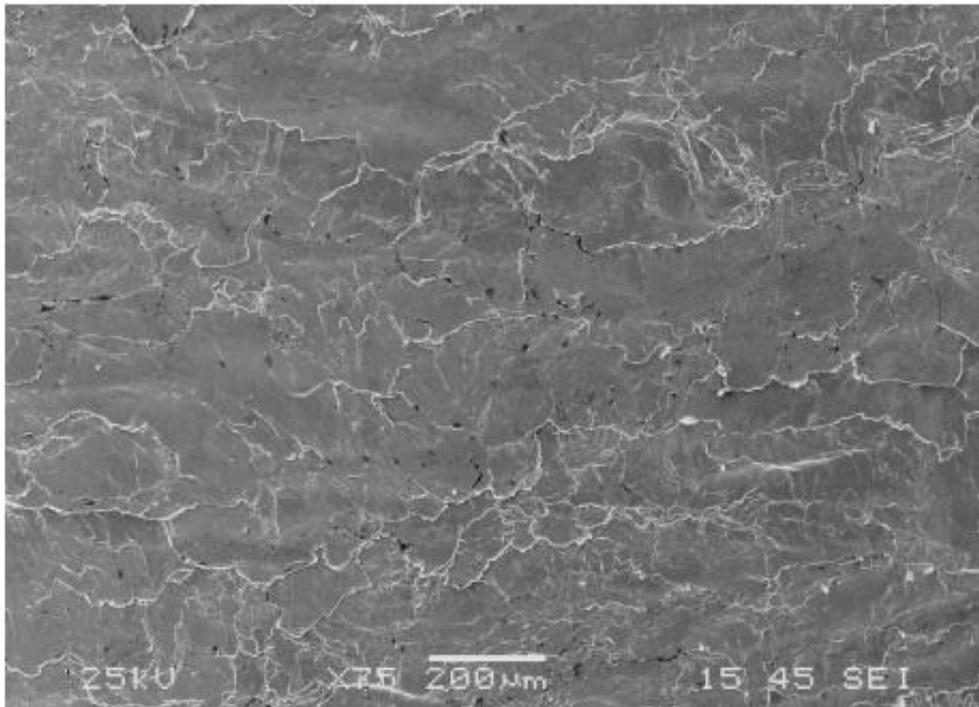
Figure 22. Fractured bolt away from threads under SEM.

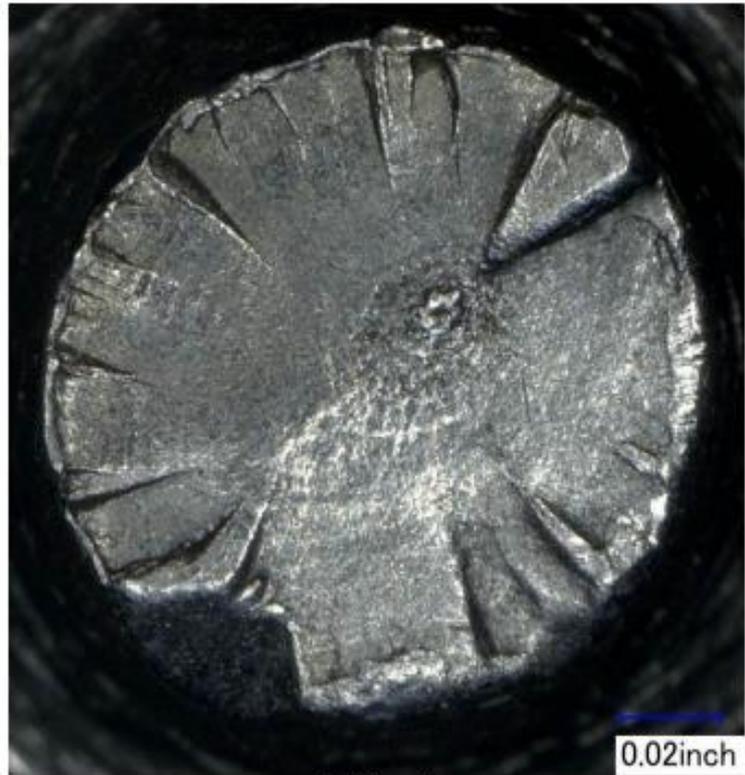
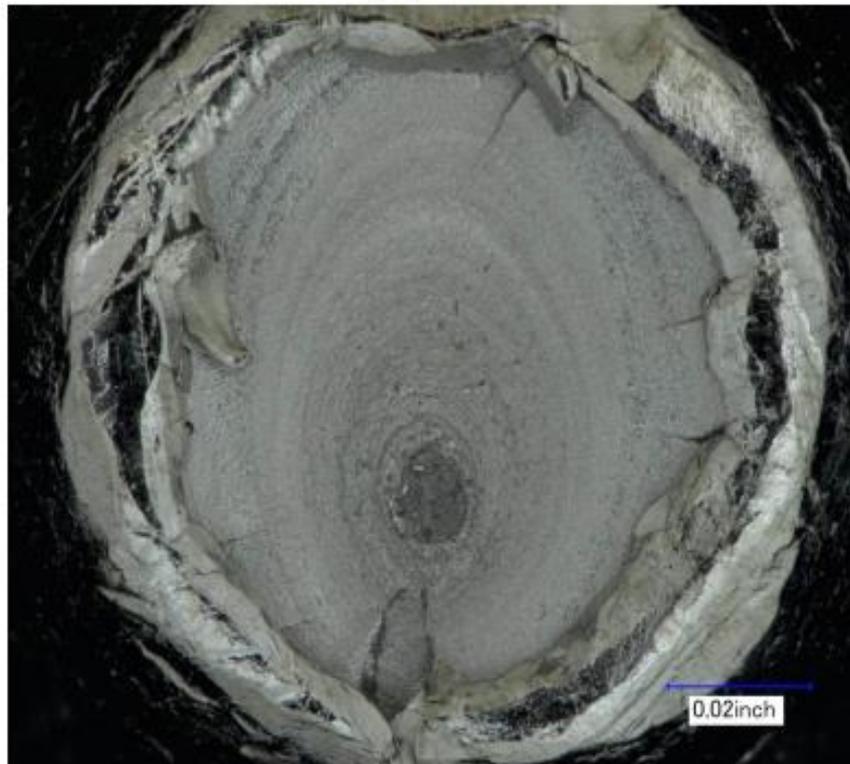
Figure 23. Bolt fracture surfaces. Ratchet marks and beach marks are evidence of fatigue.

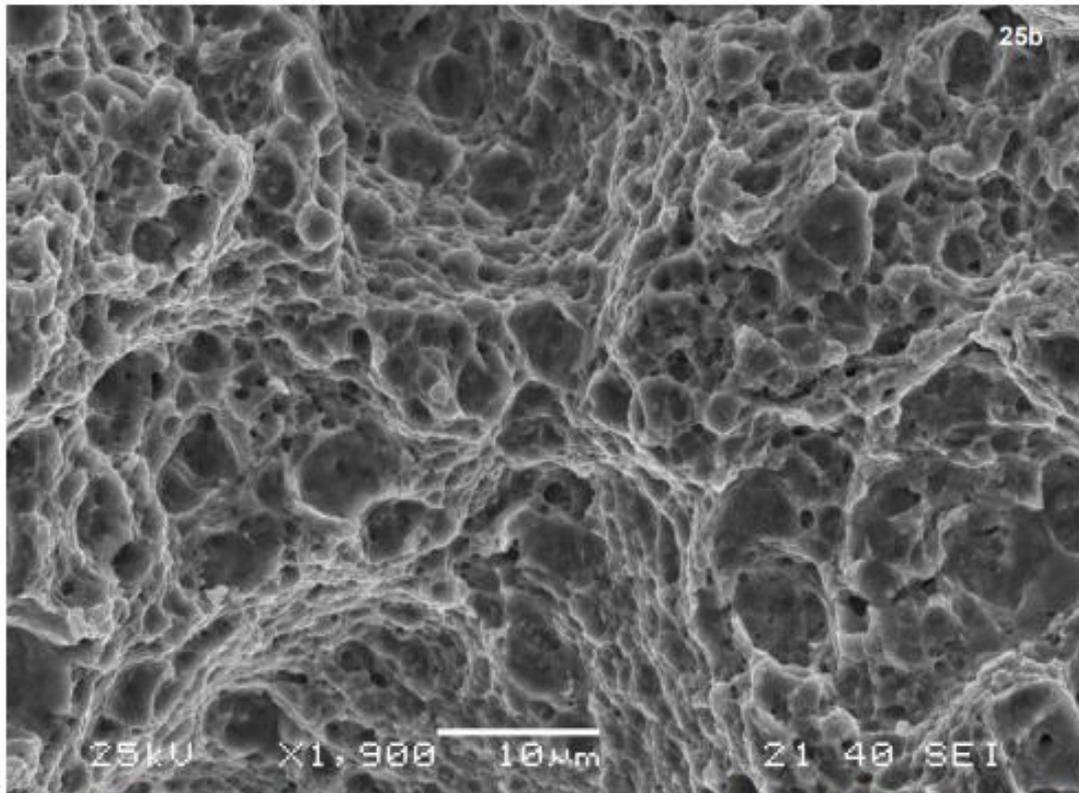
Figure 25. The base fracture surface center region contains evidence of ductile overloading.

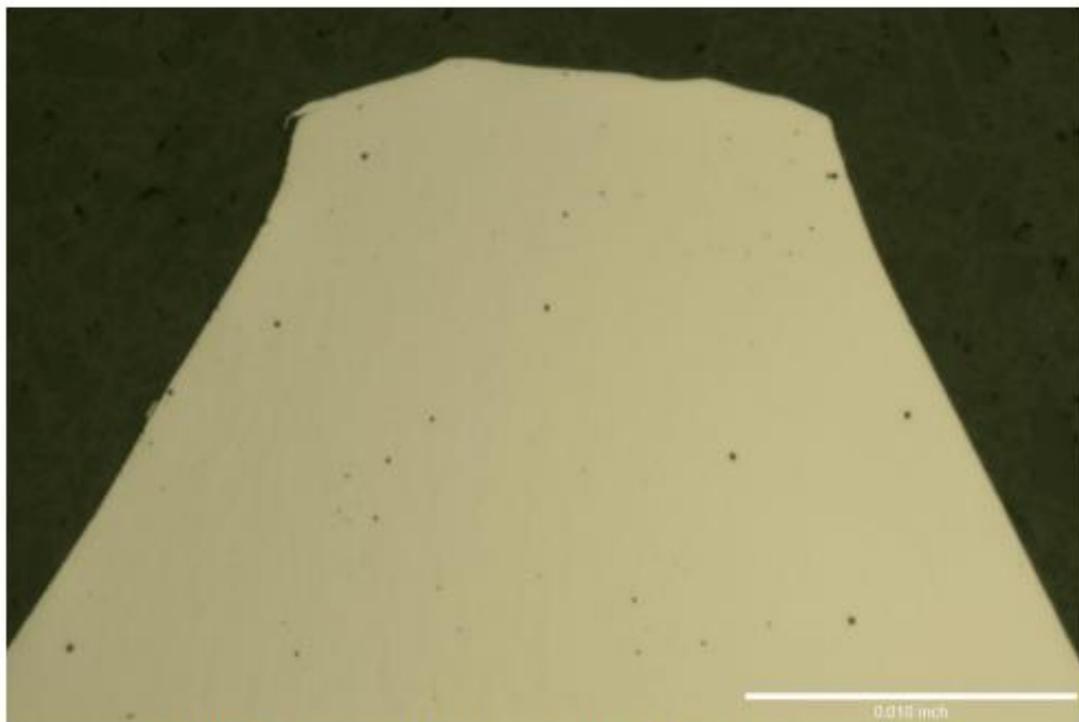
Figure 26. Fractured bolt cross-section thread tops are worn.

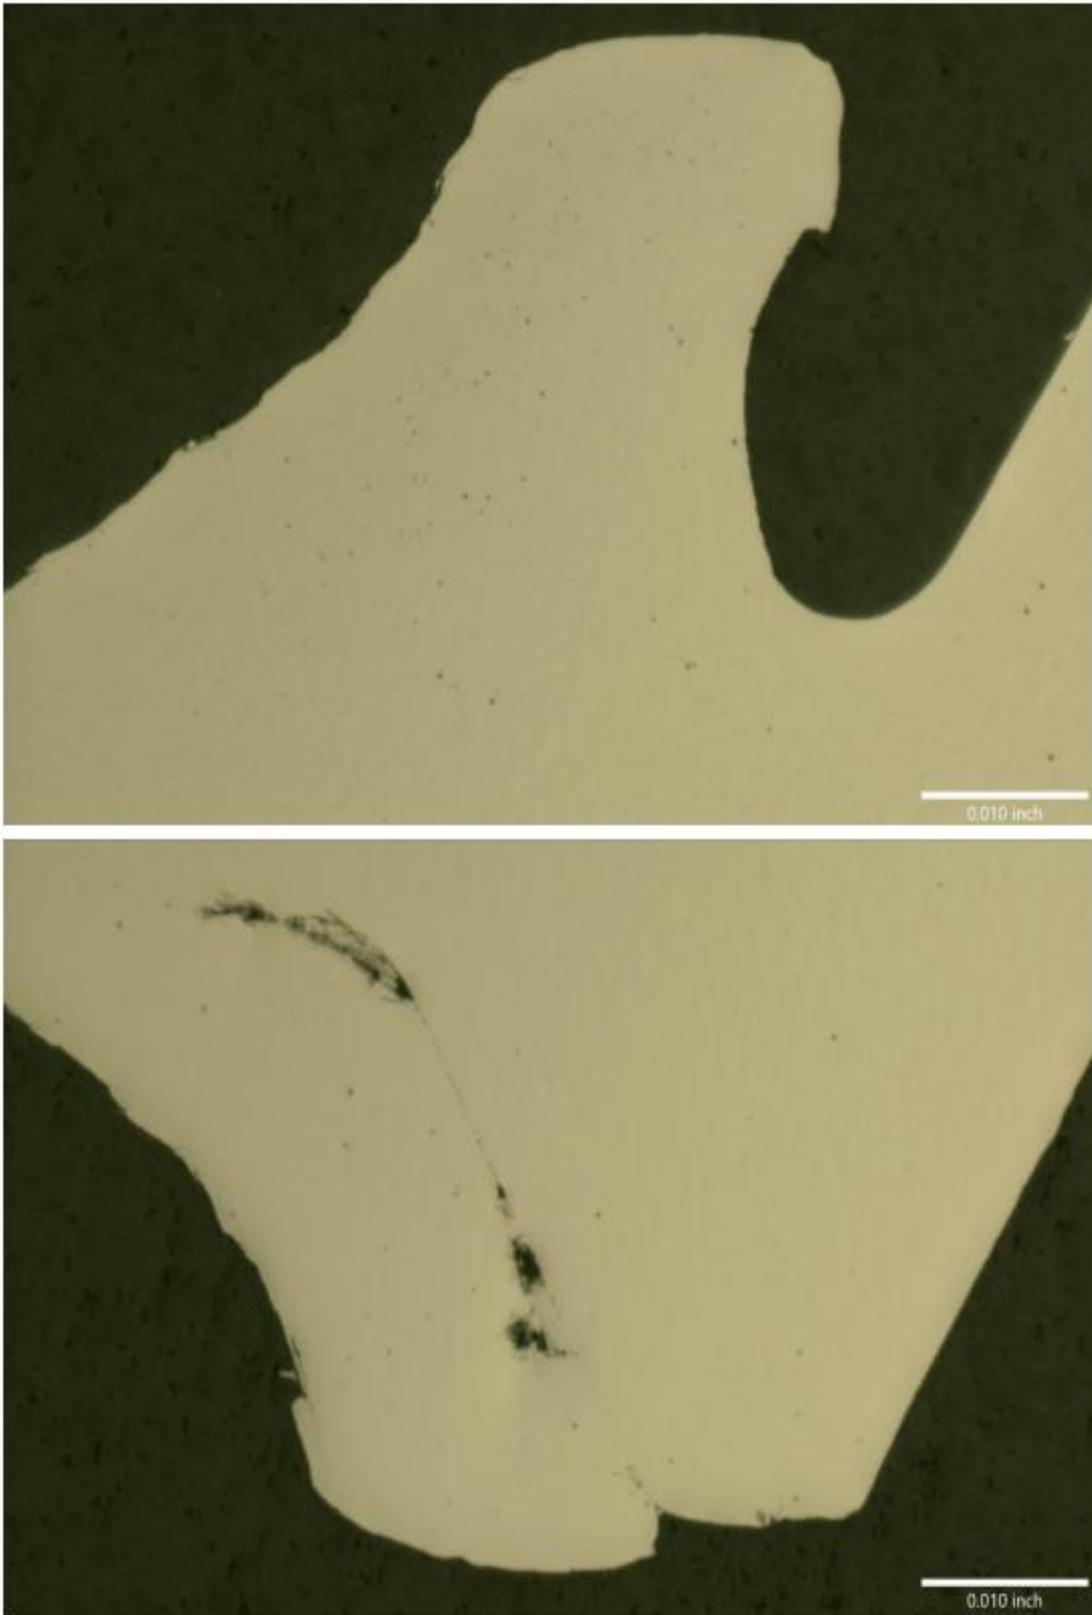
Figure 27. Fractured bolt cross-section last thread is severely deformed.
The restrictions stated on the first page of this document are applicable to all pages of this document.

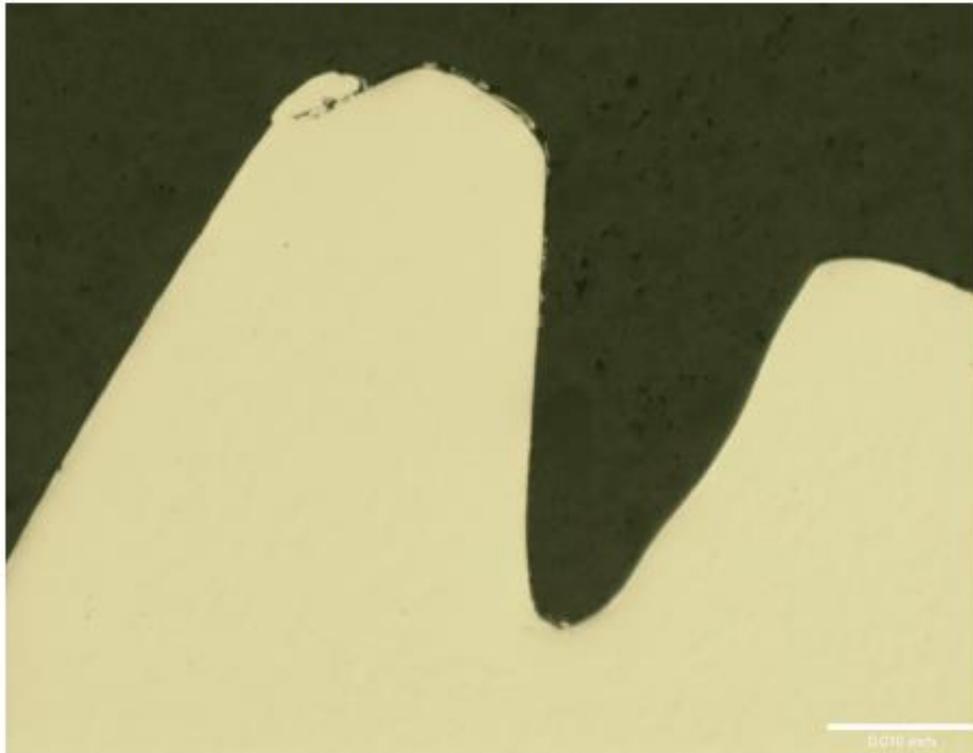
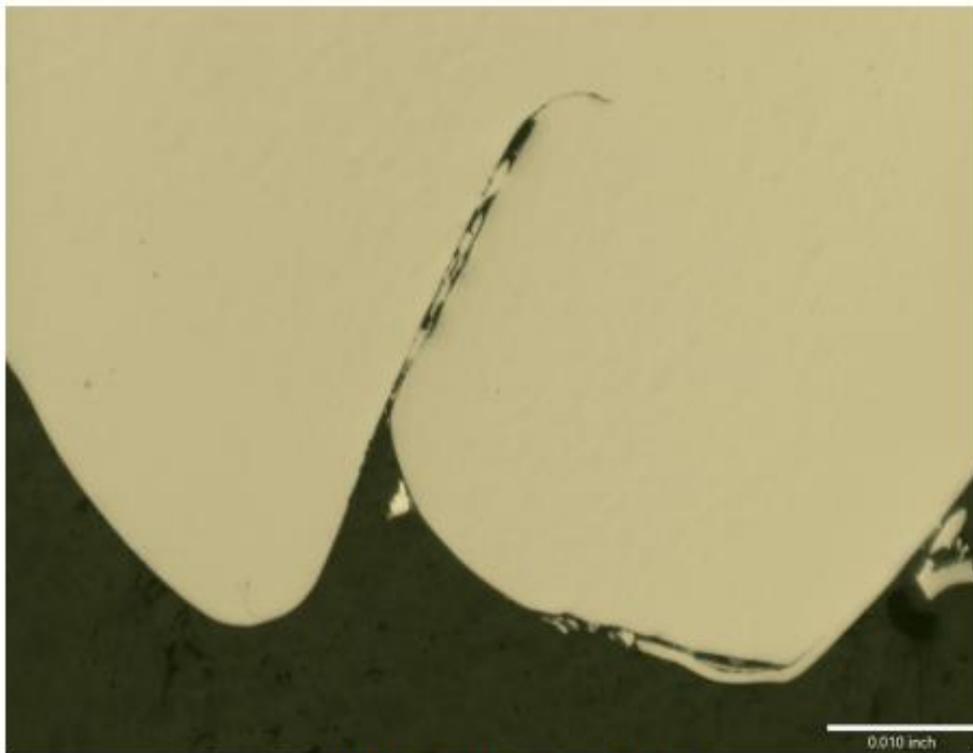
Figure 34. The non-fractured stud cross-section threads are severely deformed. The restrictions stated on the first page of this document are applicable to all pages of this document.
