AIRCRAFT ACCIDENT REPORT AND EXECUTIVE SUMMARY

Reference:	CA18/2/3/10381		
Aircraft Registration	ZU-MWG	Date of Accident	26 October 2023		Time of Accident	1517Z	
Type of Aircraft	Speed Canard (SC01 B-160) Veteran		Type of Operation		Private (Part 94)		
Pilot-in-command Licence Type		Private Pilot Licence (PPL)	Age	76	Licence Valid	Yes	
Pilot-in-command Flying Experience		Total Flying Hours		3 416.9	Hours on Type	Unknown	
Last Point of Departure		Rand Airport (FAGM), Germiston, Gauteng Province					
Next Point of Intended Landing		Zandspruit Aero Estate Private Airstrip, Hoedspruit, Limpopo Province					
Damage to Aircraft		Destroyed					
Location of the accident site with reference to easily defined geographical points (GPS readings if possible)							
Zandspruit Aero Estate private airstrip in Hoedspruit (GPS position: 24°22'01" South 030°55'25.93" East) at an elevation of 1700 feet (ft)							
Meteorological Information		Surface wind: 210°/07 kts; temperature: 19.2°C; dew point: 0.8°C; Visibility: CAVOK

Reference Number : CA18/2/3/10258
Occurrence Category : Accident (Category 1)
Type of Operation : Private (Part 94)
Name of Operator : Marcel Theodor Anthonius Johannes Nijdam
A

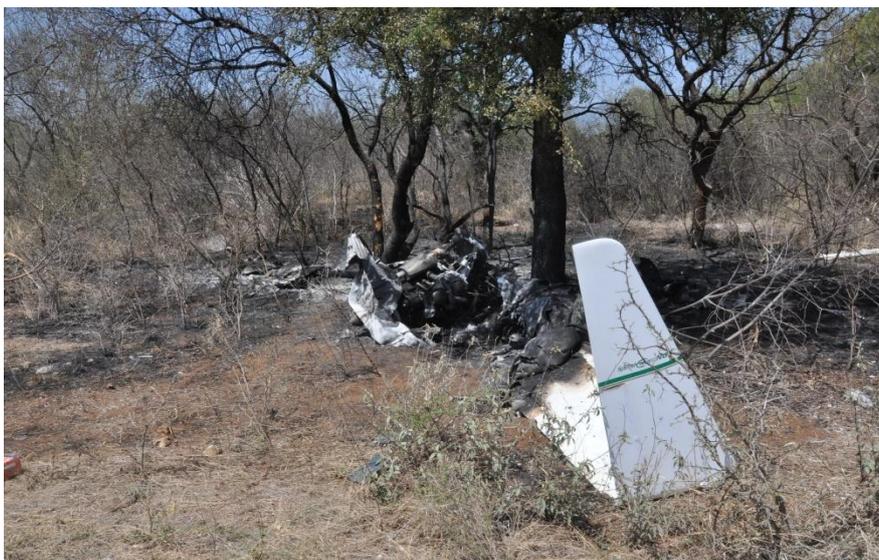
1.12.1 The aircraft touched down deep, about 250m from the threshold of Runway 35. The flaps were fully extended. During the landing roll, the aircraft drifted to the left and impacted a tree. The fuel tanks ruptured, which caused the fuel to spill. It is likely that the fuel ignited due to the hot engine. The fuel-fed fire ensued and consumed the aircraft.

Figure 4: The wreckage at the accident site.

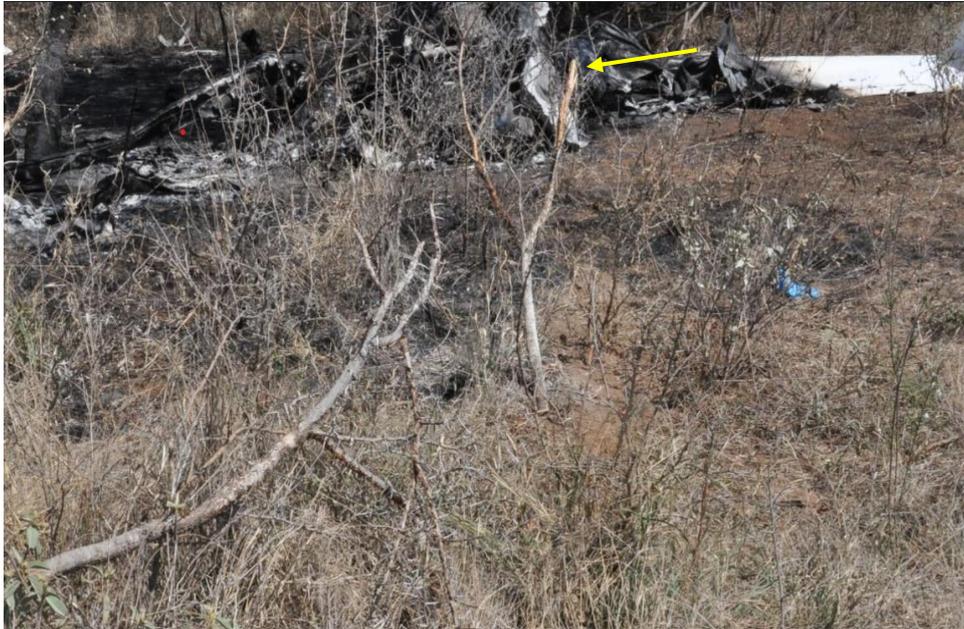
1.12.2 The witness marks on the tree (close to the propeller blades) indicated that the engine was producing a substantial amount of power at the time of impact. The amount of power the engine was producing cannot be determined. The control cables were examined and nothing abnormal was found.

Figure 5: A tree that was cut by the propeller.

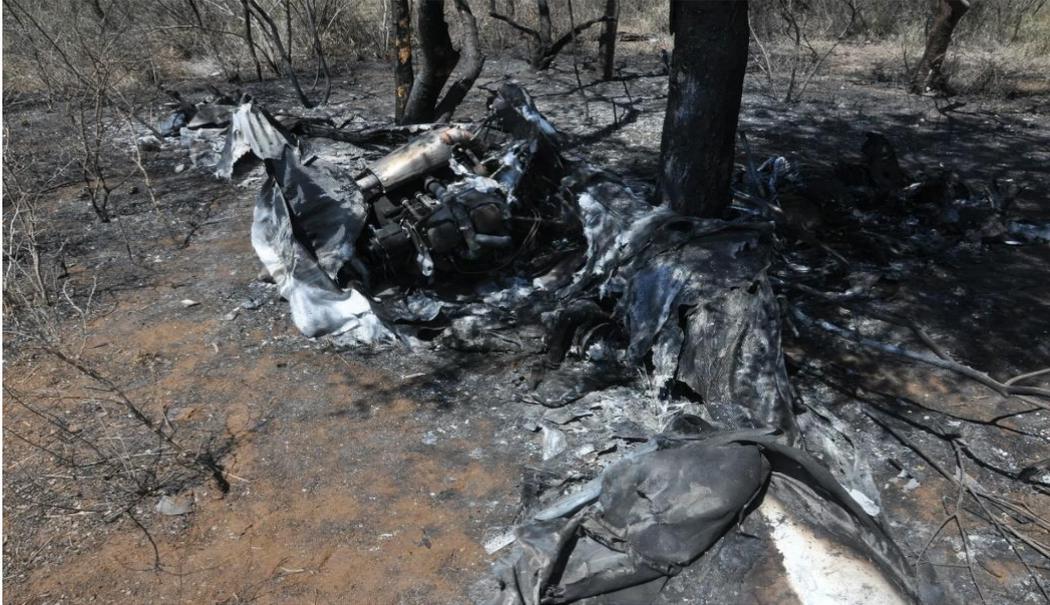
1.14.1 The aircraft was consumed by the post-impact fuel-fed fire that had erupted.

Figure 6: The wreckage post-accident.

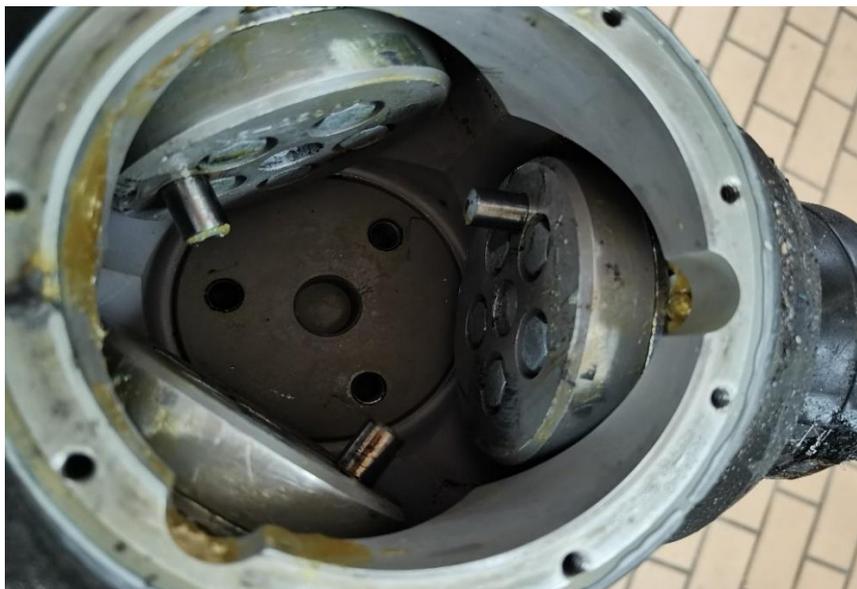
1.16.2 The propeller was removed from the engine and was dismantled. The bearings on the hubs had sufficient lubricant; also, the seals on the hubs were intact and in good condition. The propeller was put on a test rig, and it operated normally.

Figure 8: The propeller hubs after dismantling.

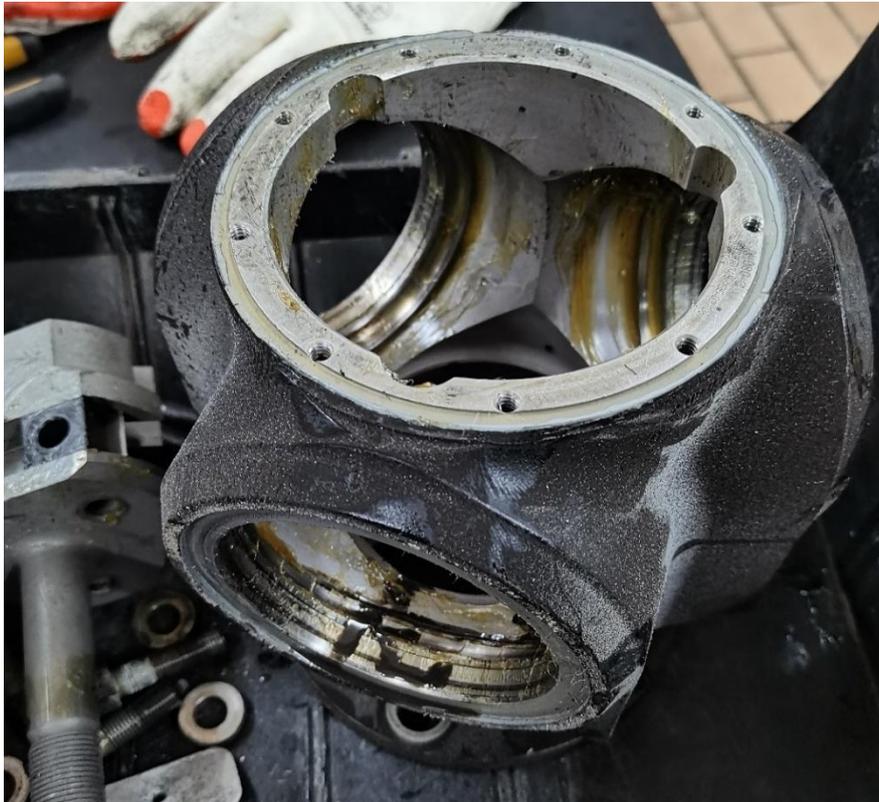
Figure 9: The propeller hubs and evidence of adequate lubrication on the bearings.

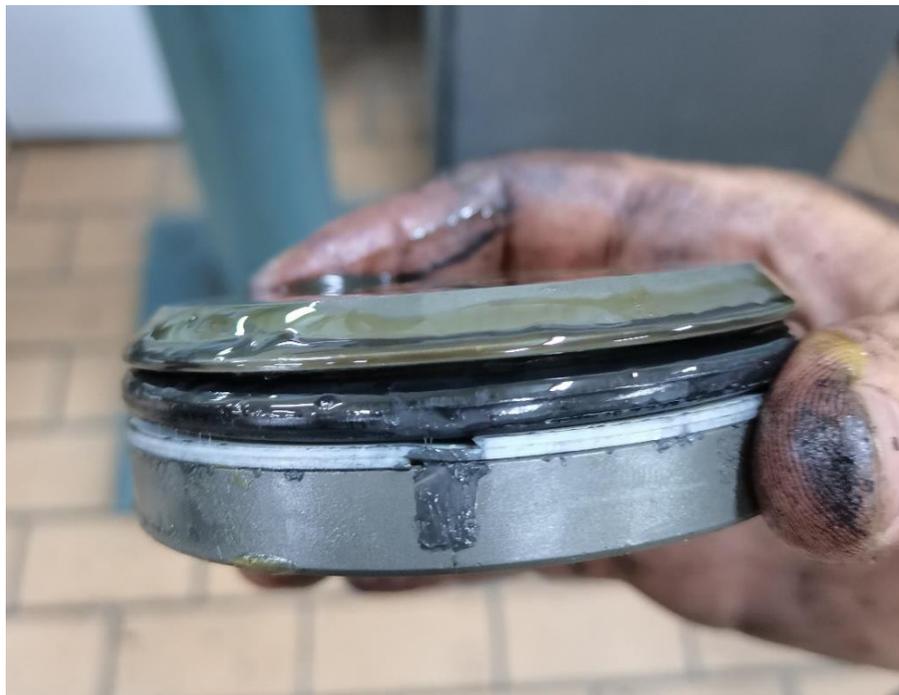
Figure 10: The seals on all three hubs were still intact.

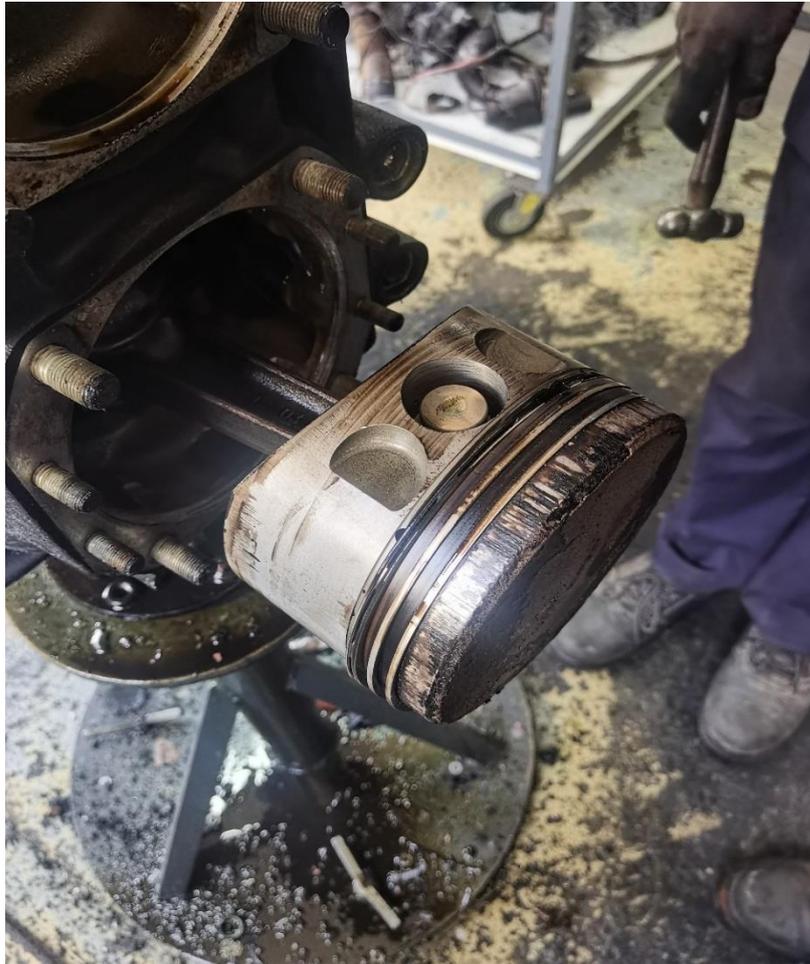
1.16.4 The oil sump contained sufficient oil. The cylinders revealed no damage that could have affected the engine from operating normally. The cylinder heads assembly, valves and rocker arms were intact. All pistons and rings were in good condition. All the connecting rods were found intact and connected at both the big- and small-ends. The plain sleeve bearing sets, main and big end showed no damage or excessive wear. The crankshaft was still in good condition. Nothing abnormal was noted on the engine. There was no evidence that the aircraft was not capable of normal operation at the time of the accident flight.

Figure 12: The pistons and rings were in good condition.
