LIMITED OCCURRENCE INVESTIGATION REPORT – FINAL

Reference Number	CA18/2/3/10382						
Classification	Accident	Date	27 October 2023	Time	1030Z		
Type of Operation	Private (Part 94)						
Location							
Place of Departure	Oudtshoorn Airport (FAOH), Western Cape Province		Place of Intended Landing	Oudtshoorn Airport (FAOH), Western Cape Province			
Place of Occurrence	Runway 22 at Oudtshoorn Airport (FAOH), Western Cape Province						
GPS Co-ordinates	Latitude	33° 36'2.55" S	Longitude	022° 11'20.95" E	Elevation	1073 ft	
Aircraft Information							
Registration	ZU-TFA						
Make; Model; S/N	Blackshape/Rossouw JJ V.B-560 (Serial Number: BPU011-13)						
Damage to Aircraft	Substantial			Total Aircraft Hours	295.6		
Pilot-in-command							
Licence Type	Commercial Pilot Licence (CPL)		Gender	Male		Age	57
Licence Valid	Yes	Total Hours	6125.0		Total Hours on Type	102.7	
Total Hours 30 Days	17.3		Total Flying on Type Past 90 Days	4.1			
People On-board	2 + 0	Injuries	0	Fatalities	0	Other (on ground)	0

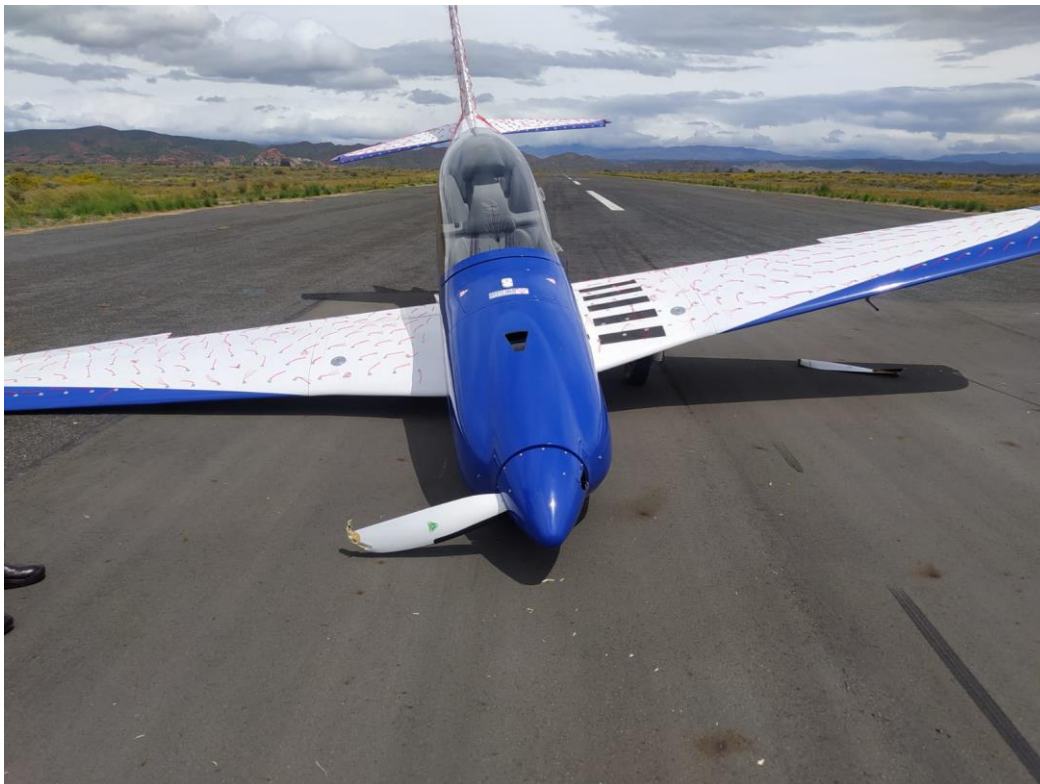
Figure 1: The front view of the aircraft after the accident. (Source: Operator)

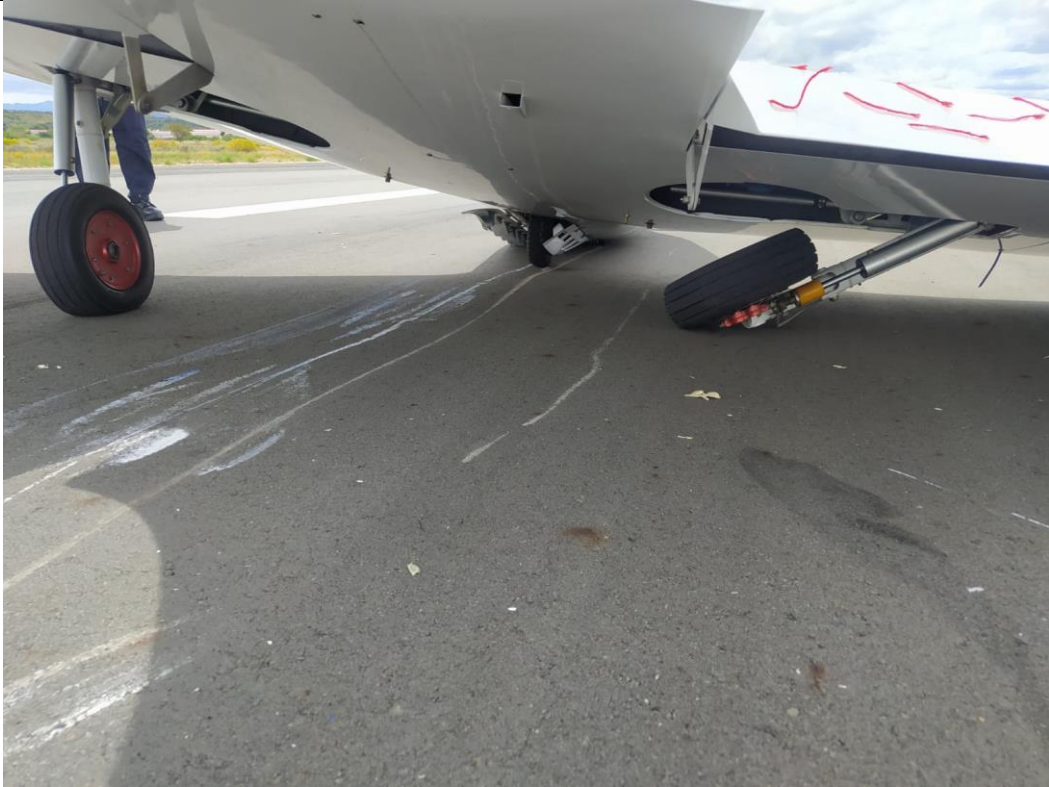
Figure 2: View of the landing gear after the accident. (Source: Operator)

The aircraft did not have a squat switch feature (on the undercarriage); thus, it is possible to retract landing gear whilst the aircraft is on the ground.

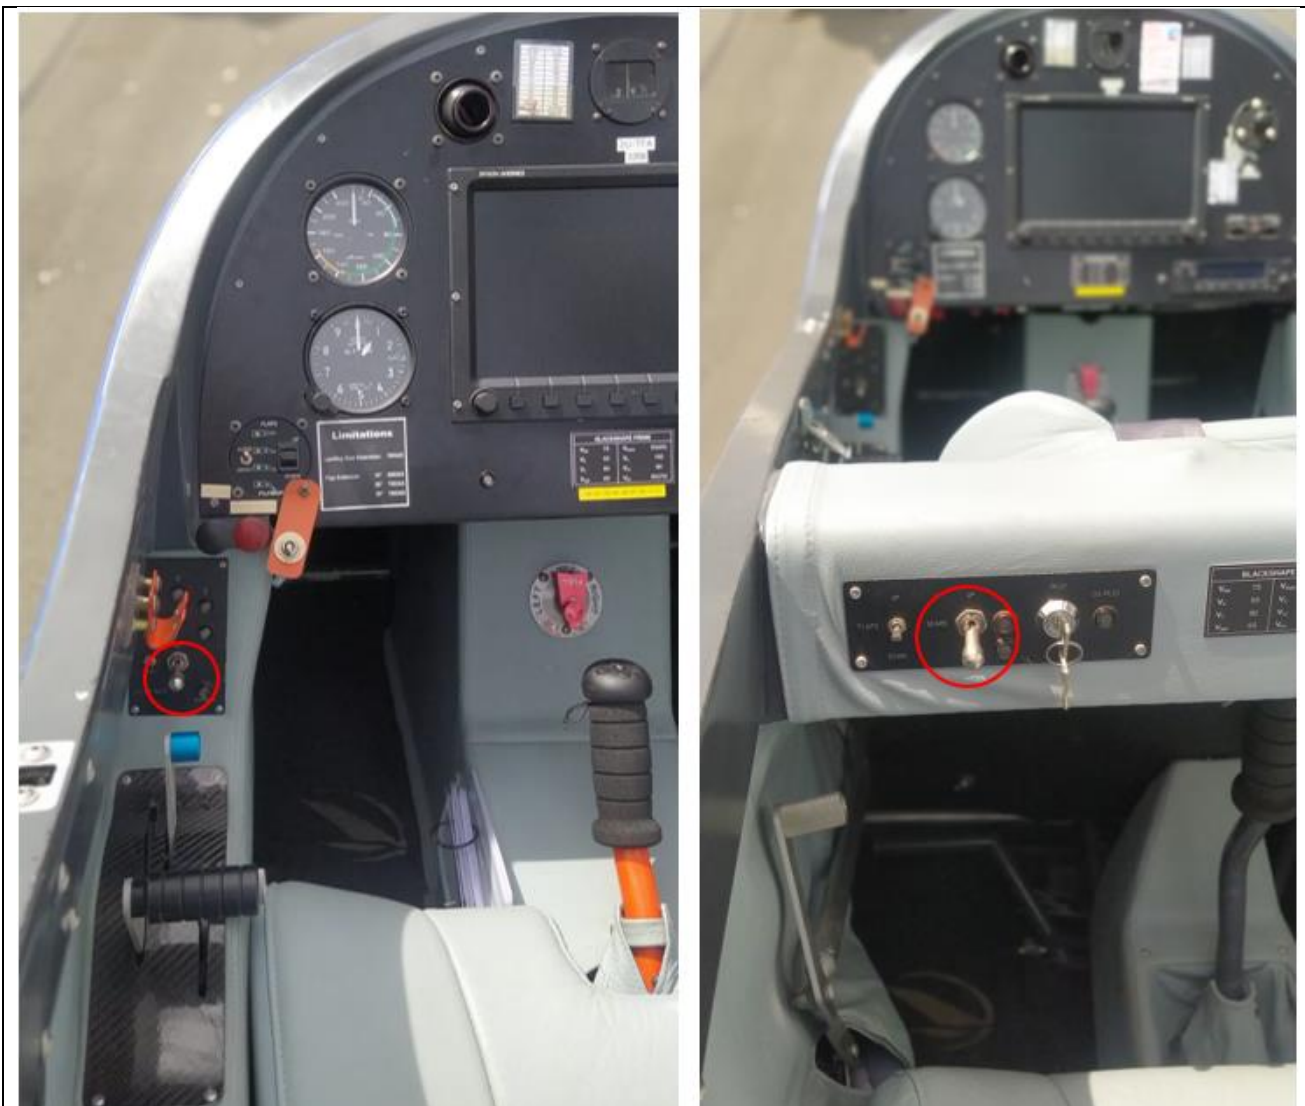
Figures 3 and 4: Red circles indicate front and rear cockpit control switches. (Source: Operator)

The rear cockpit also had a gear lever (see Figure 4). A key has to be turned to activate the rear cockpit control panel. When the rear cockpit control panel is activated, it overrides the front cockpit.

6. Fine weather conditions prevailed at the time of the flight. The weather did not have a bearing to this accident.
7. The rear cockpit gear lever was in the UP position, and the front cockpit gear lever was in the DOWN position. When the rear cockpit control panel was activated, it overrode the front cockpit; and with the gear selector in the UP position, this resulted in the landing gears retracting during a demonstration of the flap indication when the aircraft was being backtracked.

8. The mode selector key was rotated during the landing roll, which was not in line with the manufacturer's procedures. The key was not removed as recommended by the manufacturer.
Probable Cause(s)
Inadvertent retraction of the landing gear during a demonstration of the flap indication whilst the aircraft was being backtracked.
Contributing Factor(s)
Disregard of the manufacturer's instruction which required the removal of the rear cockpit key.
Safety Action(s)
None.
Safety Message
To avoid injuries and damage to property, the landing gear micro switch (squat switch) should be installed to this aircraft to avoid inadvertent retraction of landing gear when the aircraft is on the ground.
About this Report
<i>The decision to conduct a limited investigation is based on factors including whether the cause is known and the evidence supporting the cause is clear, the level of safety benefit likely to be obtained from an investigation and that will determine the scope of an investigation. For this occurrence, a limited investigation has been conducted, and the Accident and Incident Investigations Division (AIID) has relied on the information submitted by the affected person/s and organisation/s to compile this limited report. The report has been compiled using information supplied in the initial notification, as well as from follow-up desk top enquiries to bring awareness of potential safety issues to the industry in respect of this occurrence, as well as possible safety action/s that the industry might want to consider in preventing a recurrence of a similar occurrence.</i>
