**LIMITED OCCURRENCE INVESTIGATION REPORT – FINAL**

<b>Reference Number</b>		CA18/2/3/10383						
<b>Classification</b>		Accident		<b>Date</b>		28 October 2023	<b>Time</b>	0830Z
<b>Type of Operation</b>		Private (Part 91)						
<b>Location</b>								
<b>Place of Departure</b>		Wonderboom Airport, (FAWB) Gauteng Province		<b>Place of Intended Landing</b>		Wonderboom Airport (FAWB), Gauteng Province		
<b>Place of Occurrence</b>		Private farm in Bela-Bela, Limpopo						
<b>GPS Co-ordinates</b>	<b>Latitude</b>	24° 56' 31.4" S	<b>Longitude</b>	028° 16' 32.3" E	<b>Elevation</b>	4100ft		
<b>Aircraft Information</b>								
<b>Registration</b>		ZS-MKY						
<b>Make; Model; S/N</b>		Piper; PA28-180 Cherokee (Serial Number: 28-1171)						
<b>Damage to Aircraft</b>		Substantial		<b>Total Aircraft Hours</b>		3705.16		
<b>Pilot-in-command</b>								
<b>Licence Type</b>	Private Pilot Licence		<b>Gender</b>	Male		<b>Age</b>	23	
<b>Licence Valid</b>	Yes	<b>Total Hours</b>	77.4		<b>Total Hours on Type</b>		77.4

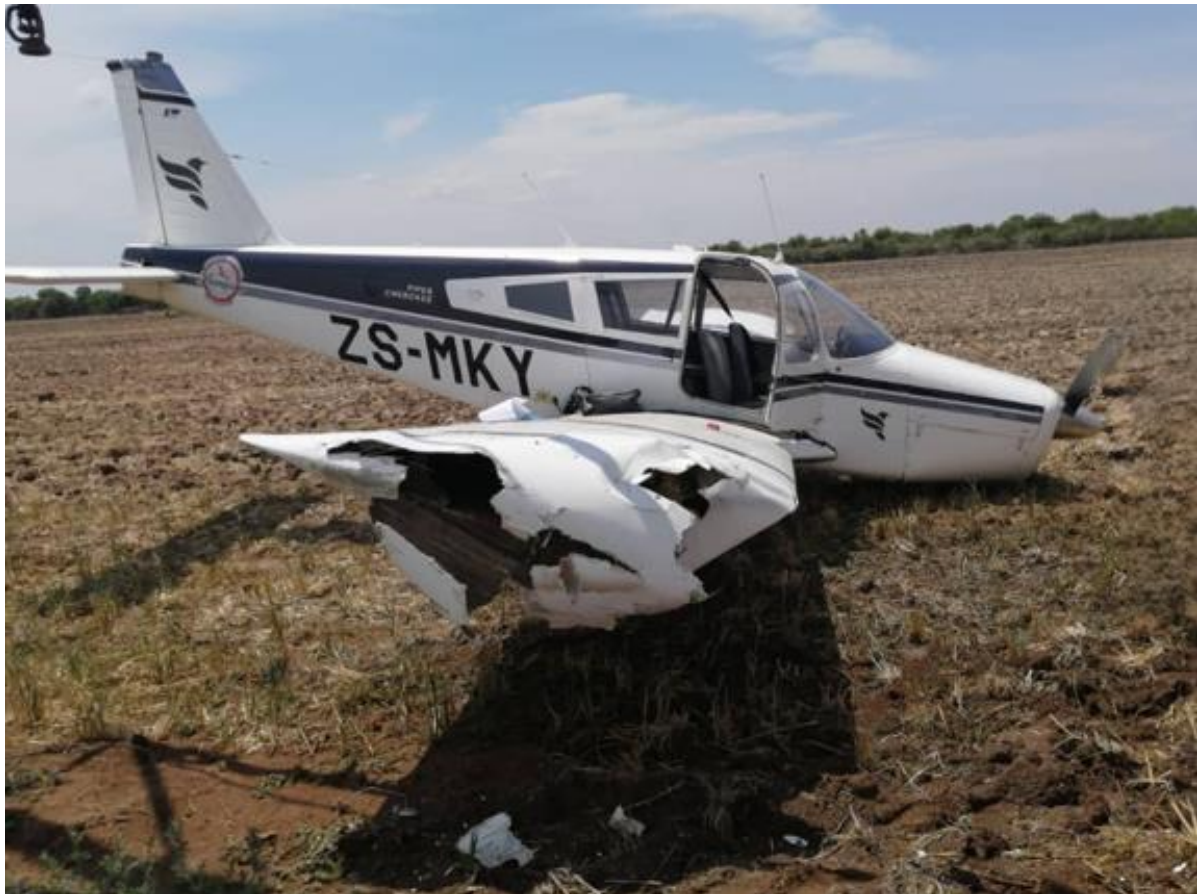
The aircraft sustained damage to the right-wing tip, the nose landing gear, engine cowlings and the propeller blade. No injuries were reported during this accident. All occupants disembarked from the aircraft unassisted.

**Figure 1:** The damaged aircraft after the accident. (Source: Operator)

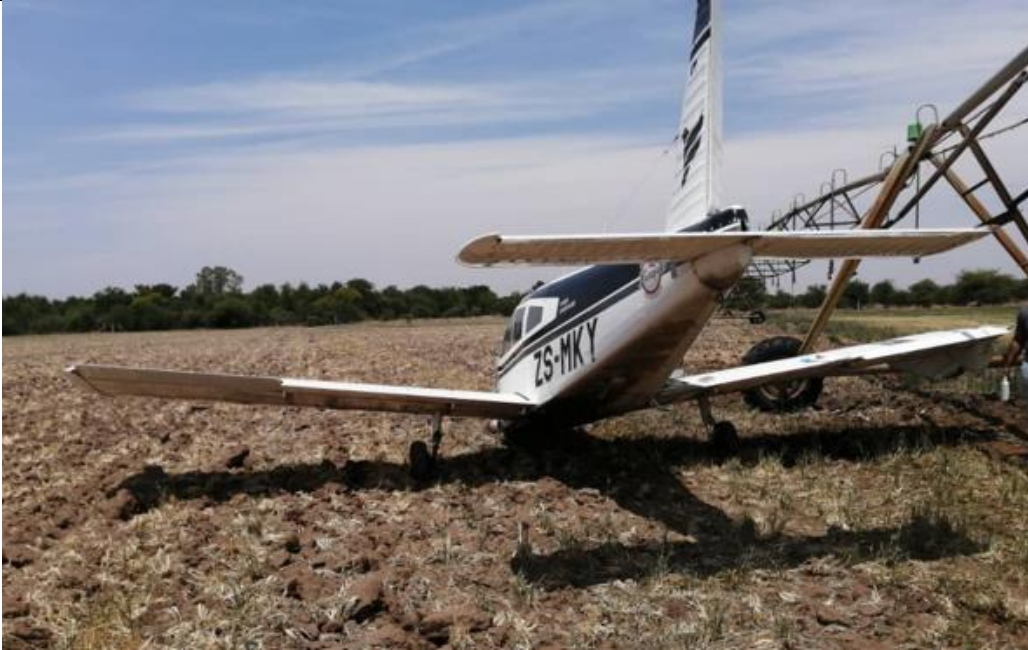
When the nose gear touched the ground, the pilot applied brakes to reduce speed. However, the aircraft veered off to the left whereafter it impacted an irrigation machine with its right wing before it stopped. During impact, the aircraft abruptly shifted to the left and the nose landing gear broke, which caused the propeller to impact the ground. One of the propeller blades caused the engine to stop.

**Figure 2:** The aircraft's resting position post-accident. (Source: Operator)

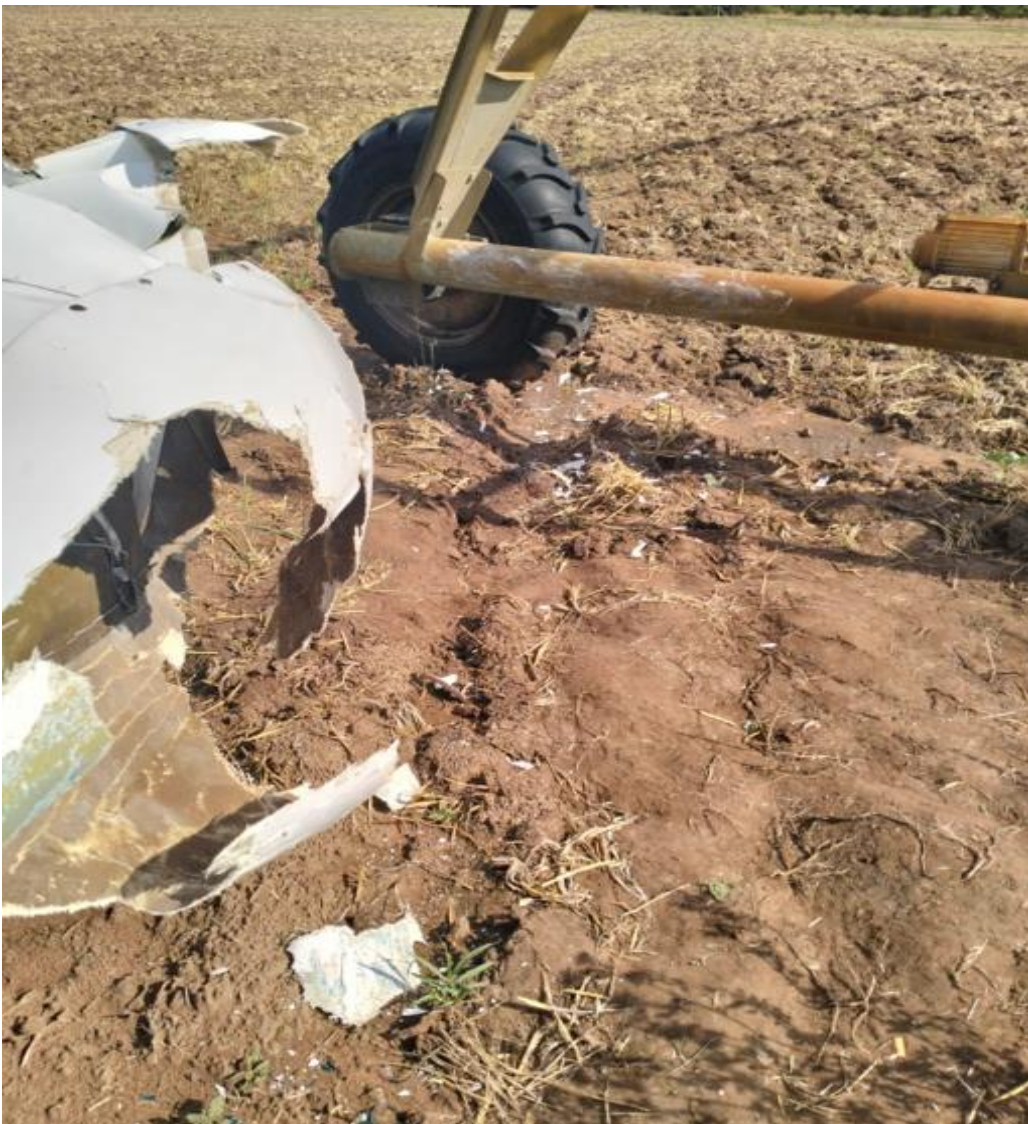
**Figure 3:** Damaged caused to the irrigation machine.
