LIMITED OCCURRENCE INVESTIGATION REPORT – FINAL

Reference Number	CA18/2/3/10384						
Classification	Accident	Date	4 November 2023			Time	1145Z
Type of Operation	Private (Part 91)						
Location							
Place of Departure	Lydenburg Airfield (FALL), Mpumalanga Province		Place of Intended Landing			Lydenburg Airfield (FALL), Mpumalanga Province	
Place of Occurrence	Runway 04, Lydenburg Airfield (FALL) Mpumalanga Province						
GPS Co-ordinates	Latitude	25°6'76" South (S)	Longitude	030°24'63" East (E)	Elevation	4 880 feet	
Aircraft Information							
Registration	ZS-DOB						
Make; Model; S/N	Beech Aircraft Corporation; G35 Bonanza (Serial Number: D-4654)						
Damage to Aircraft	Substantial			Total Aircraft Hours	8225.54		
Pilot-in-command							
Licence Type	Private Pilot Licence (PPL)		Gender	Male		Age	50
Licence Valid	Yes	Total Hours	405		Total Hours on Type	145.6	
Total Hours 30 Days	9		Total Flying on Type Past 90 Days			42	
People On-board	1+3	Injuries	0	Fatalities	0	Other (on ground)	0

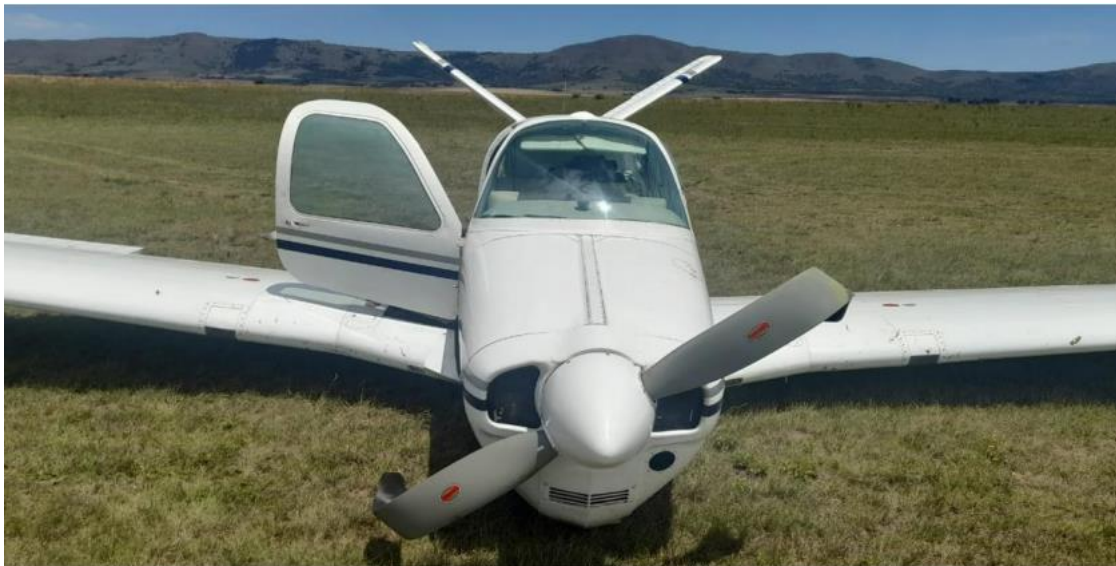
After the accident, the aircraft maintenance organisation (AMO) conducted a visual inspection of the aircraft, and the following damage was recorded: the undercarriage covers and the engine lower cowlings sustained damage; the propeller blades were curled backwards (see Figure 1). The landing gear selector lever was found in the down position (see Figure 2).

Figure 1: The damaged propeller blades. (Source: Operator)

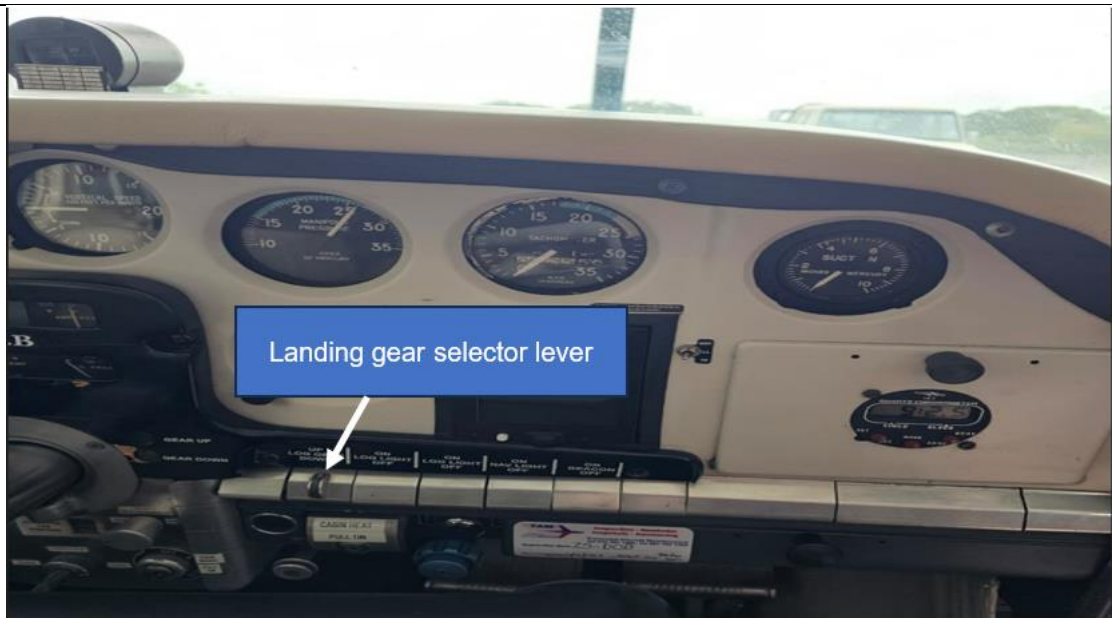
Figure 2: The cockpit instruments. (Source: Operator)
