**LIMITED OCCURRENCE INVESTIGATION REPORT – FINAL**

<b>Reference Number</b>	CA18/2/3/10385						
<b>Classification</b>	Accident	<b>Date</b>	06 November 2023		<b>Time</b>	0941Z	
<b>Type of Operation</b>	Training (Part 141)						
<b>Location</b>							
<b>Place of Departure</b>	Port Elizabeth International Airport (FAPE), Eastern Cape Province		<b>Place of Intended Landing</b>		Port Elizabeth International Airport (FAPE), Eastern Cape Province		
<b>Place of Occurrence</b>	Runway 26 at Port Elizabeth International Airport (FAPE)						
<b>GPS Co-ordinates</b>	<b>Latitude</b>	33°59'18.22"S	<b>Longitude</b>	25°36'37.71"E	<b>Elevation</b>	172.8 ft	
<b>Aircraft Information</b>							
<b>Registration</b>	ZU-IAE						
<b>Make; Model; S/N</b>	Sling II (Serial Number: 143)						
<b>Damage to Aircraft</b>	Substantial			<b>Total Aircraft Hours</b>	7734.9		
<b>Pilot-in-command</b>							
<b>Licence Type</b>	Student Pilot Licence (SPL)		<b>Gender</b>	Male		<b>Age</b>	22

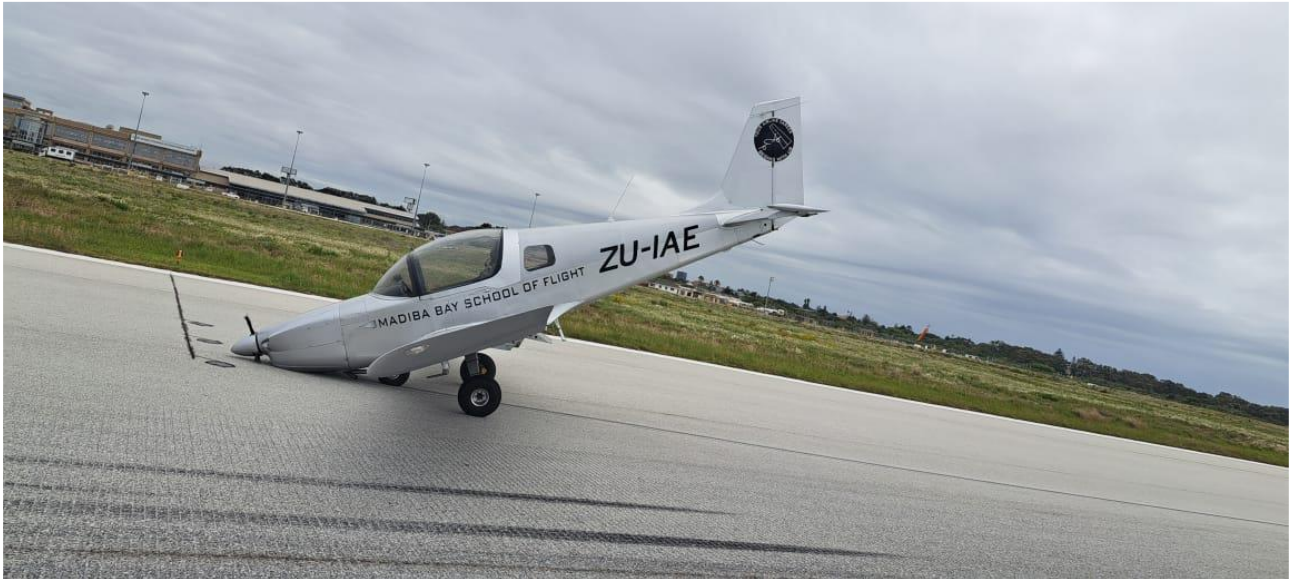
**Figure 1:** The aircraft after it stopped on the runway. (Source: Operator)

The student pilot lost control of the aircraft whilst attempting to land at a higher-than-normal approach speed.

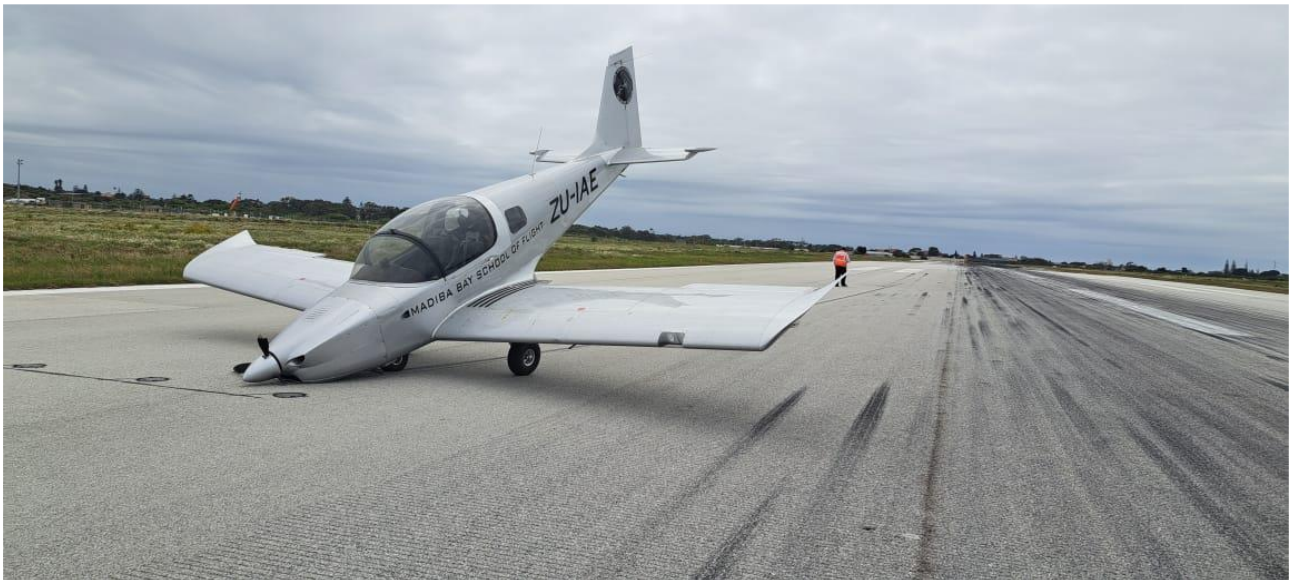
**Figure 2:** All propeller blades were damaged, and the nose wheel bent backwards. (Source: Operator)
