**LIMITED OCCURRENCE INVESTIGATION REPORT – FINAL**

<b>Reference Number</b>	CA18/2/3/10386						
<b>Classification</b>	Accident	<b>Date</b>	5 November 2023		<b>Time</b>	1409Z	
<b>Type of Operation</b>	Private (Part 94)						
<b>Location</b>							
Place of Departure	Klipriver Airfield (FAKP), Gauteng Province		Place of Intended Landing	Klipriver Airfield (FAKP), Gauteng Province			
Place of Occurrence	On the grass approximately 70 metres (m) south of Runway 02 threshold at FAKP, Gauteng province						
GPS Co-ordinates	Latitude	26°28'55.06" S	Longitude	28°06'36.45" E	Elevation	4 985 feet	
<b>Aircraft Information</b>							
Registration	ZU-IOX						
Make; Model; S/N	Zenith Aircraft, Zodiac CH 601HD (Serial Number: 6-6719)						
Damage to Aircraft	Substantial			Total Aircraft Hours	51.75		
<b>Pilot-in-command</b>							
Licence Type	Private Pilot Licence (PPL)		Gender	Male		Age	47
Licence Valid	Yes	Total Hours	199.21		Total Hours on Type	13.91	
Total Hours 90 Days	13.91		Total Flying on Type Past 30 Days	13.91

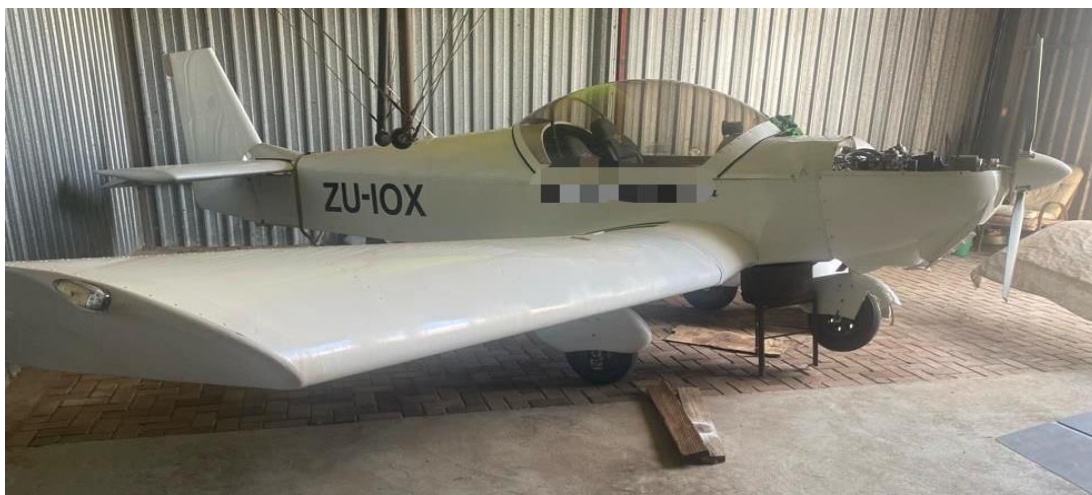
The pilot tried to restart the engine, but without success. He then glided the aircraft towards Runway 02; however, he could not reach it; he landed the aircraft on the grass-covered area approximately 70m short of Runway 02 threshold. During the landing roll, the nose gear strut collapsed and the propeller struck the ground. The aircraft sustained substantial damage. The pilot was not injured during the accident sequence.

**Figure 2:** The aircraft in the hangar after it was recovered.

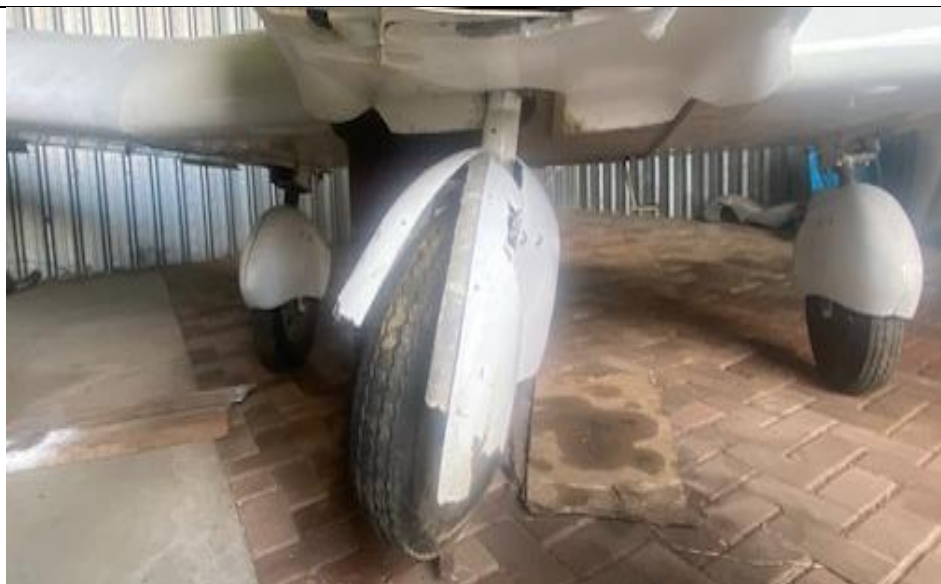
**Figure 3:** Bent nose gear strut and the damaged wheel fairing.
