AIRCRAFT ACCIDENT REPORT AND EXECUTIVE SUMMARY

Reference:		CA18/2/3/10387	
Aircraft Registration	ZS-OKN	Date of Accident		1 November 2023		Time of Accident	1309Z
Type of Aircraft	Beechcraft B1900 D		Type of Operation			Air Transport Operations (Part 135)	
Pilot-in-command Licence Type		Commercial Pilot Licence (CPL)		Age	33	Licence Valid	Yes
Pilot-in-command Flying Experience		Total Flying Hours		2 700		Hours on Type	1 650
First Officer Licence Type		Commercial Pilot Licence (CPL)		Age	39	Licence Valid	Yes
First Officer Flying Experience		Total Flying Hours		2 298.3		Hours on Type	1 526
Last Point of Departure		Bram Fischer International Airport (FABL), Free State Province					
Next Point of Intended Landing		Port Elizabeth Airport (FAPE), Eastern Cape Province					
Damage to Aircraft		Substantial					
Location of the accident site with reference to easily defined geographical points (GPS readings if possible)							
Port Elizabeth Airport (FAPE) apron at GPS co-ordinates determined to be 33°59'02.62" South 025°36'49.02" East, at an elevation of 196 feet (ft)

Reference Number : CA18/2/3/10387
Occurrence Category : Accident (Category 1)
Type of Operation : Air Transport Operations

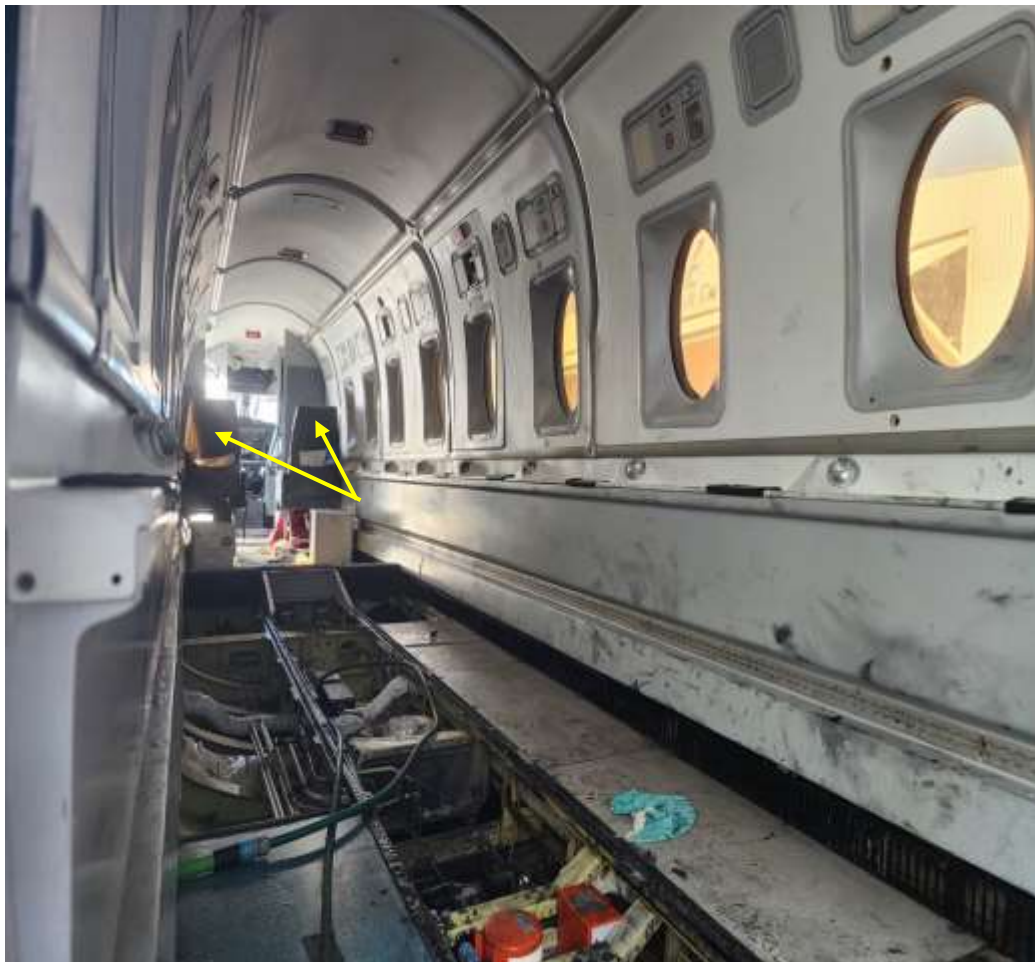
Figure 2: A picture showing the aircraft cabin with the floorboards removed to view damage. The yellow lines point to the two passenger seats behind the cockpit partitioning. (Source: Operator)

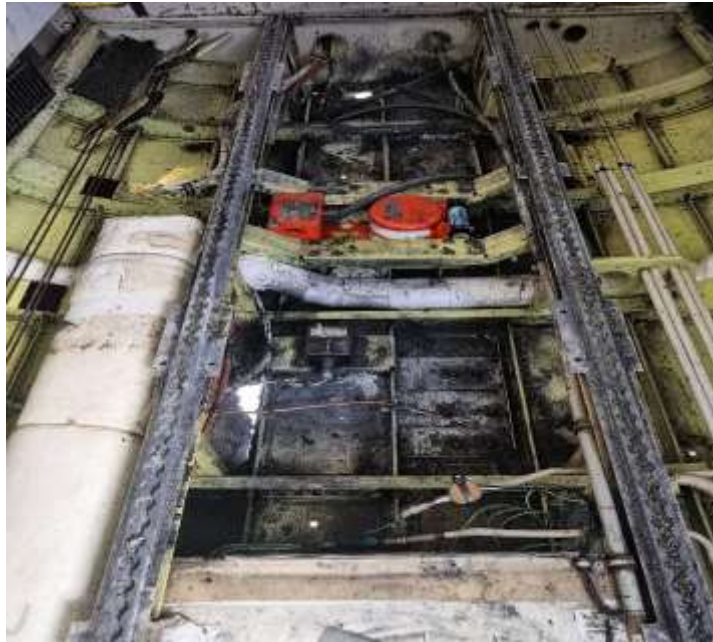
Figure 3: A closer view of the cabin area with evidence of damage on the under-fuselage skin caused by the corrosive chemical. (source: Operator)

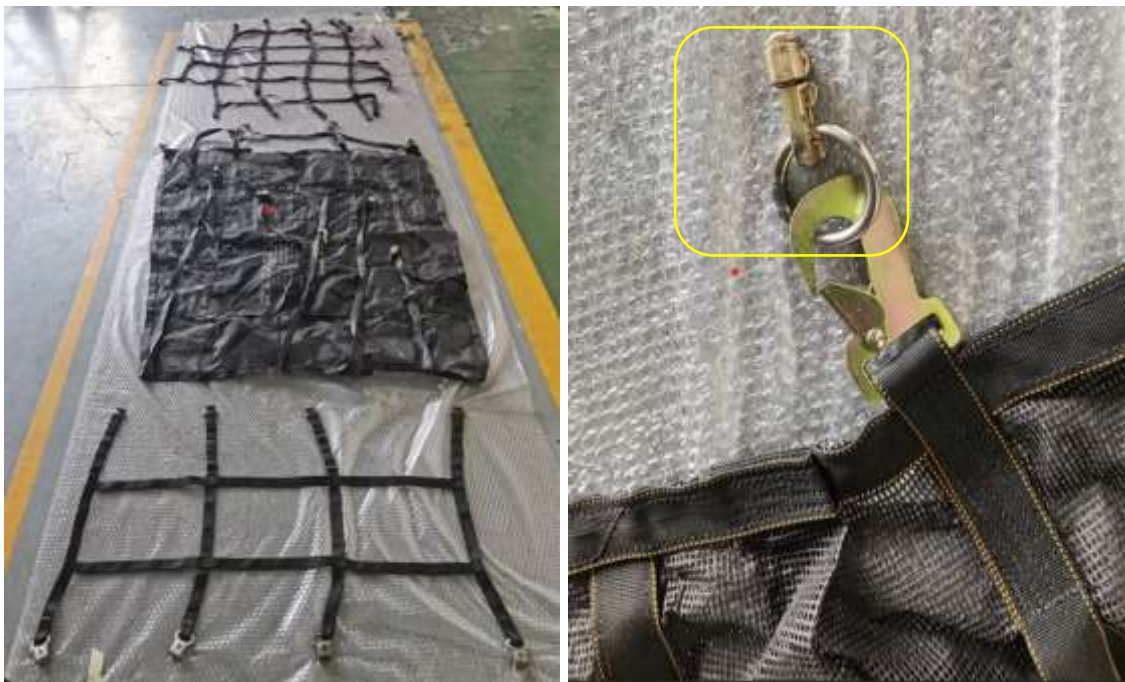
1.16.2 The cargo which comprised toxic corrosive chemical was secured with the net to the aircraft cabin floor rails (Figure 6). No pallets or drip trays (spill trays) were used during the loading of the cargo, and the net holding the cargo was secured to the cabin floor rails. The floor panels inside the aircraft were secured with DZUS fasteners. It was discovered post-accident that one of the DZUS fasteners had pierced the bottom part of one of the 20l chemical containers; the fastener had come loose from the cabin floorboards. The aircraft was thoroughly cleaned, including the underside of the floorboards. The PIC notified the operator after the accident, and the AME was dispatched from FALA to inspect the aircraft. During the aircraft inspection at FAPE, the AME did not notice any sign/s of structural damage or defects. The aircraft was then cleared to fly back to FALA. After a few days, engineers at the operator's facility noted that the chemical had caused substantial corrosive damage to the main wing spar, the floor rails and the underbelly structure/skin. The aircraft was assessed

Figures 6 and 7: The net used to secure the cargo (left). The type of a lock that secured the cargo to the cabin floor rail.

3.4.1 Unavailability of drip trays underneath the cargo that contained corrosive chemical.

- Polyethylene drip trays - 6 for the aircraft and 2 for the cargo area acquired.
- Chemical spill kits, goggles, chemical breathing apparatus and gloves acquired.
- Chemical mask with chemical respirators acquired.
- Speed tape to tape any risks to the items being loaded will be used to ensure nothing can breach the cargo / DG.
- Training of all Ops Flight co-ordinators with Category A (CAT 6) training.
- Operation Manual (OM), Part 1,10 has been updated with all the DG IATA paperwork.

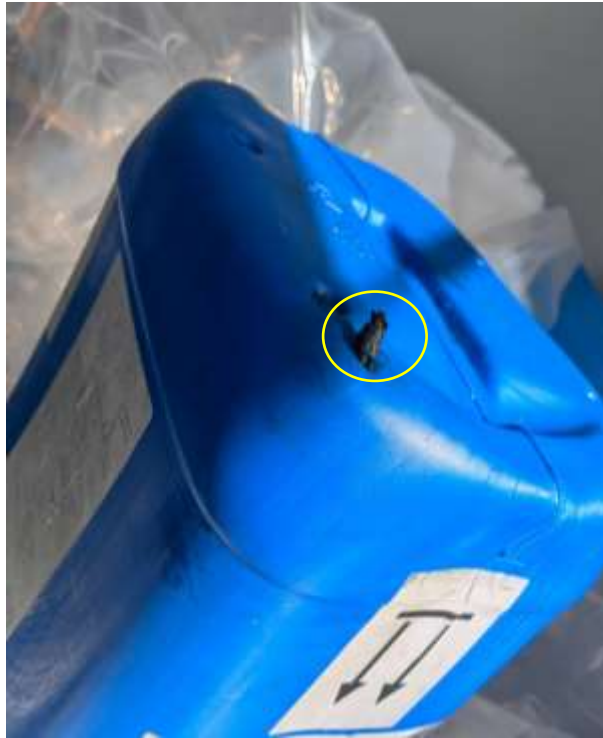
Figure 8: A DZUS fastener pierced through the bottom part of a chemical container.

- 3.2.11. A DZUS fastener pierced the bottom of the plastic container with corrosive chemical which leaked out and caused substantial corrosive damage primarily to the wing spars, the floor rails and underbelly; consequently, the aircraft was declared a constructive total loss or a write off.

3.3.1 A DZUS fastener pierced one of the containers containing a corrosive chemical. This resulted in the chemical leaking and seeping underneath the cabin floorboards, subsequently causing substantial corrosive damage to the main wing spars and the underbelly structure.

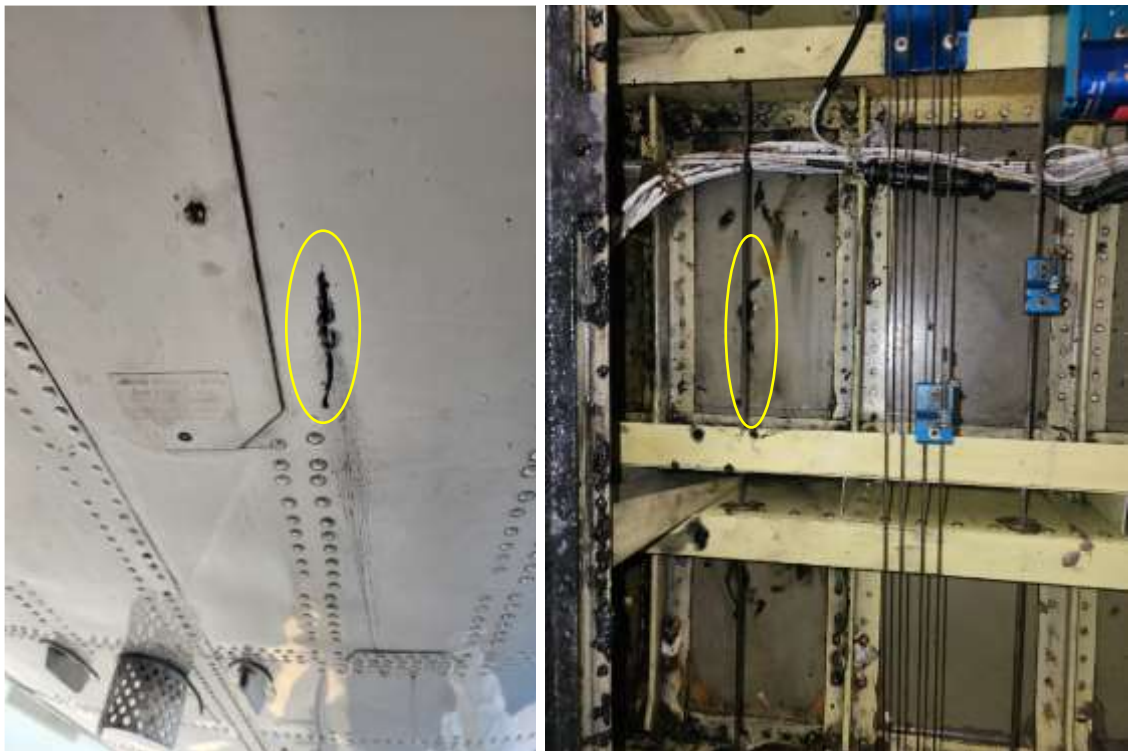
Figures 9 and 10: A crack on lower fuselage caused by the corrosive chemical (left and right pictures). (Source: Operator)

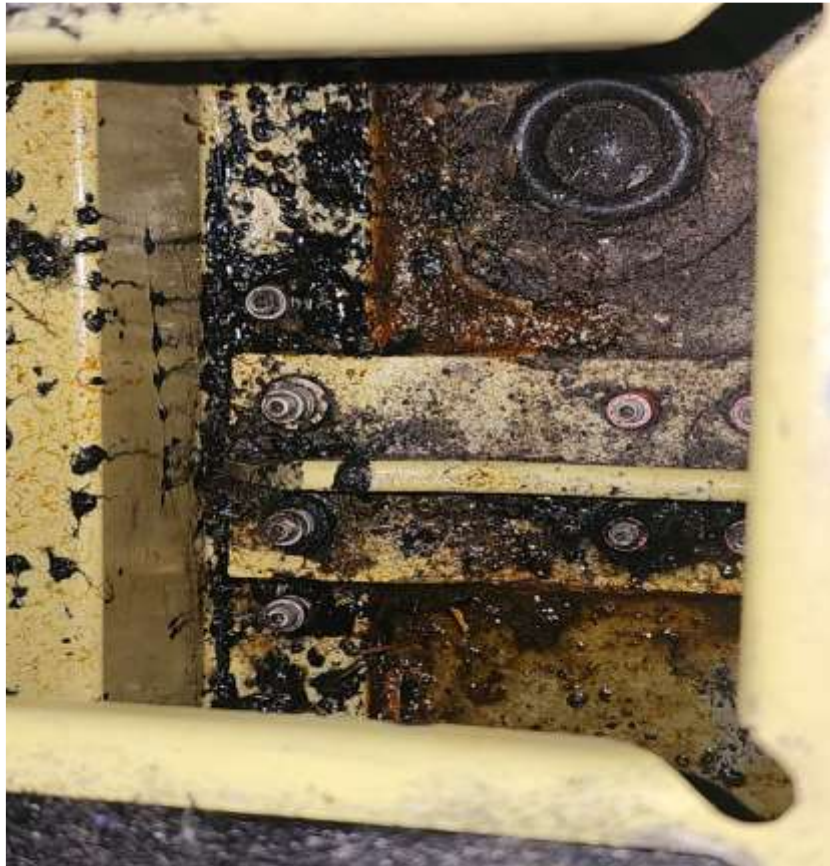
A DZUS fastener punctured one of the containers containing a corrosive chemical which leaked and seeped underneath the cabin floorboards, subsequently causing substantial corrosive damage to the main wing spars and the underbelly structure of the aircraft.

Figure 11: Corrosion on the main wing spars. Note*: The black spots are where the chemical began to eat through the metal. (Source: Operator)
