LIMITED OCCURRENCE INVESTIGATION REPORT – FINAL

Reference Number	CA18/2/3/10388					
Classification	Accident	Date	10 November 2023	Time	1315Z	
Type of Operation	Private (Part 94)					
Location						
Place of Departure	Private airstrip near Pilanesberg, North West Province		Place of Intended Landing	Hoedspruit Civil Airfield (FAHT), Limpopo Province		
Place of Occurrence	On the left of Runway 17 at Hoedspruit Civil Airfield (FAHT)					
GPS Co-ordinates	Latitude	24° 20' 57.39" S	Longitude	030° 56' 50.37" E	Elevation	1766 ft
Aircraft Information						
Registration	ZU-TAE					
Make; Model; S/N	Airplane Factory; Sling II (Serial Number: 004)					
Damage to Aircraft	Substantial		Total Aircraft Hours	1800.3		
Pilot-in-command						
Licence Type	Private Pilot Licence (PPL)		Gender	Male	Age	67
Licence Valid	Yes	Total Hours	27 700	Total Hours on Type	74	
Total Hours 30 Days	5.5	Total Flying on Type Past 90 Days	5.5			
People On-board	1+1	Injuries	0	Fatalities	0	Other (on ground) 0

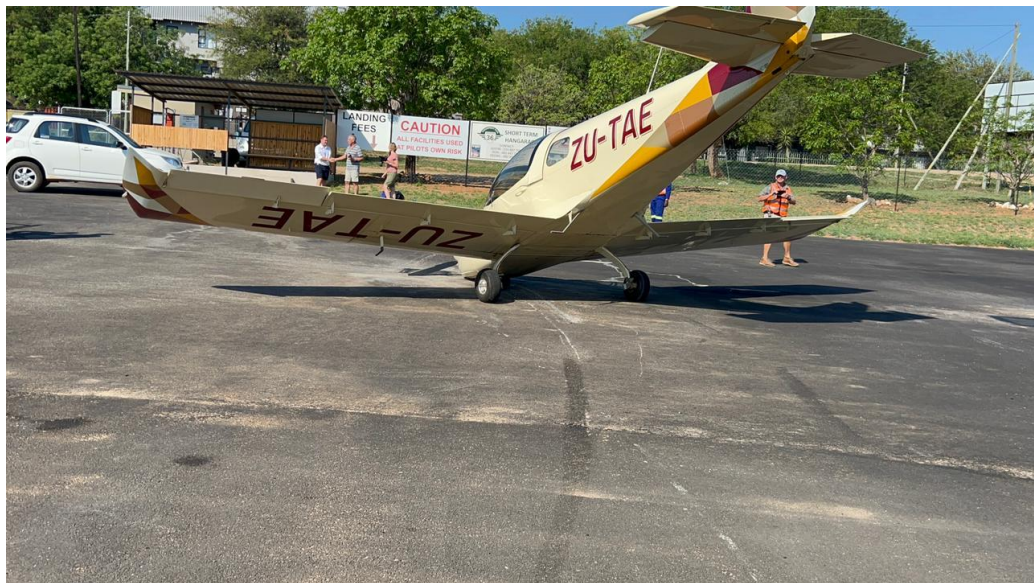
After the aircraft had come to a stop, the pilot and the passenger disembarked from the aircraft unassisted, they were not injured. The nose landing gear, right wing tip (that scrapped the runway) and the propeller were damaged.

Figure 2: The aircraft with the collapsed nose gear after the accident.

6. To avoid overshooting the runway and subsequently impacting the parameter fence, the pilot turned the aircraft to the left; as a result, the nose landing gear collapsed which brought the aircraft to a stop. During the nose landing gear collapse, the propeller contacted the runway surface whilst the engine was still running at high speed. Thus, the propeller was damaged, and one of the three blades broke off.

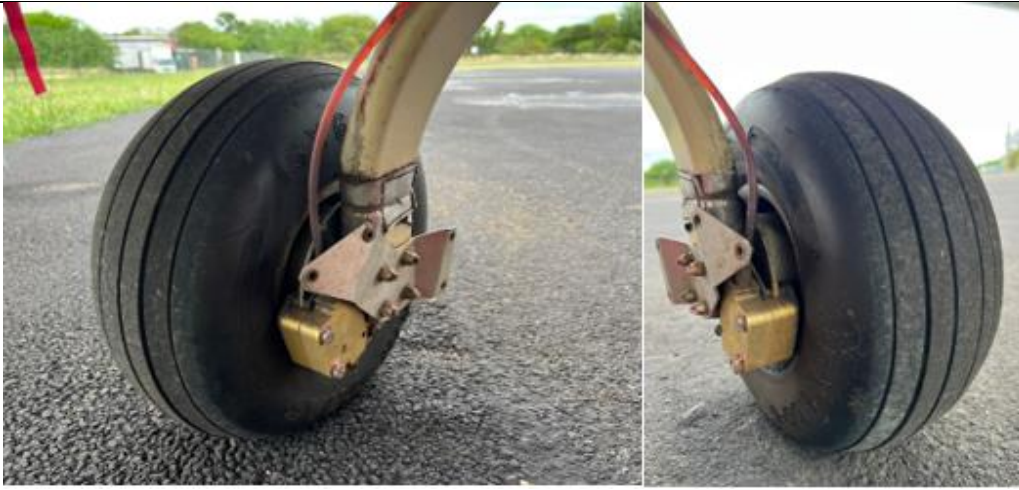
Figure 3: The right and left main landing gear brake pipelings showed no leakage. (Source: AMO)

The aircraft's brake system was tested, and no anomalies were found. There was no brake fluid leakage, and the brake linings and disc were still within limits.
