**LIMITED OCCURRENCE INVESTIGATION REPORT – FINAL**

<b>Reference Number</b>	CA18/2/3/10389						
<b>Classification</b>	Accident	<b>Date</b>	15 November 2023		<b>Time</b>	1625Z	
<b>Type of Operation</b>	Training (Part 141)						
<b>Location</b>							
Place of Departure	Brakpan Aerodrome (FABB), Gauteng Province		Place of Intended Landing		Bethlehem Aerodrome (FABM), Free State Province		
Place of Occurrence	Runway 26 at Bethlehem Aerodrome (FABM), Free State Province						
GPS Co-ordinates	Latitude	28°14'55.38"S	Longitude	28°20'37.04"E	Elevation	5424 ft	
<b>Aircraft Information</b>							
Registration	ZS-ESU						
Make; Model; S/N	Piper-28-140 (Serial Number: 28-22011)						
Damage to Aircraft	Substantial			Total Aircraft Hours	4290.3		
<b>Pilot-in-command</b>							
Licence Type	Private Pilot Licence (PPL)		Gender	Male		Age	21
Licence Valid	Yes	Total Hours	160.7		Total Hours on Type	127.5	
Total Hours 30 Days	5.7		Total Flying on Type Past 90 Days	66.5

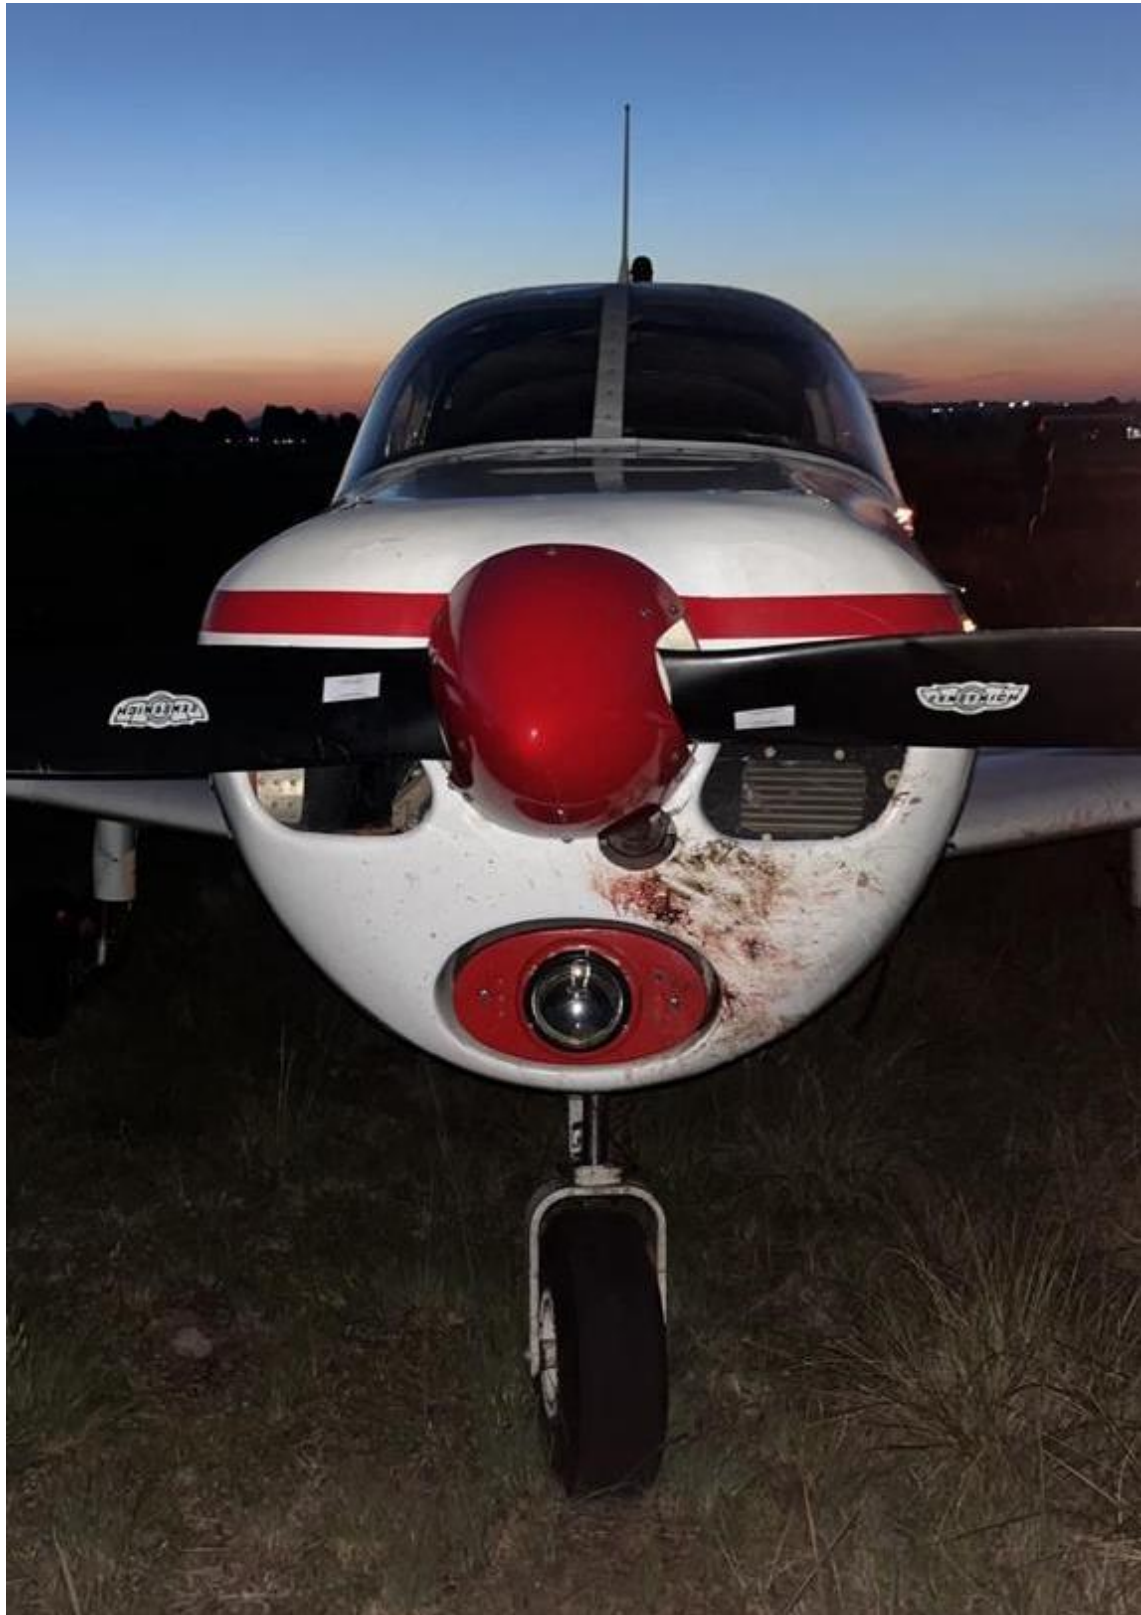
**Figure 1:** Bird strike mark on the aircraft. (Source: Operator)

8. Following the touch-and-go landing and whilst on the take-off roll, the aircraft collided with a bird and the pilot aborted the flight. Due to the insufficient remaining runway surface, the pilot could not bring the aircraft to a safe stop, and it overran the runway and impacted the concrete pole supporting the perimeter fence.
9. FABM RWY 11 dimensions are 1175 metres (m) long and 15m wide. It is likely that the aircraft landed deep and, following the aborted take-off, the remaining runway was insufficient to bring the aircraft to a safe stop and it overran the runway and impacted the concrete pole supporting the perimeter fence.

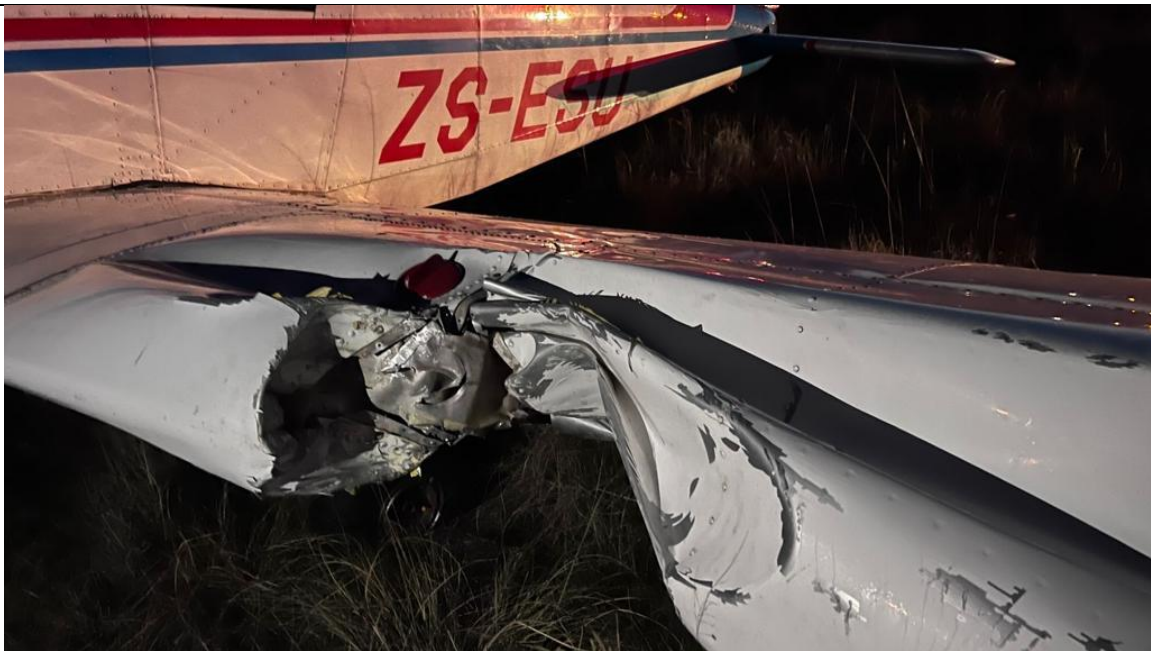
The aircraft sustained damage to the left wing. The two occupants were not harmed. According to the pilot questionnaire, the weather was fine at FABM at the time of the flight.

**Figure 2:** Damage to the left wing of the aircraft. (Source: Operator)

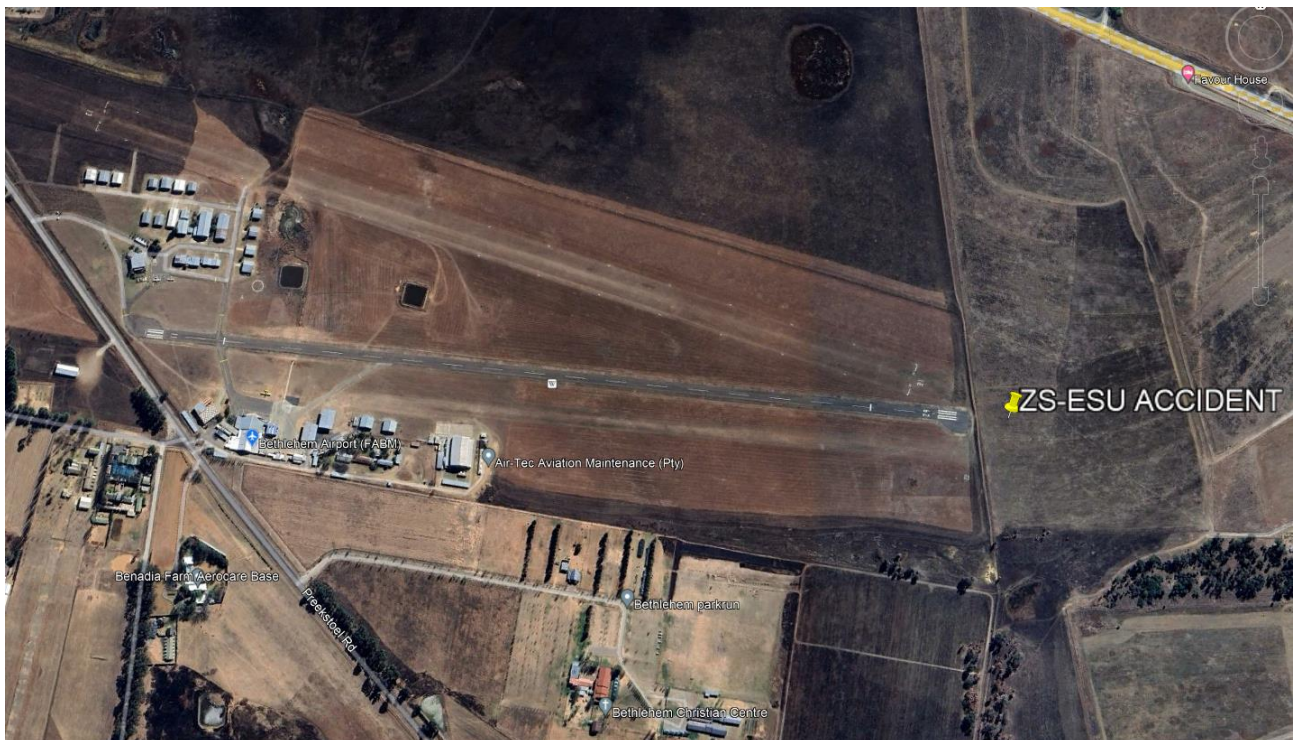
**Figure 3:** The aircraft landed on RWY 11 and came to a stop 56m beyond the threshold. (Source: Google Earth)

It is likely that the aircraft landed deep and, following the aborted take-off, the remaining runway length was insufficient to bring the aircraft to a safe stop and, thus, the aircraft overran the runway and impacted the concrete pole that supported the perimeter fence.
